1MC03 Main Works – Contract Lot S1

HERITAGE AGREEMENT METHOD STATEMENT (HAMS)-MONITORING AND CONSERVATION MANAGEMENT OF GROUND MOVEMENTS DUE TO BELOW GROUND CONSTRUCTION AT 12 PARK VILLAGE EAST - APD-ESCT-01

Document no: 1MC03-SCJ-EV-MST-SS01_SL03-000009

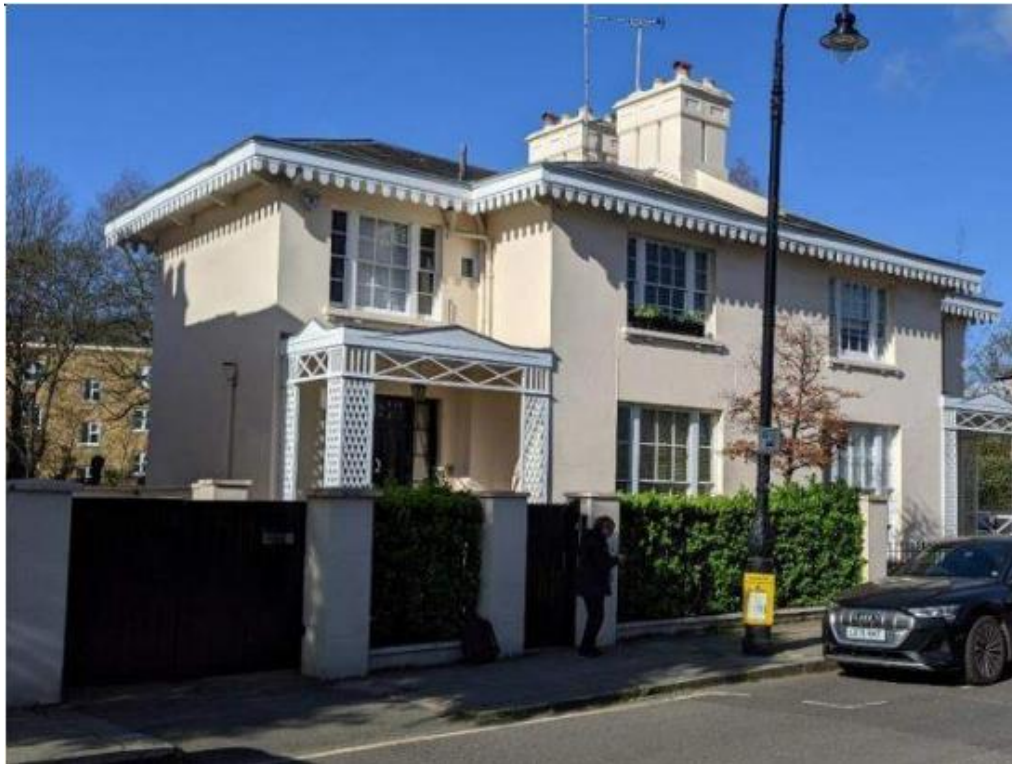
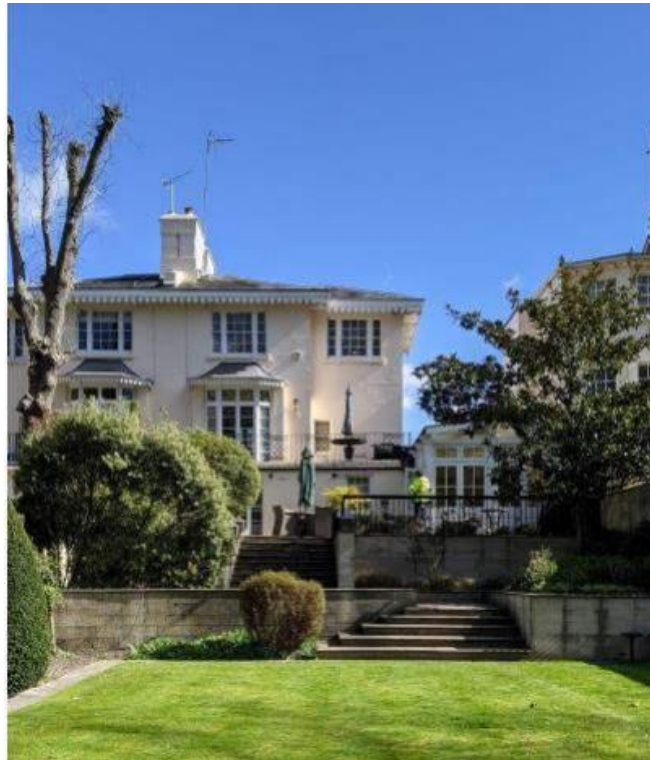
Figure 2 12 Park Village East front and rear elevations

4.1.1 12 Park Village East is one of the detached residential villas laid out between 1824 and 1832 to John Nash's Regent's Park village suburb design (Figure 2). A 2005 listed building consent permitted a lower ground floor infill connection to 14 Park Village East and the garden boundary between 12 and 14 Park village East has been partially removed.

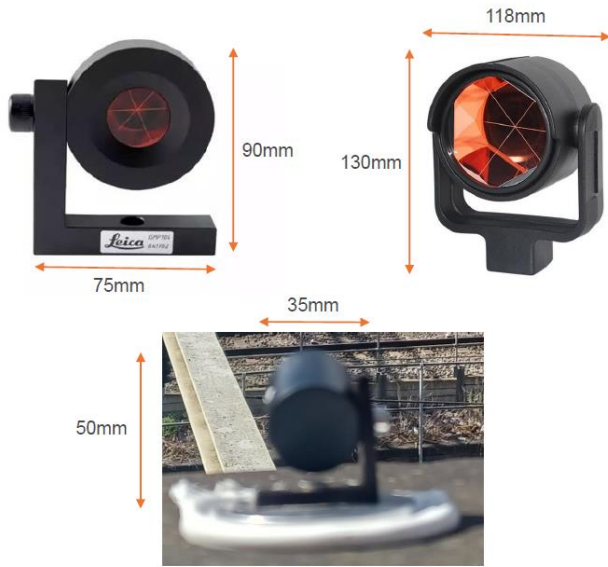
Figure 7 Typical 3D prism

7.5.2 3 D prisms, crack monitors, laser distometers, and ground surface levelling studs will measure movements affecting the key building components and adjoining ground surfaces. The devices illustrated (Figures 7 & 8) are typical examples, but specific instruments used may vary according to situation.

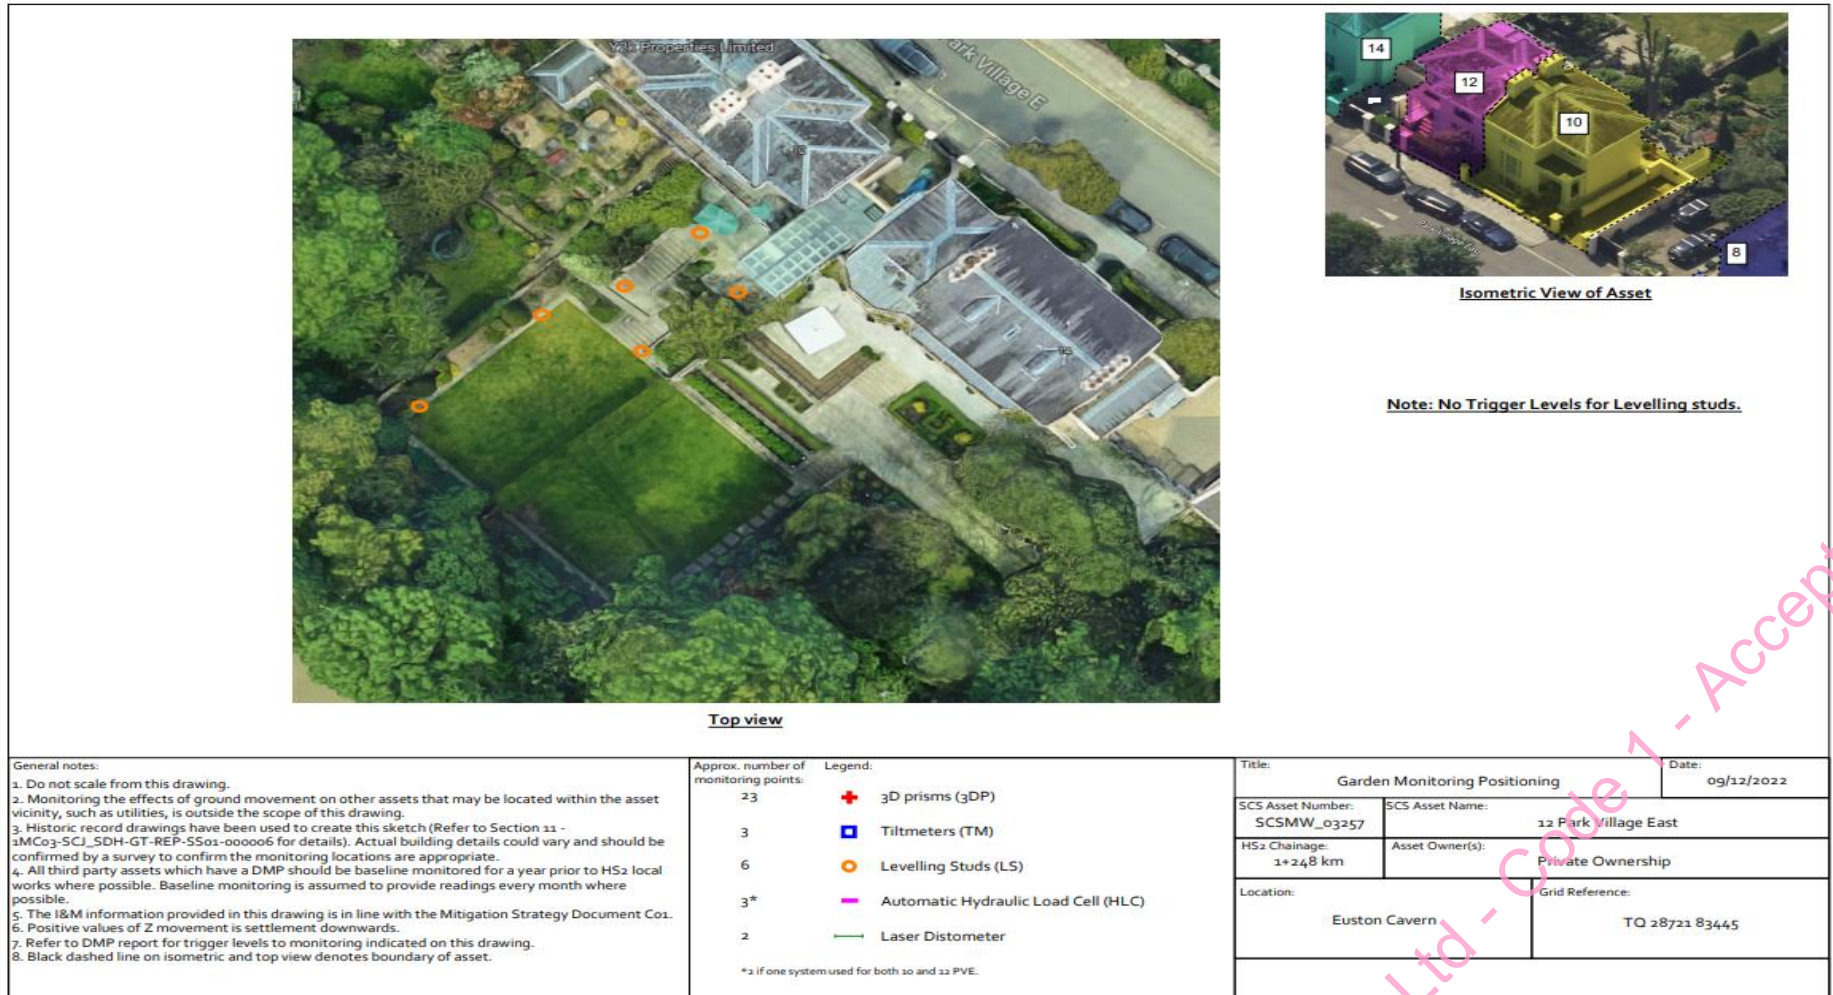
Appendix A – Instrumentation Design Drawings (as proposed in SCSjv Designers Monitoring Plan - 10 12 14 16 26 28 Park Village East Asset Protection Area East - Euston Throat West Buildings Package 1 - APD-ESCT-01 Document no: 1MCo3-SCJ_SDH-GT-REP-SSo1-000012)

- 7.5.10 Settlement of the rear gardens within the influence zone of the HS2 works is to be monitored by means of precise levelling studs, generally at 5m centres. Indicative positions have been indicated in Appendix A Instrumentation Design Drawings.
- 7.5.11 This should extend to the historic rear retaining wall to the canal.
