2.0 Design & Sustainability

2.1 Design Overview

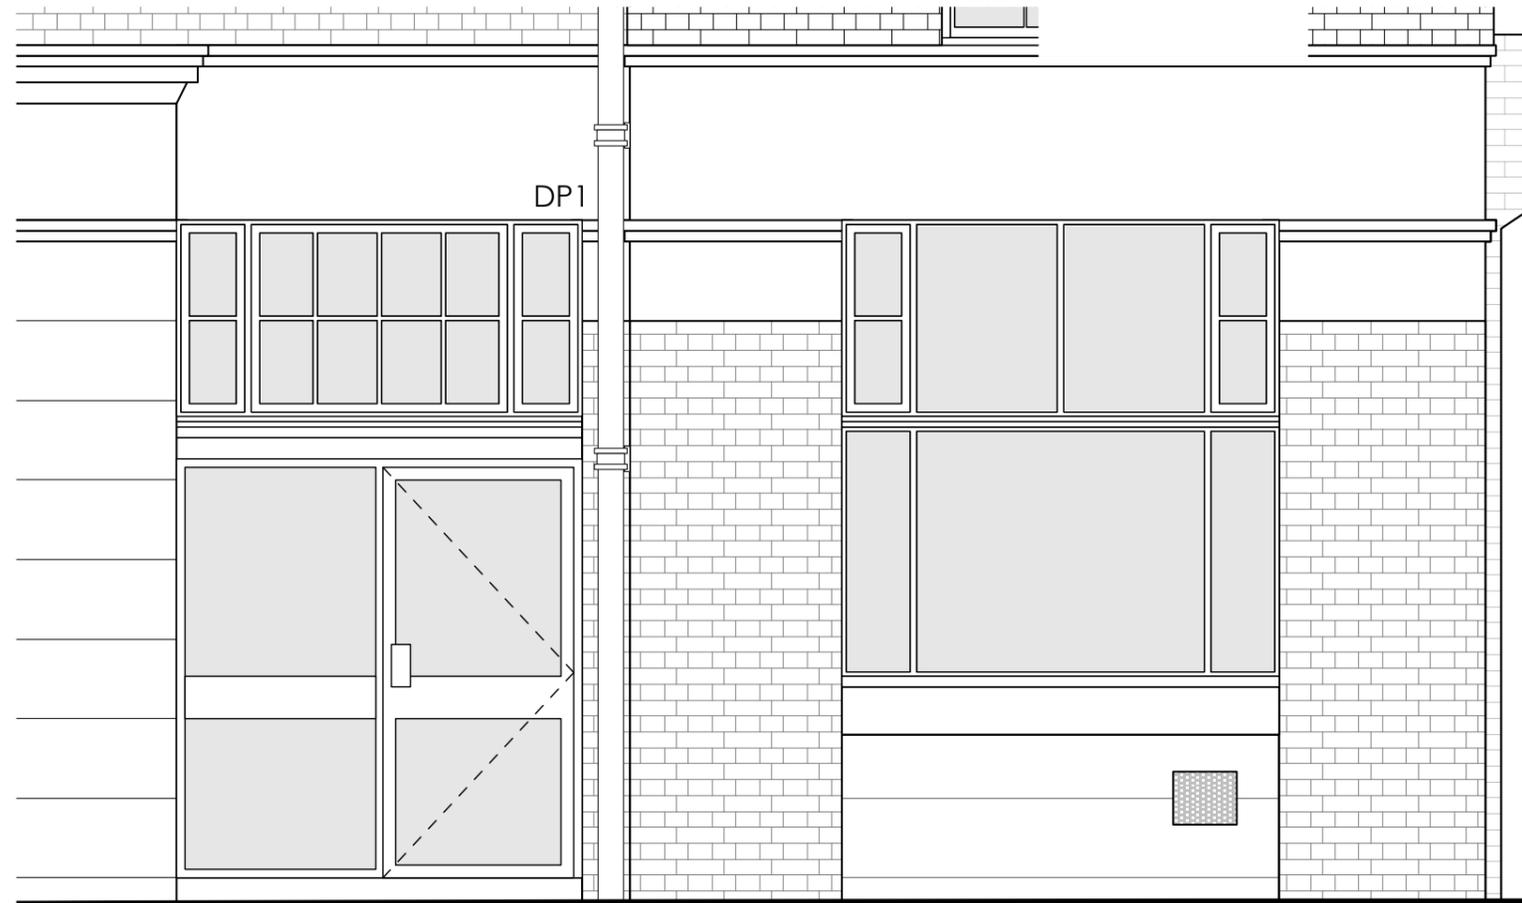
The existing shop front door opening to No.123 (which is currently boarded up for security reasons) has aluminium frames which are in poor condition, as well as a timber framed fanlight over the door opening. It is proposed that these are both replaced with a new aluminium framed door and fanlight unit to mirror the existing arrangement of transoms and mullions.

Unlike the existing shop front door, the existing ground floor window opening onto Clerkenwell Road has a timber frame. However, this is also in poor condition and in need of replacement. As such, it is proposed to replace the unit with an aluminium framed window unit, mirroring the existing arrangement of mullions and transoms.

Proposed Replacement Shop Front Window and Door to Clerkenwell Road Elevation

The proposed replacement of the shop front door and window will be more in keeping with the rest of the building, and make the facade more homogenous, with a single material to used across both the window and door opening, superseding the currently mismatched materials. Works are limited to these bays and the heritage facade of the Radcliff building will otherwise remain unchanged.

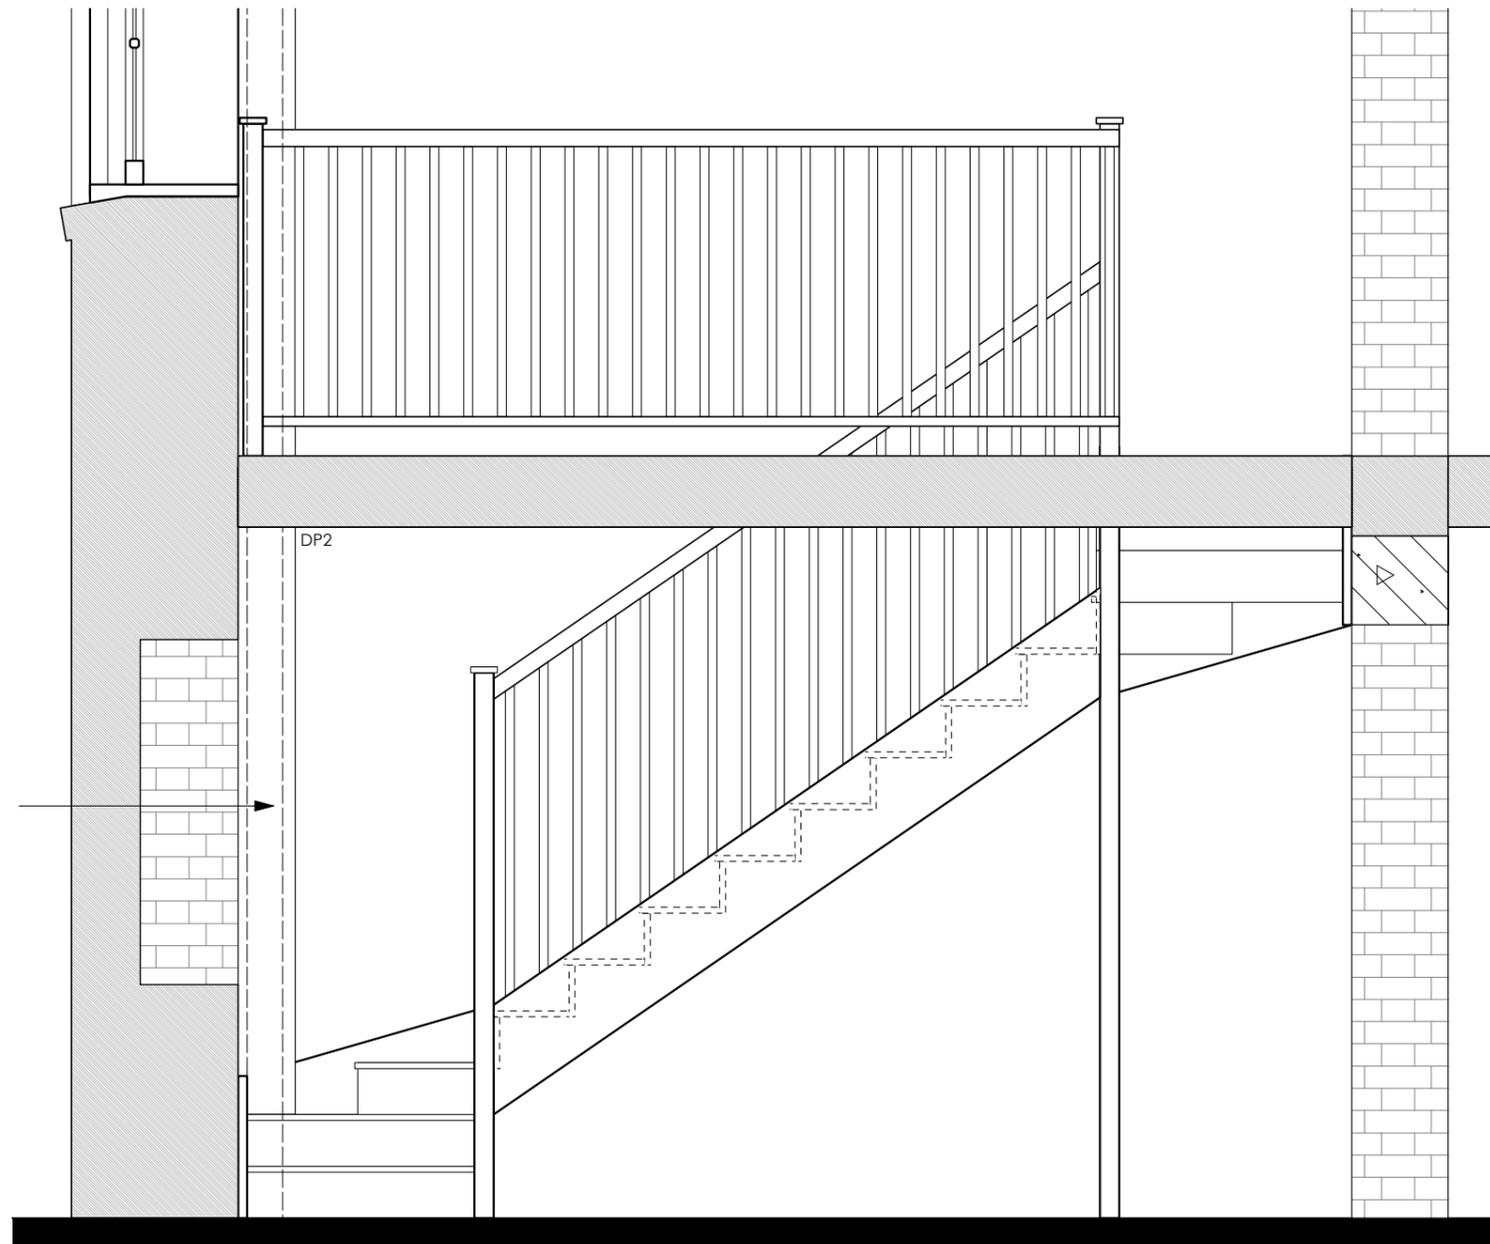
As such, it is proposed that a new staircase is installed to provide access between the two levels for users of the property. These works will involve adaptations to the existing ground floor structure, including cutting and trimming of existing joists, along with removal of boards as required to form the proposed opening for the stair. Following this, a new timber staircase, with timber stringers to the edge of each flight, is to be installed. The proposed stair is of a simple design, with square profile balustrade and square newel posts with simple capping details.

Proposed Stair Between Ground Floor and Basement

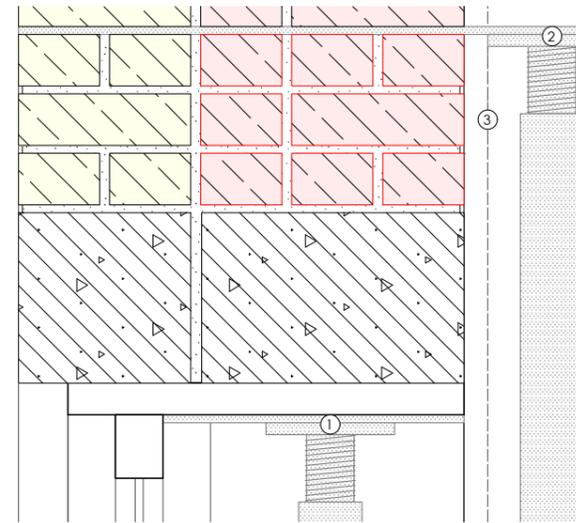
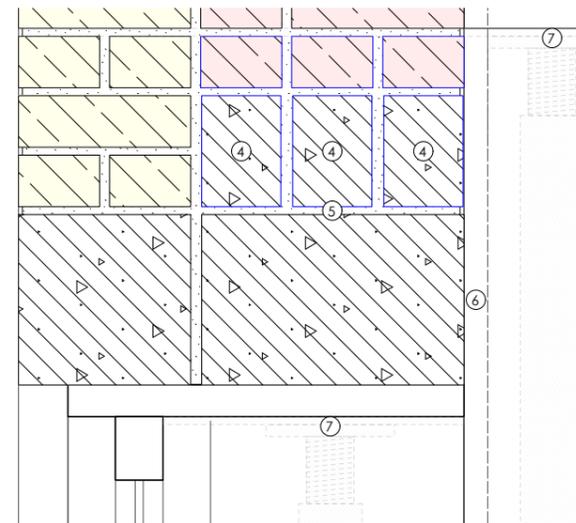
The proposed sequence of works is illustrated in the adjacent detail drawings, with annotations for each numbered label as follows:

1. Strongboy & acrow prop above window frame, below the lintel (post FosRoc repair, if it is viable);
2. Strongboy & acrow prop in the mortar bed 3 courses above the Clinker lintel. The walls in this area are solid brick, English bond, London Stock outer skin and London Red inner skins. The strong-boy pockets will be created to support the London Stock skin during the renovation process, but the outer skin will not be removed as part of the works. Any disturbed pointing will be replaced like-for-like;

3. Carefully remove the mortar beds and cut out bricks above the existing Clinker Lintel, retain for re-use post lintel installation;
4. Replace with 3 no. back-to-back, pre-cast, concrete lintels (Naylor R6, 100(W)x145(H)mm @ 1800mm to be trimmed on site, with a minimum end bearing of 150mm at both ends, for each lintel). Install one then the other, set in place, then reinstate the retained original bricks

5. above the lintels using matching mortar to the original spec (Hydraulic Lime mortar) and leave to set for 48hrs;
6. Dry pack and compact between the old and new lintels with a strong mix and leave for 48hrs;
7. Return after setting time, make good to old lintel using Sika 615 High Build and 620 fairing coat;
8. Remove propping and re-point the brickwork pockets using matching mortar to the original spec (Hydraulic Lime mortar).

Proposed Sequence of Works to Install New Lintel/Repair Existing

Along with this, the existing clinker lintel supporting the inner leaf of brickwork is showing serious signs of disrepair. As such, it is proposed that a new lintel is installed above the existing clinker lintel, preserving the fabric of the existing Listed Building, but ensuring its structural performance is completed by a new and undamaged structure. This will ensure no further damage occurs to the clinker lintel, or the external wall should it continue to degrade.

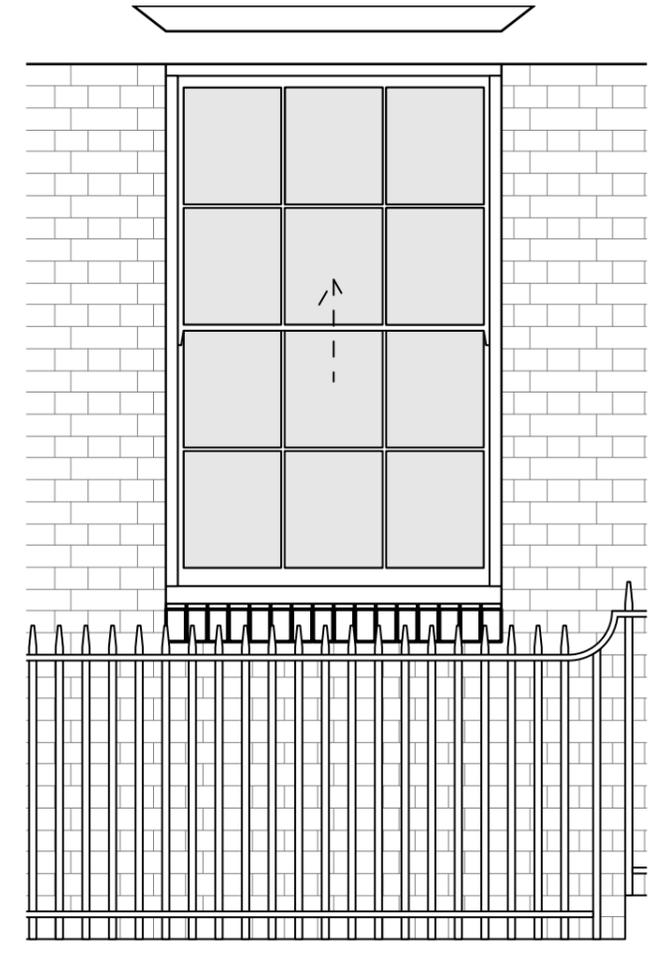
External Elevation of Ground Floor Rear Window

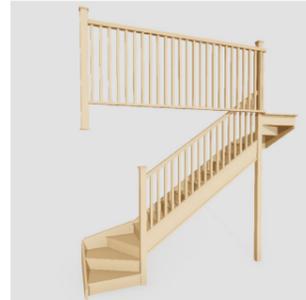
The proposed stair is intended to be constructed out of pine timber. 3D model of proposed stair adjacent

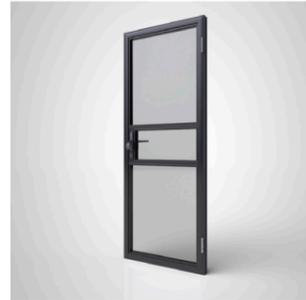
New Aluminium door and window frames to the shop front door and window openings anodized or polyester powder coated to a dark grey finish

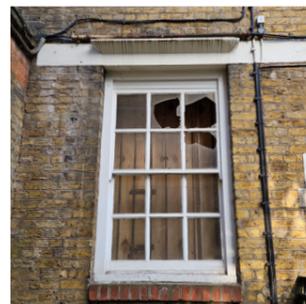
Existing timber sash window frame, boxes, weights, stiles etc to be retained, and broken glazing to be replaced with single glazed panes to match the existing. Beads/putty to be retained/replaced as necessary to match the existing.

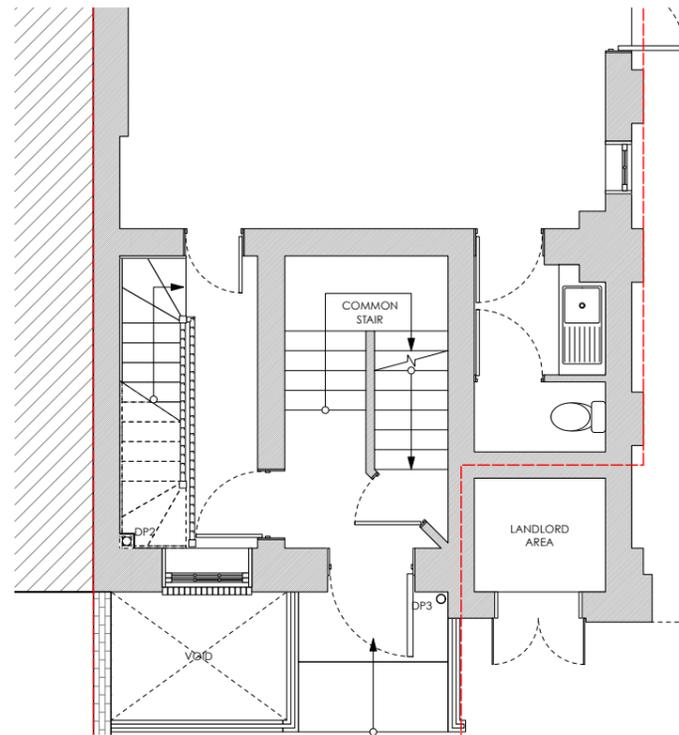
Proposed Ground Floor Plan

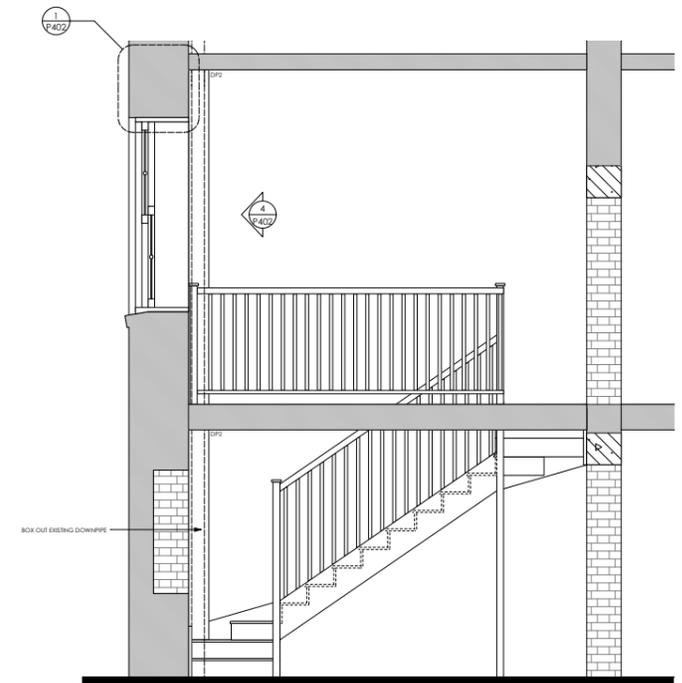
Proposed Section - Stair

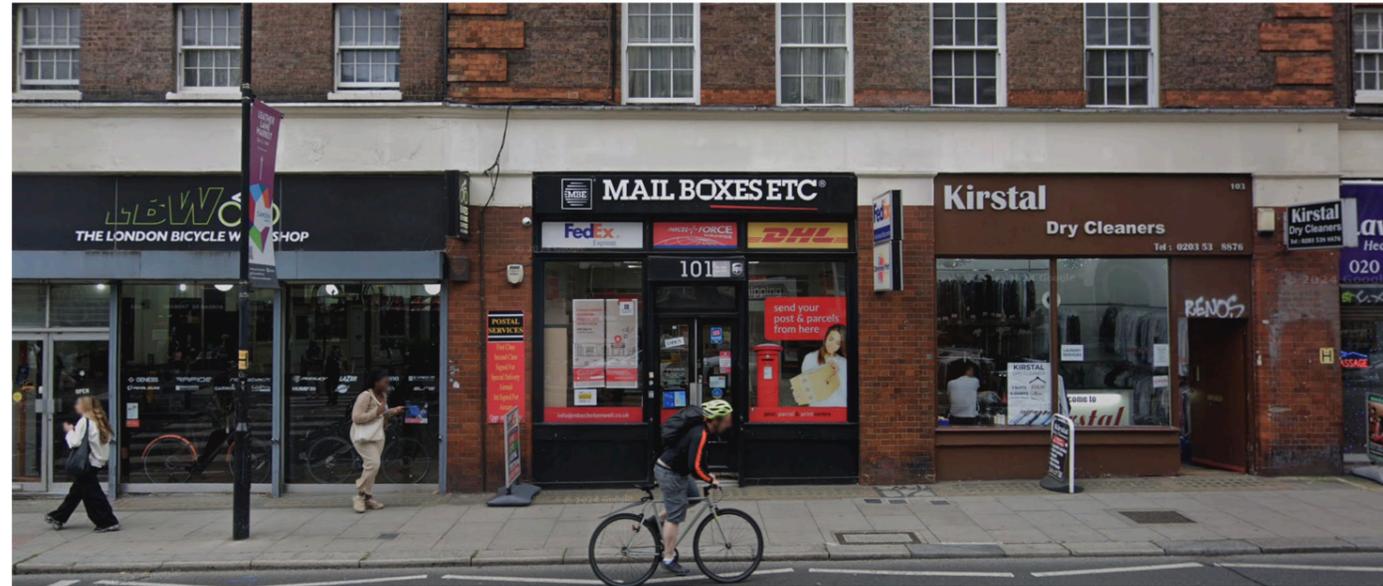
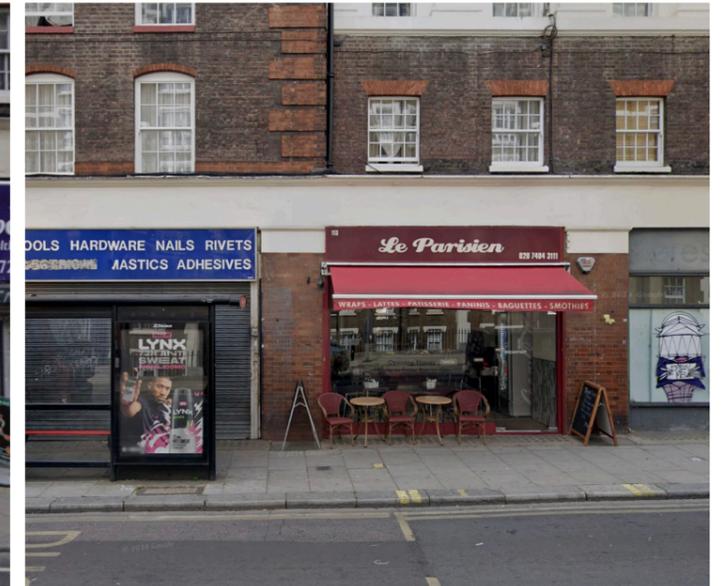
Although the change away from the original timber will impact on the heritage asset, a precedent of ground floor retail units utilising stand-alone and modern materials within the bounds of the opening - flanked by glazed brick piers and capped with a simple stucco pediment - as already well established along the elevation.

Other Shop Fronts In The Radcliff Building

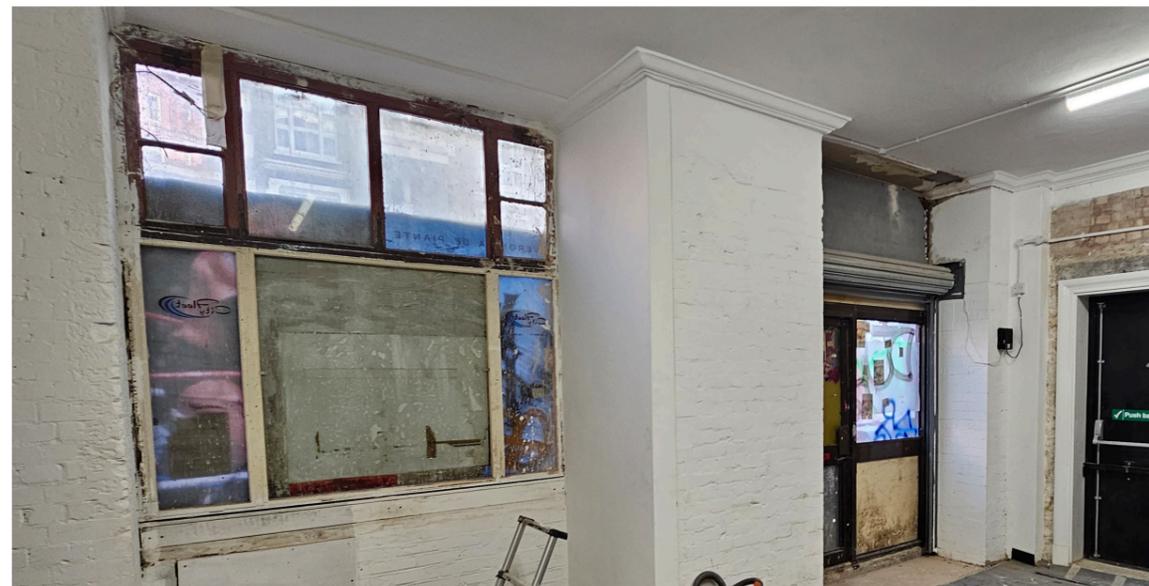
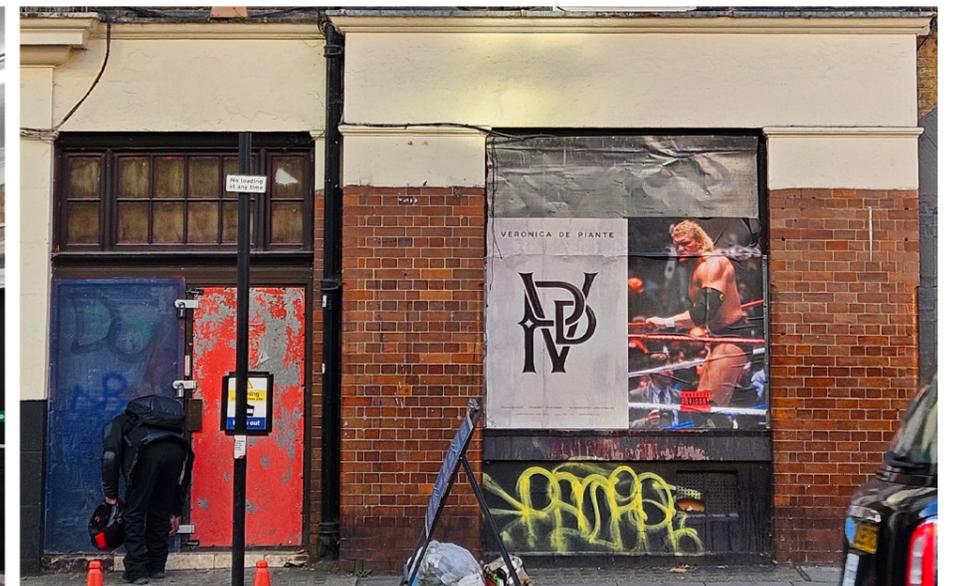
Internal & External Views of Existing Shop Front to No.123

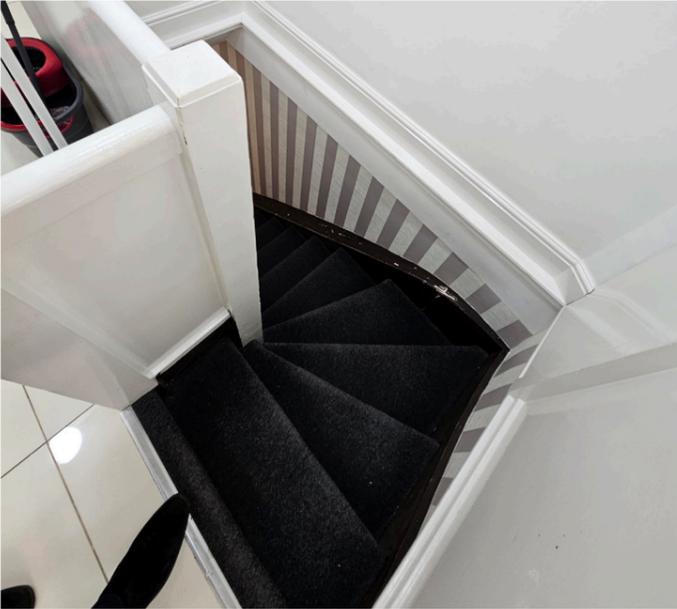
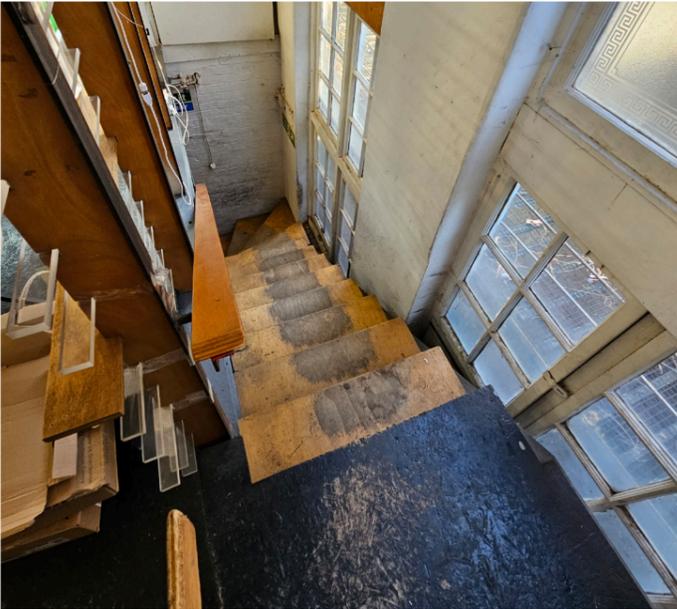
As with alterations to shop fronts, there is also precedent for stairs being added to retail units along the Clerkenwell Road elevation of the Radcliff building. A review of some of the existing units found ground to basement circulation stairs had been added to at least 2No adjacent properties, including No.117-119 and No.121, photos of which are included adjacent.

Existing Stairs to No.121 (above) and No.117-119 (below)

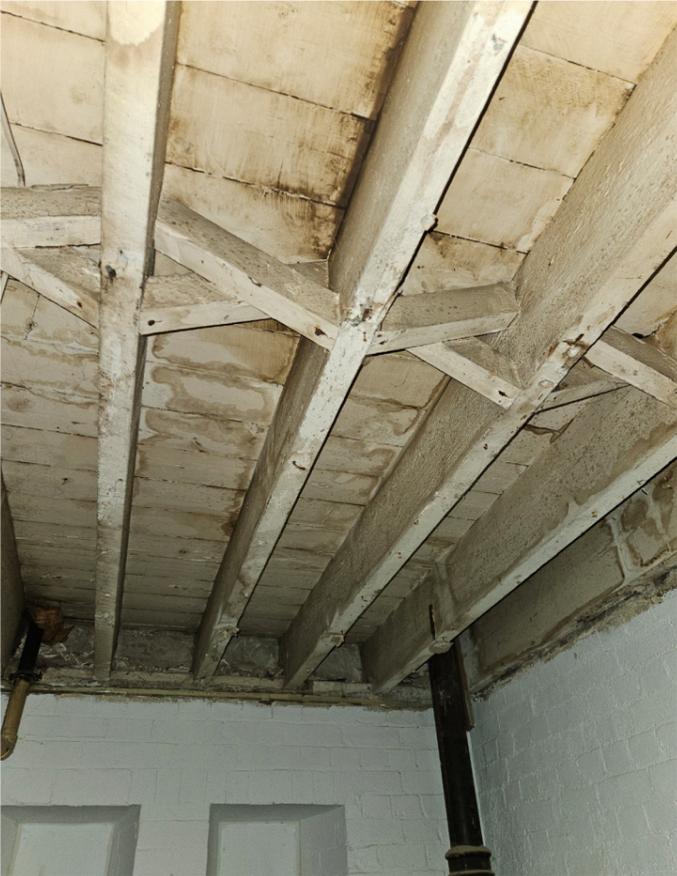
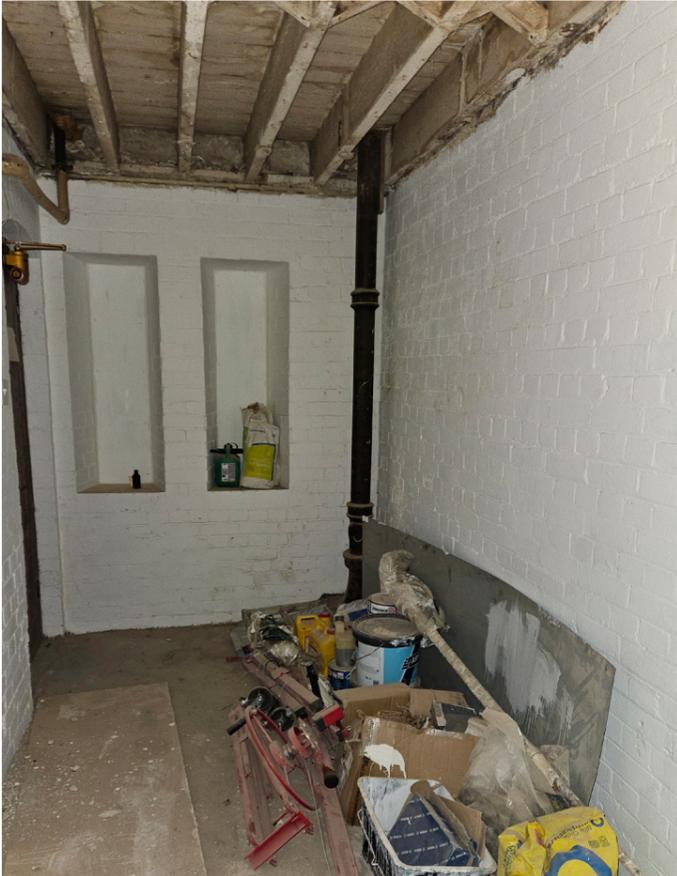
The proposed internal circulation stair will impact on the existing heritage asset through the works required to form the opening in the ground floor, providing access to the basement level. This will involve the cutting and trimming of the existing floor joists, along with the removal of a small area of floorboards to create the floor opening required.

Existing Floor Construction to Location Where Stair is Proposed

There will be a small loss of heritage fabric resulting from this, however, where possible, the existing timber joists are to be re-used to trim the new opening, and the existing floorboards are to be reused in other areas of the property as far as possible.

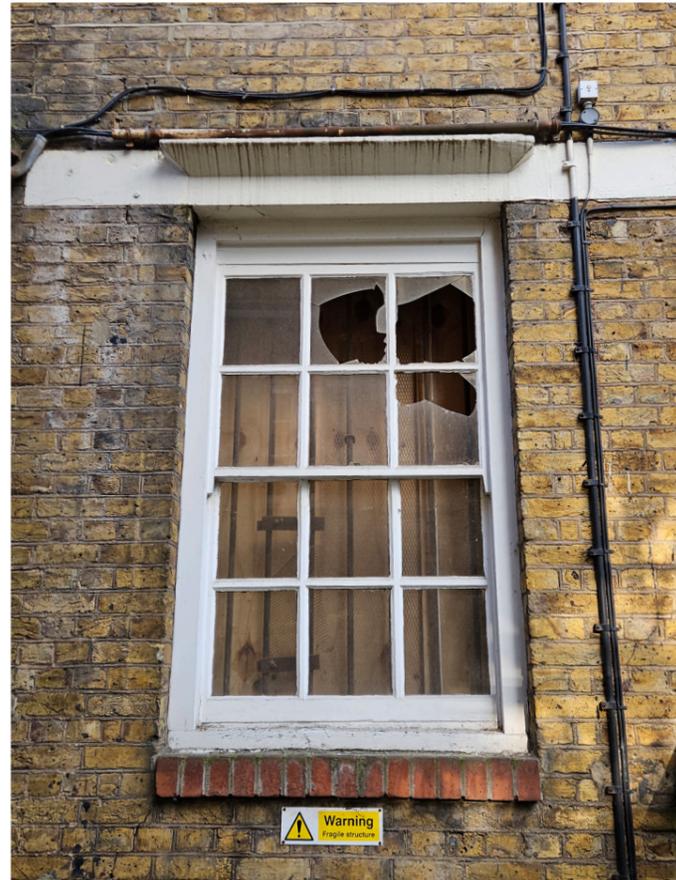
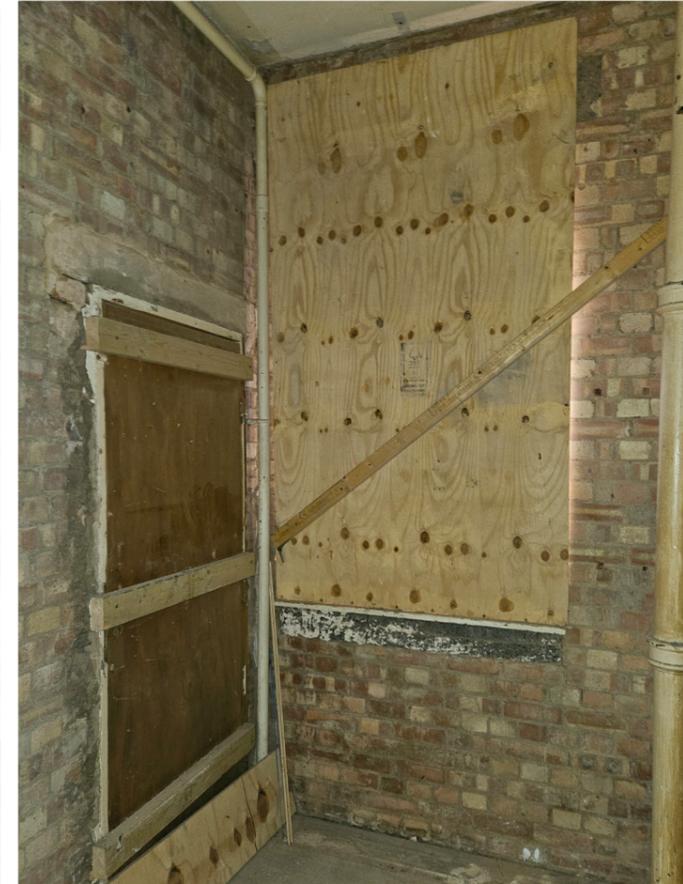
The rear elevation has fewer historic features and but is still referenced to within the Listing of the building, facing toward the rest of the Bourne Estate. The repairs on the rear window look to extend the life of the original window by replacing some broken panes. Some repairs to the lintel from the interior side will help maintain the original fabric around the opening. If left unattended, may otherwise result in more significant damage to the facade of the Listed Building.

The main impact on the heritage asset will result from the replacement lintels, which will be visible from the inside of the building within the inner leaf of brickwork. Although this will result in a jarring appearance internally, it avoids the replacement of the existing clinker lintel, which would not only result in the loss of heritage building fabric, but also possibly result in damage to the external facade surrounding the window opening.

External & Internal View of Window to be Repaired

3No of the existing glazing panes to the existing ground floor rear window to No.123 are broken and in need of replacement. In the completion of these works it is proposed the existing timber sash window frame, boxes, weights, rails etc are retained, and only the broken glass between the glazing bars is replaced. It is not clear whether the panes of glass are kept in place with timber beading or putty, however, works will aim to retain timber beading profiles where possible, and replace putty to match existing as necessary.
