1MC03 Main Works – Contract Lot S1

HERITAGE AGREEMENT METHOD STATEMENT (HAMS)-MONITORING AND CONSERVATION MANAGEMENT OF GROUND MOVEMENTS DUE TO BELOW GROUND CONSTRUCTION AT 26 PARK VILLAGE EAST - APD-ESCT-01

Document no: 1MC03-SCJ-EV-MST-SS01_SL03-000017

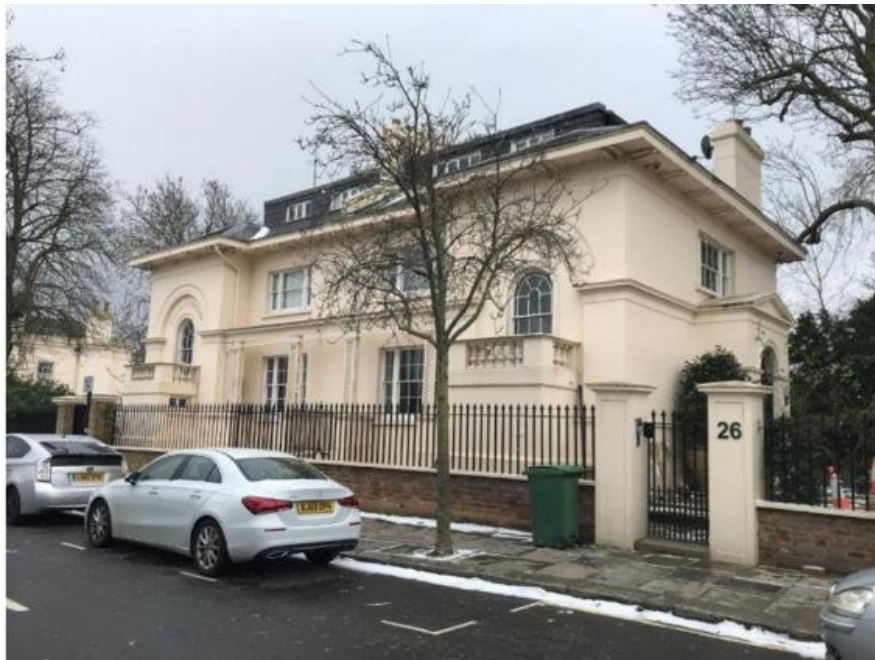
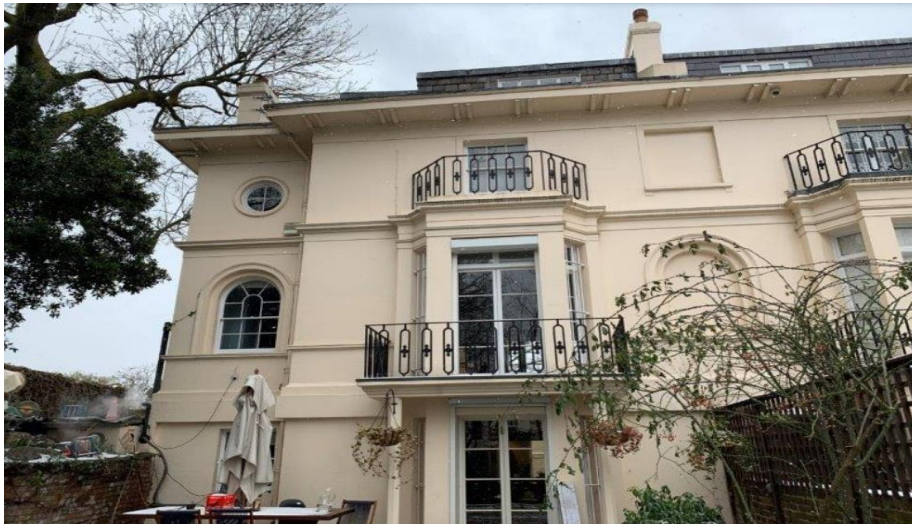
Figure 2 26 Park Village East front and rear elevations

4.1.1 26 Park Village East is one of the 3-storey semi-detached residential villas laid out between 1824 and 1832 to John Nash’s Regent’s Park village suburb design (figure 2). All sixteen surviving residential properties are jointly grade II* listed.

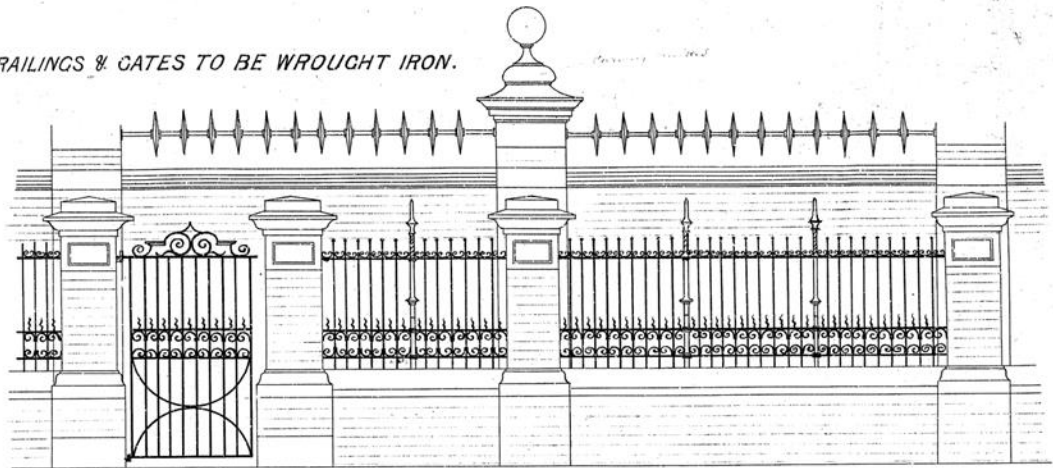
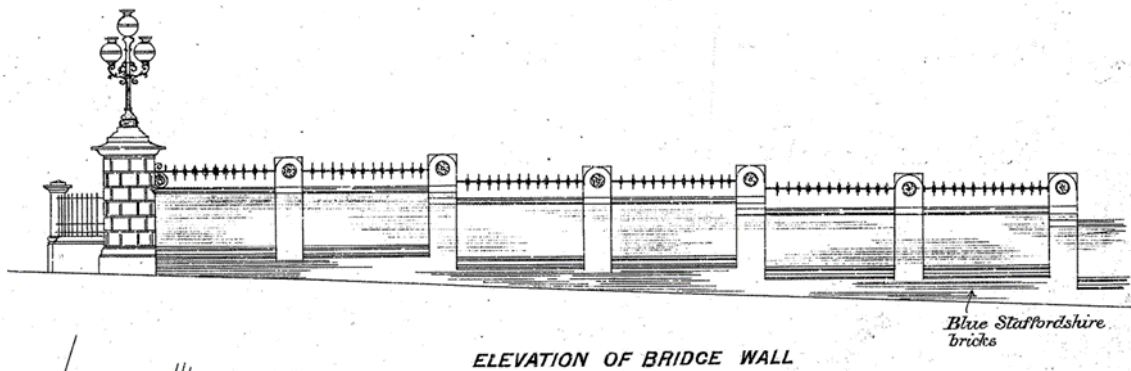
Figure 7 'L.&N.W.R. EUSTON WIDENING Details of Boundary walls and Ironwork', 1900. (Source: Network Rail Archives)

- at street level the Park Village East retaining wall incorporates architectural features that complement the immediate neighbouring streetscape, using a red brick facing and dressed Portland stone coping and ball finials (figure 7). A matching dwarf wall, originally designed with brick piers to support ornate metal railings and gates, forms planting beds for shrubs and trees, intended to soften the imposing street level retaining wall and maintain Nash’s ‘wooded valley’

ALL ORNAMENTAL RAILINGS & GATES TO BE WROUGHT IRON.

BOUNDARY AND DWARF WALL TO PLANTATION
(TWO GATES TO EACH PLANTATION)

- 4.2.8 The new 60 m wide 17m deep cutting was supported by monumental brick retaining walls that employ closely spaced shallow buttresses, carried up to form piers with decorative ball finial stone caps at street level. Architectural design aesthetics match the quality and refinement of Stephenson’s older work but use blue engineering brick instead of the earlier red stock brick; does not rely on the curved batter for structural integrity; and at street level replaces Stephenson’s distinctive open decorative iron railing with brick panels. A section of the original retaining wall survives on the east side of the cutting in the approaches to and throughout the Upper Parkway tunnel. Sections of original railing survive along the parapets to the rear of some of the adjoining properties, including 57 Mornington Terrace.

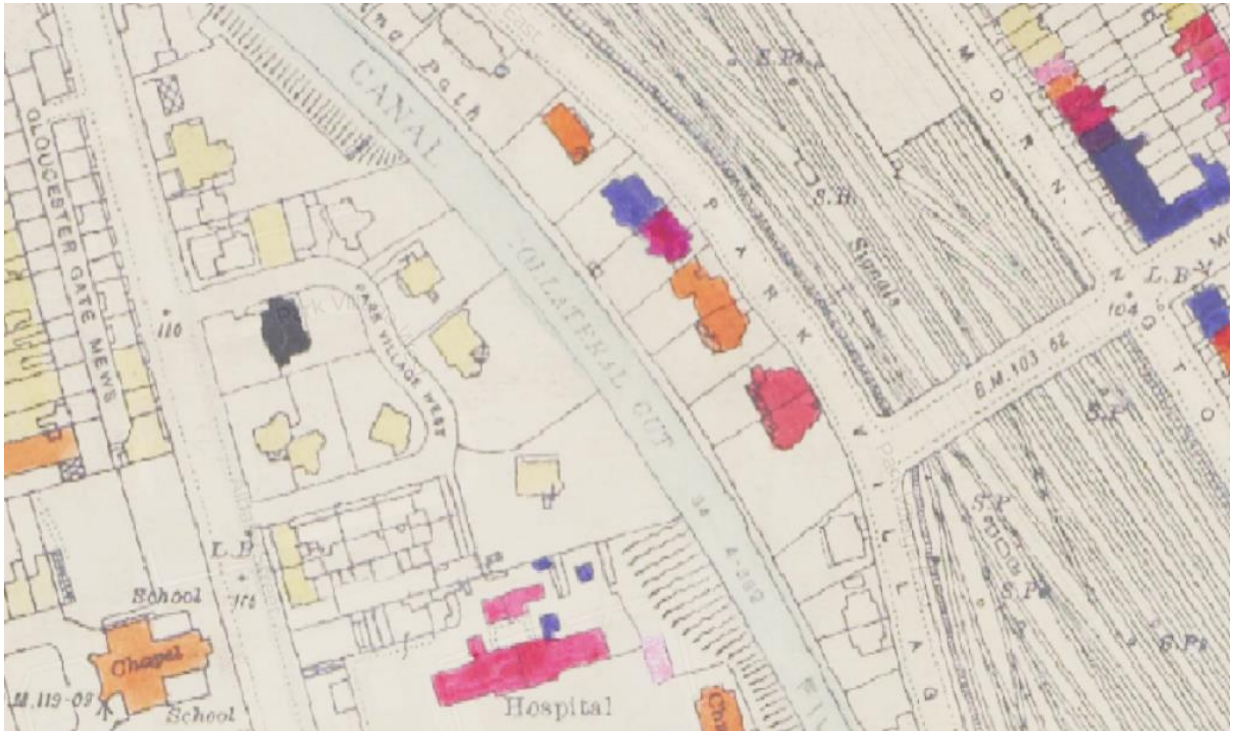
Figure 8 – London Bomb Damage 1945 (based on 1916 OS)

4.2.10 During World War II many of the nearby Regent Park terraces provided office accommodation for the UK Ministry of Works. The area suffered heavy bombing during the 1940 London Blitz, including extensive damage to a number of Park Village East properties and associated townscape (figure 8 The London County Council Bomb Damage Maps 1939- 1945, Page 49). and 2010/3675/P).

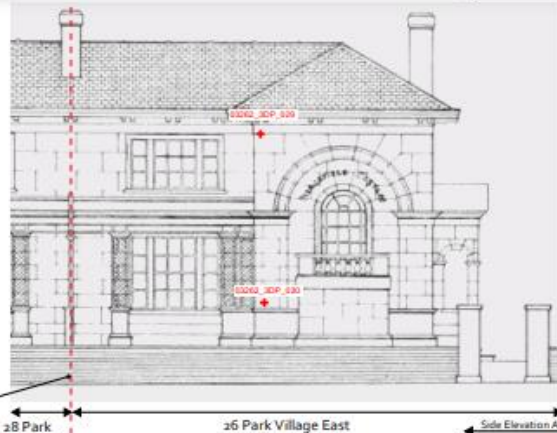
Front Elevation view

Elevation of Hydraulic Load Cell (HLC)
Installation can be amended on site to suit conditions/HAMS approval

Refer to 28 Park Village East drawings for instrumentation on party wall line.
