1MCo3 Main Works - Contract Lot S1

HERITAGE AGREEMENT METHOD STATEMENT HAMS - MONITORING AND CONSERVATION MANAGEMENT OF GROUND MOVEMENT DUE TO BELOW GROUND CONSTRUCTION AT 24 PARK VILLAGE EAST - ADP-ESCT-02

Document no: 1MCo3-SCJ-EV-MST-SSo1_SL03-000016

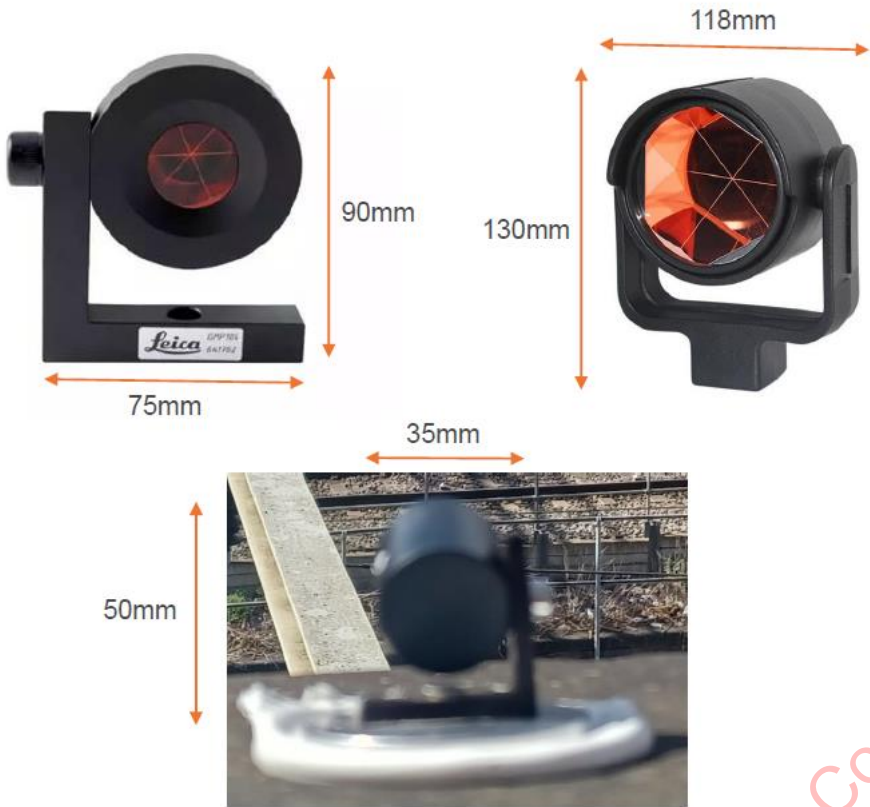
Figure 18- Example of a 3D prism

7.5.2 Primarily 3 D prisms of various sizes (figure 18), precise levelling bolts/studs and crack width gauges will be used. Devices will measure movements affecting both properties that form the semi-detached building elevations. Devices illustrated are typical examples, but specific instruments used may vary according to situation.

7.5.4 3D prisms (data recorded using mechanical Total Station) attached to external walls at the top and bottom of each façade. (If colour options can be sourced and are available, instruments that best match the external building appearance will be installed).

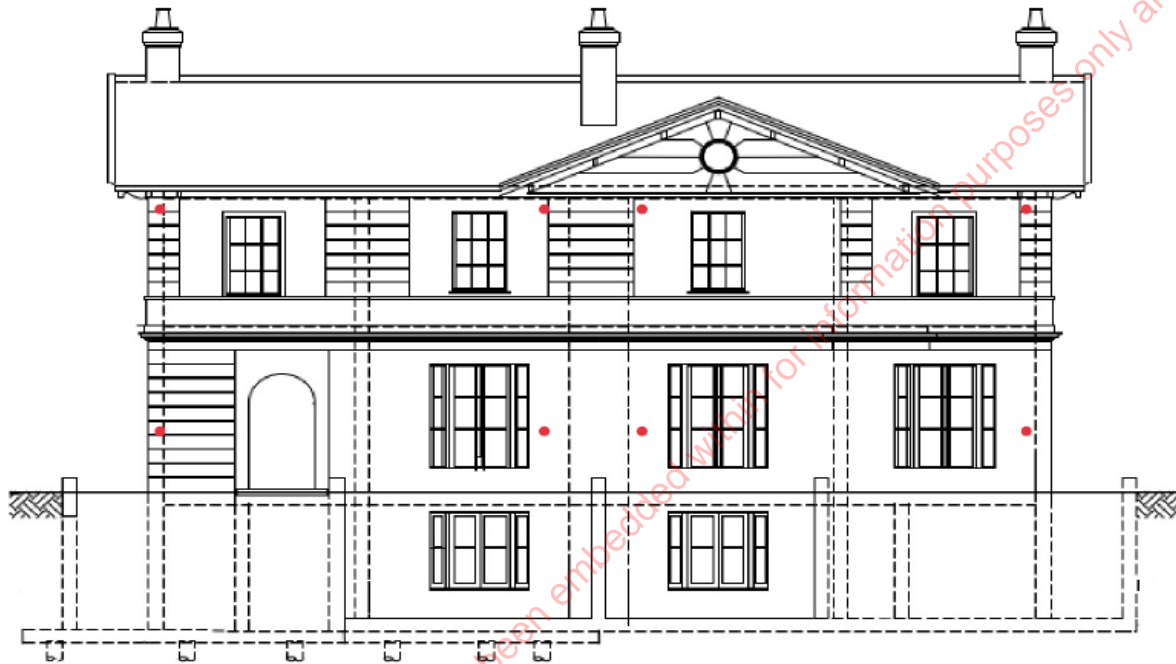
Figure 1: 22-24 Park Village East – East elevation

- 3D Prism

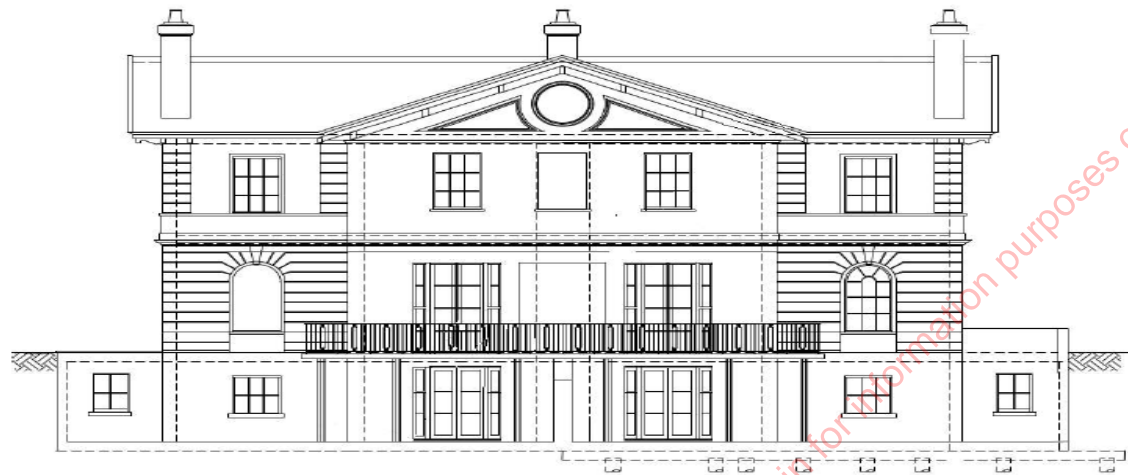
Figure 3: 22-24 Park Village East – West Elevation (Rear)
No additional monitoring proposed.
