Brickwork Repair

Pointing Repair

Charlton Brown Architecture & Interiors

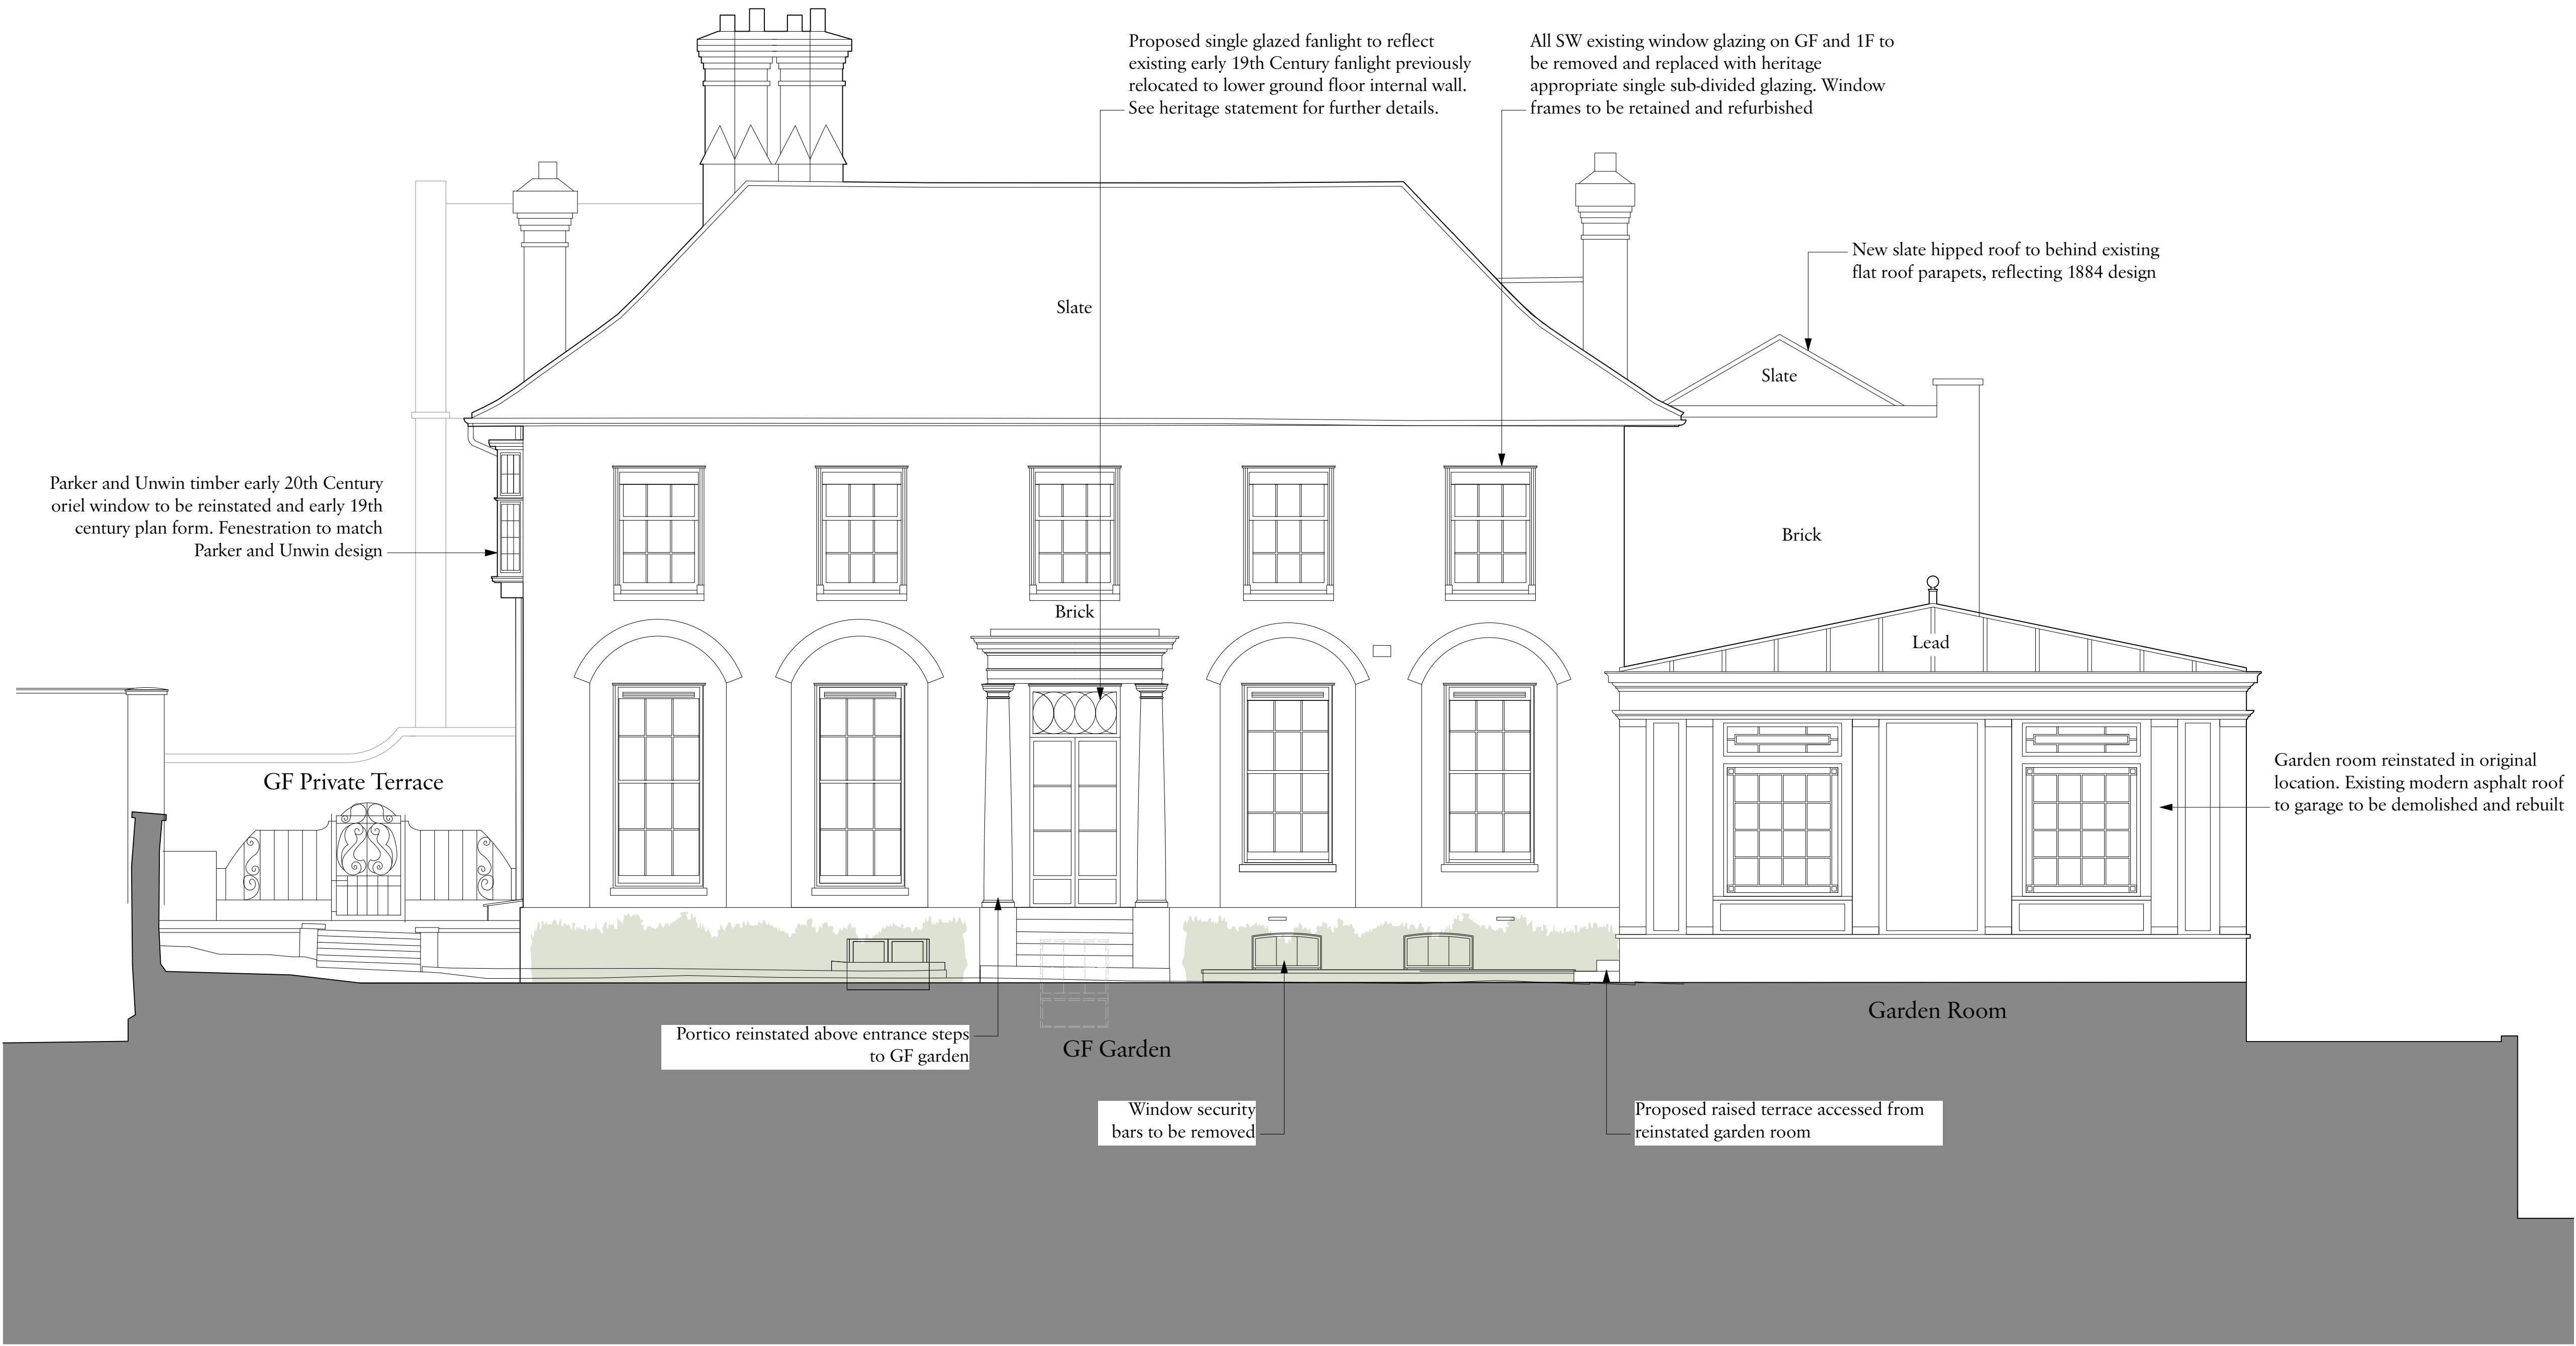
Existing Brickwork to be carefully assessed prior to undertaking works. To identify;

- Serious decay of mortar joints and bricks
- Spalling of brick faces due to frost action, particularly on parapets or chimney stacks, or the use of a cement mortar rather than a lime-based one
- Cracking or bulging of brickwork

- Brickwork replacement to be minimised with loose broken or previously poorly repaired brickwork carefully pieced in with brick to match surrounding in terms of size, texture, colour, inclusions and variety. Bond to be carefully maintained along with pointing gauge in terms of bed and perpend dimensions

- Loose, poor quality or inappropriate pointing to be carefully removed ensuring the integrity of existing brickwork arrises and faces. Once raked out to the extent required, likely c 20mm, to be repointed with a premixed lime mortar to match representative local sample in terms of colour, texture, aggregate, consistency and depth. Once semi cured pointing to be rough brushed and washed to expose aggregate and leaving the pointing semi recessed

Once brickwork and pointing repairs are complete facades to be carefully and gently doff cleaned to ensure that excessive dirt or other buildups are reduced but patination of age is maintained.
