**Brickwork Repair**

## Charlton Brown Architecture & Interiors

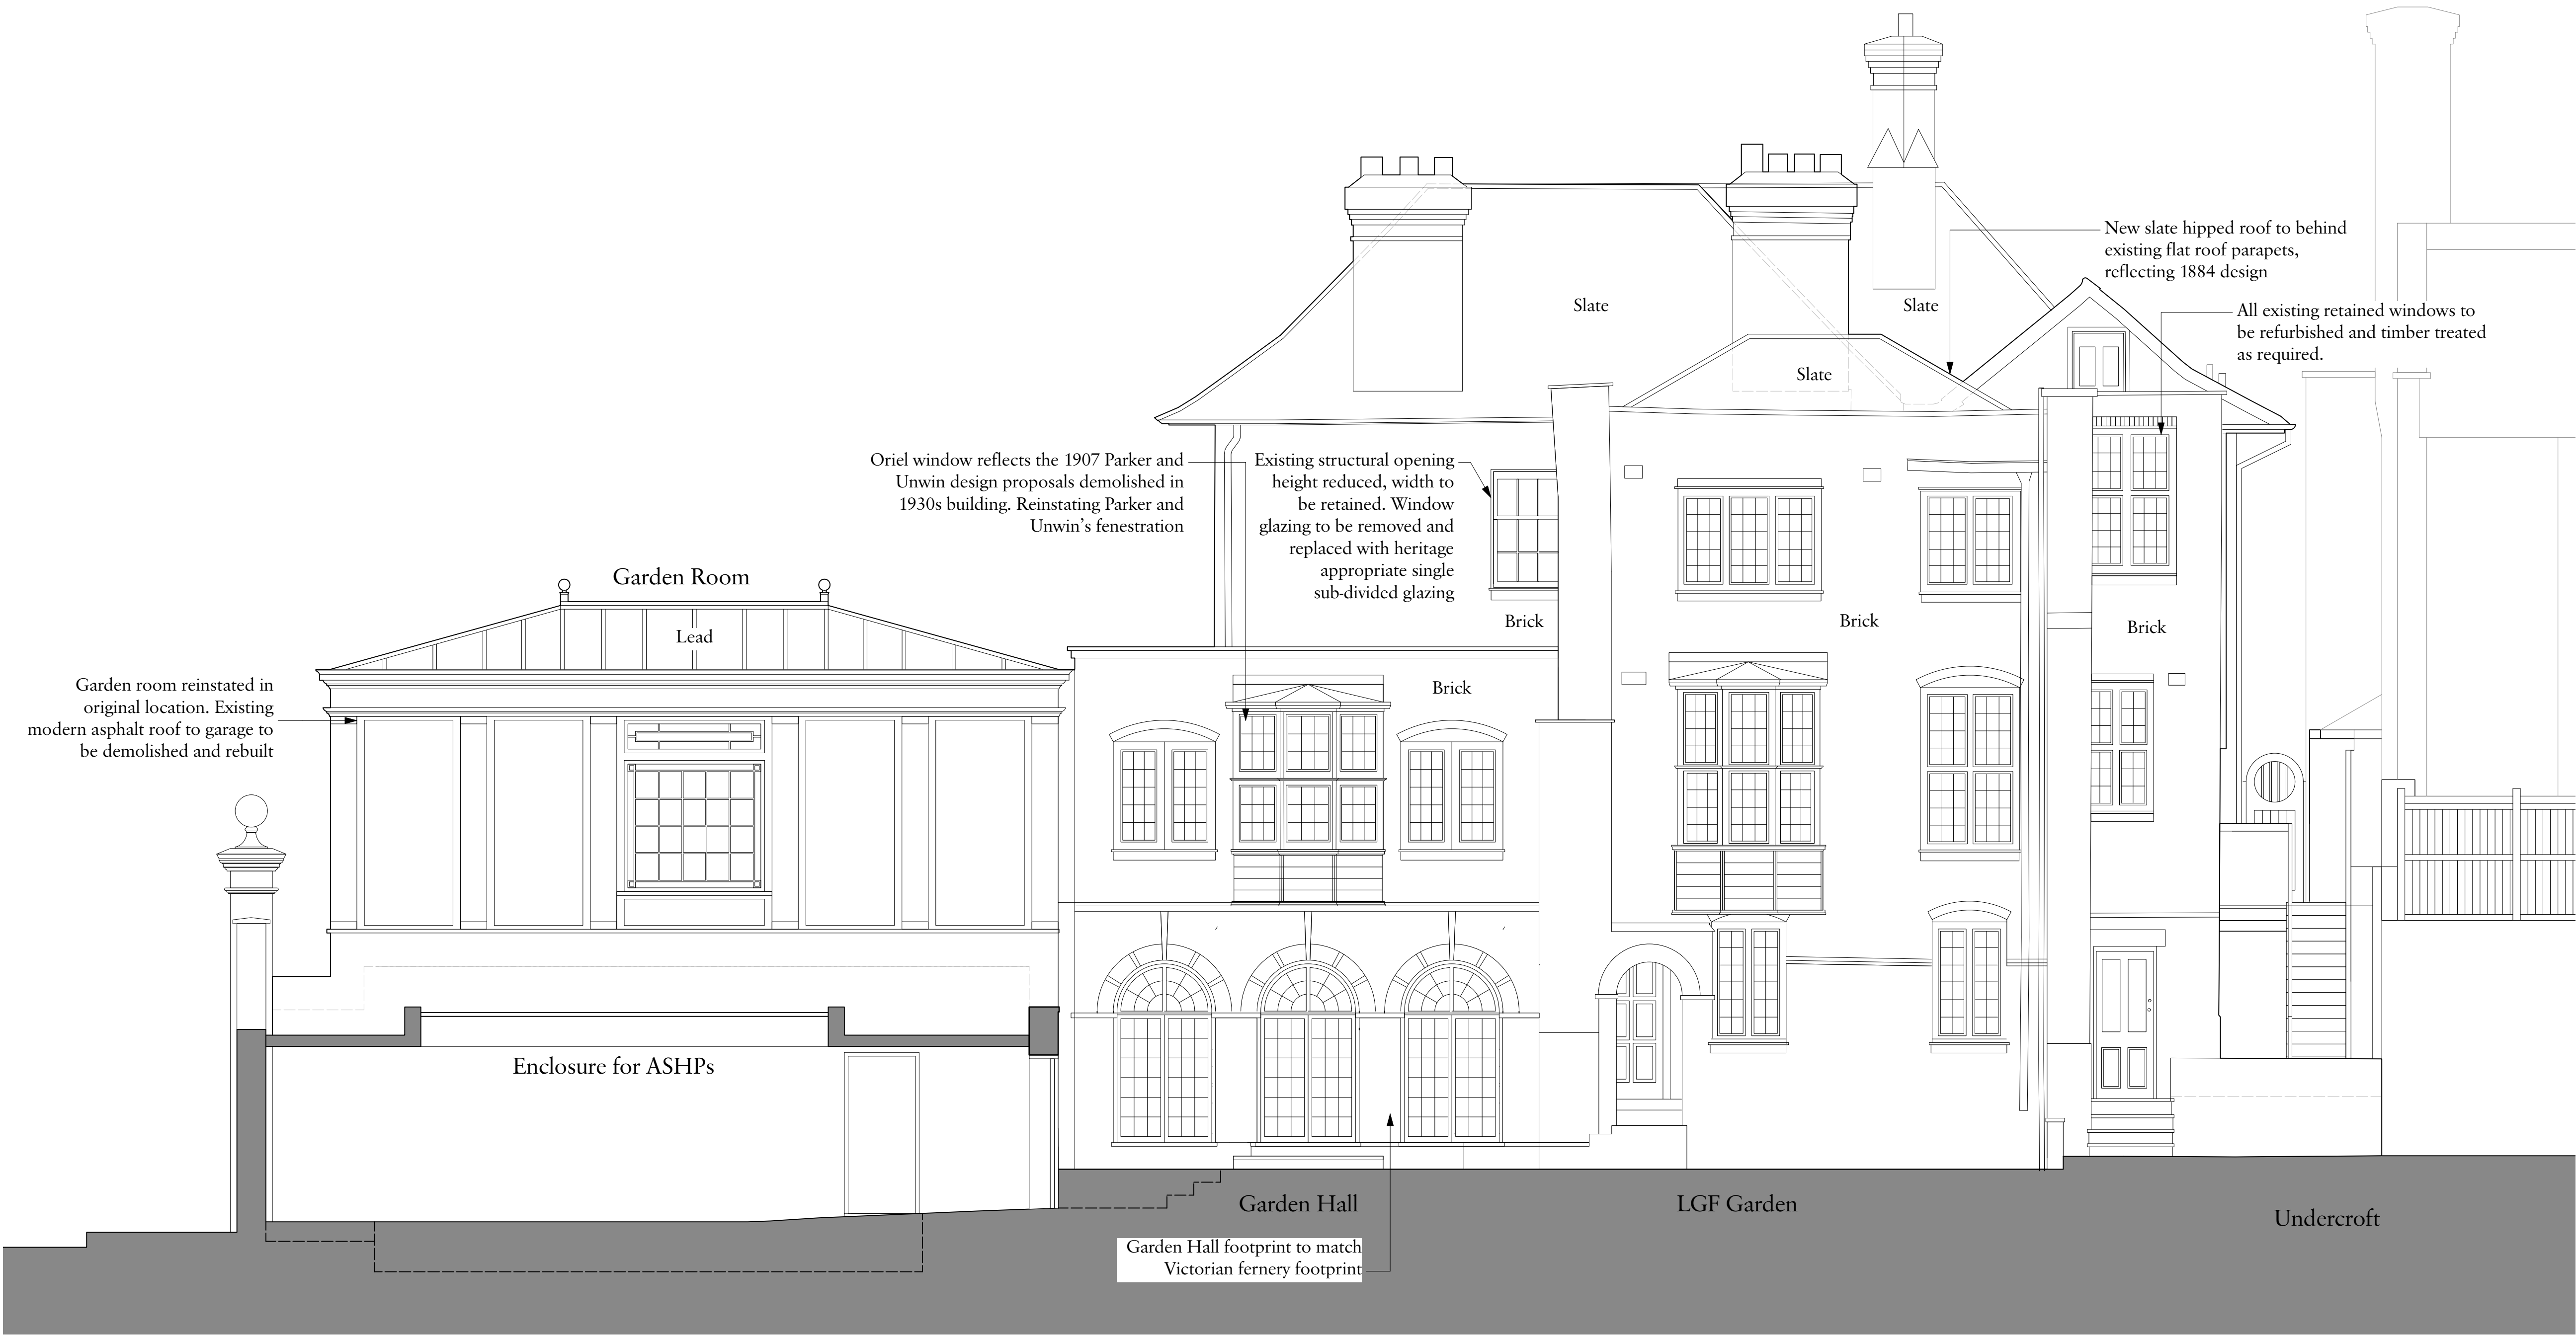
Existing Brickwork to be carefully assessed prior to undertaking works. To identify:

- Serious decay of mortar joints and bricks
- Spalling of brick faces due to frost action, particularly on parapets or chimney stacks, or the use of a cement mortar rather than a lime-based one
- Cracking or bulging of brickwork

- Brickwork replacement to be minimised with loose broken or previously poorly repaired brickwork carefully pieced in with brick to match surrounding in terms of size, texture, colour, inclusions and variety. Bond to be carefully maintained along with pointing gauge in terms of bed and perp dimensions

- Loose, poor quality or inappropriate pointing to be carefully removed ensuring the integrity of existing brickwork arrises and faces. Once raked out to the extent required, likely c 20mm, to be repointed with a premixed lime mortar to match representative local sample in terms of colour, texture, aggregate, consistency and depth. Once semi cured pointing to be rough brushed and washed to expose aggregate and leaving the pointing semi recessed

Once brickwork and pointing repairs are complete facades to be carefully and gently doff cleaned to ensure that excessive dirt or other buildups are reduced but patination of age is maintained.
