Charlton Brown  
Architecture & Interiors

Redfrog Property

Frognal Rise House

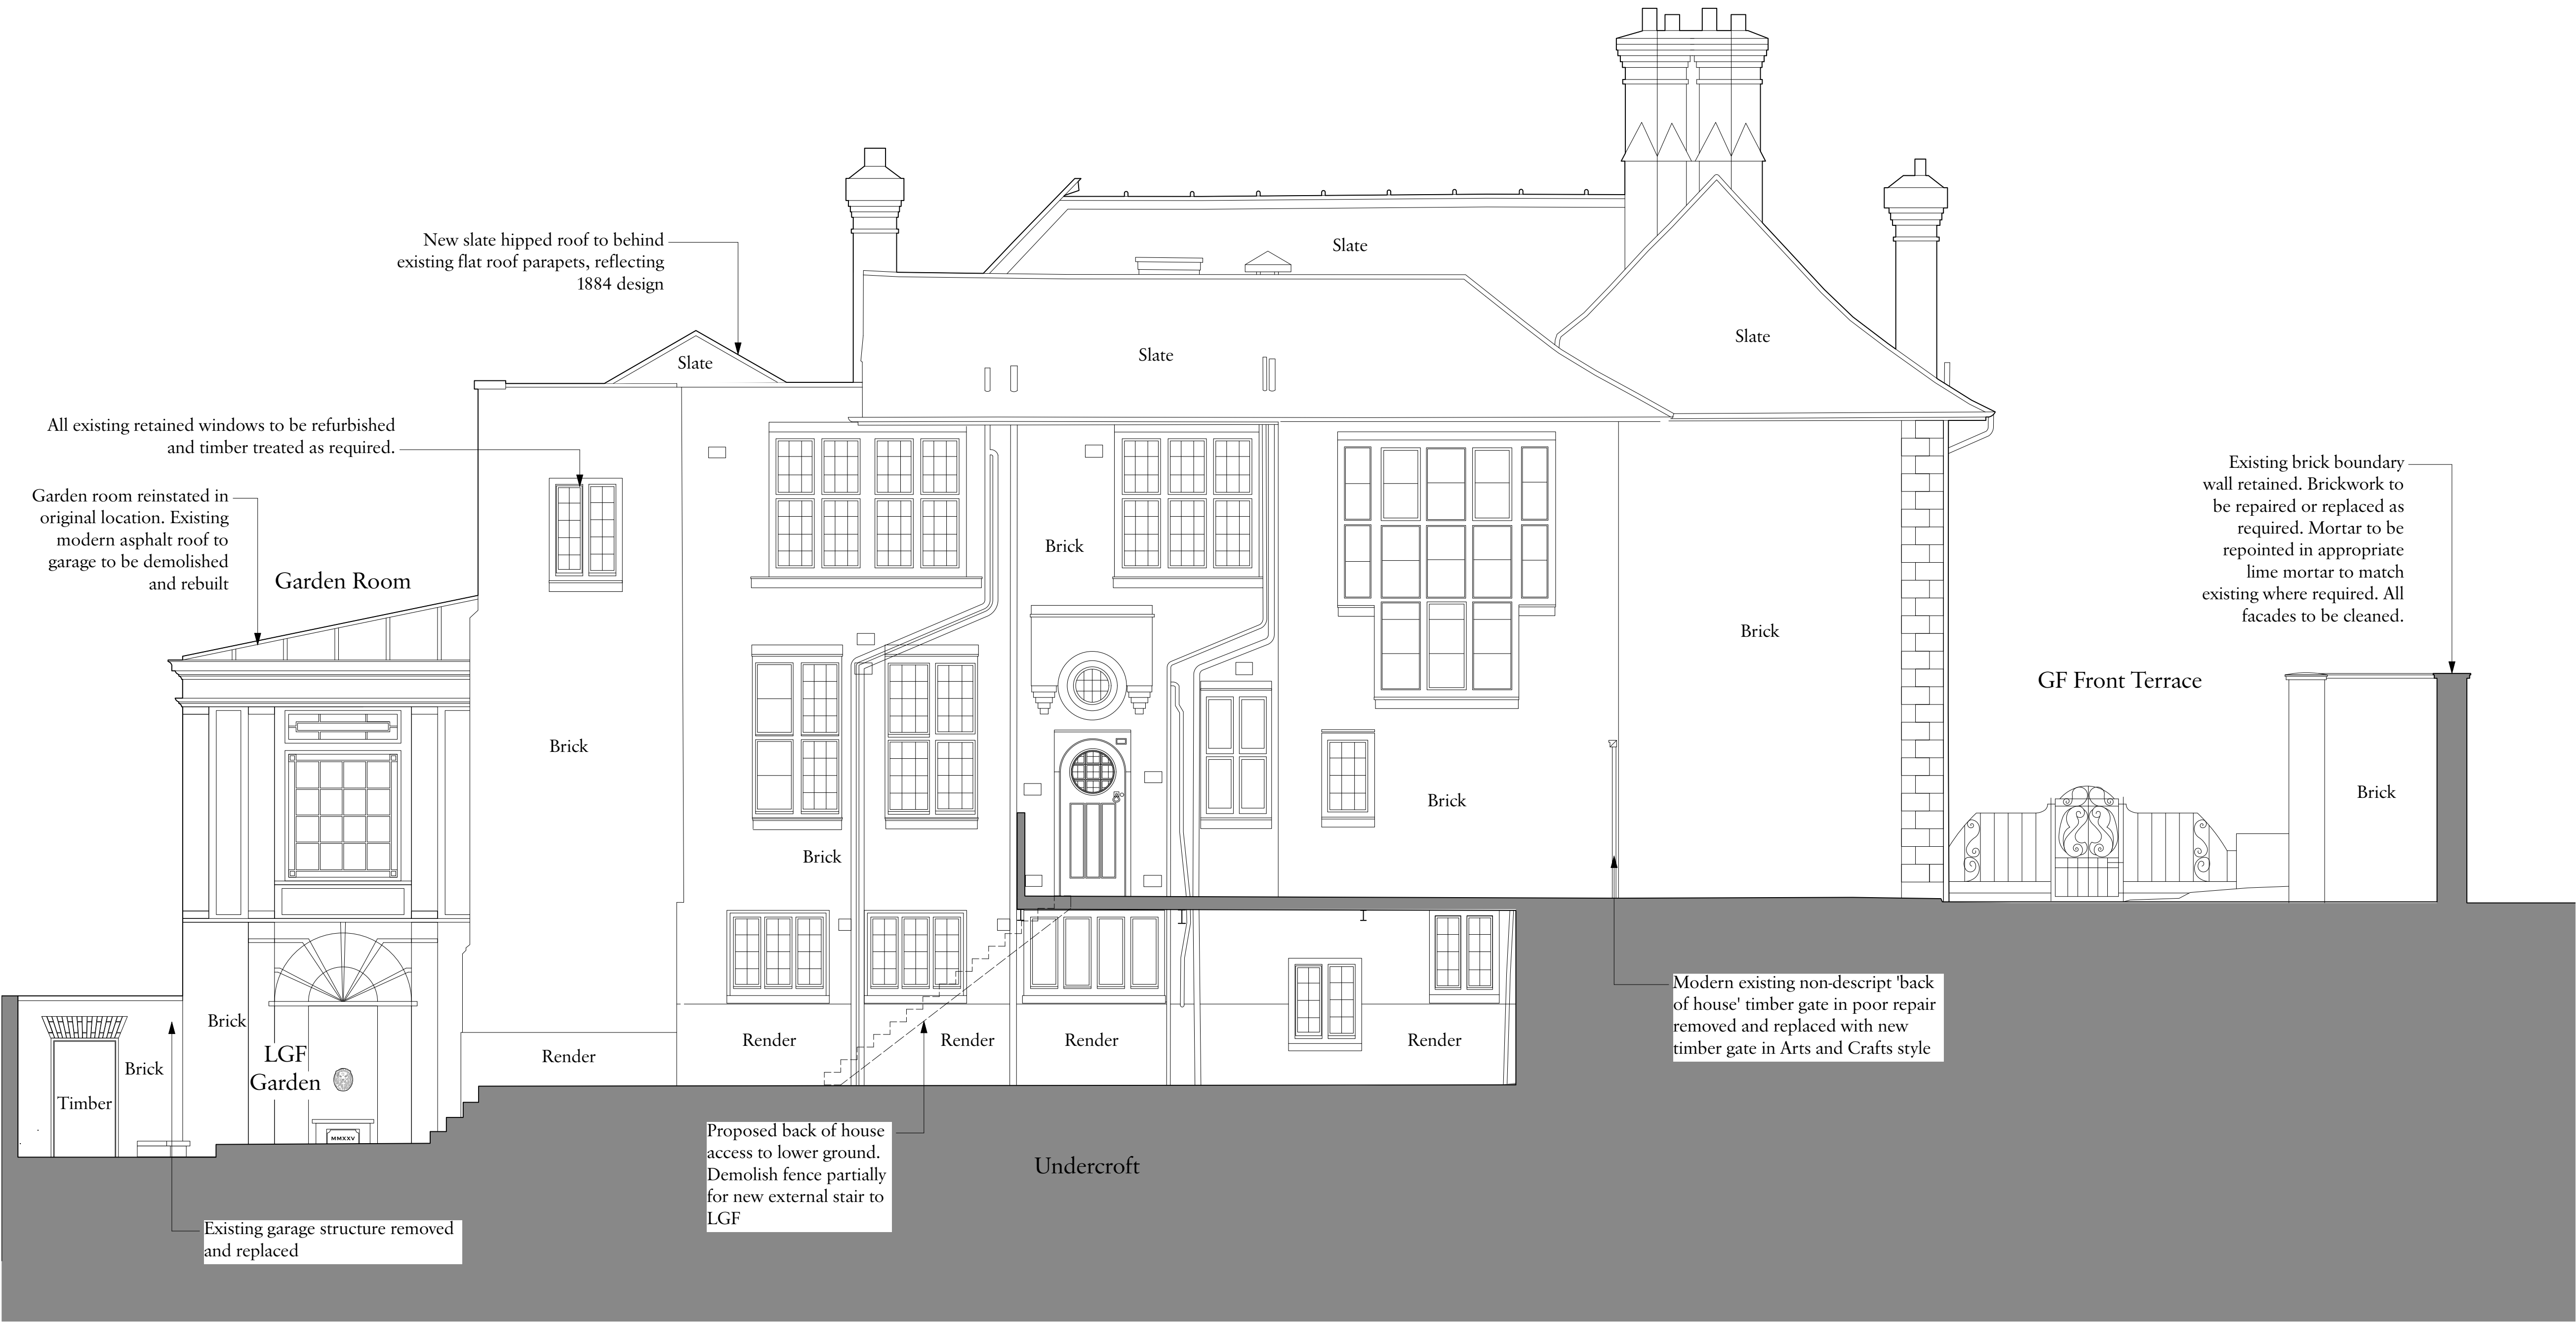
Existing Brickwork to be carefully assessed prior to undertaking works. To identify:  
- Serious decay of mortar joints and bricks  
- Spalling of brick faces due to frost action, particularly on parapets or chimney stacks, or the use of a cement mortar rather than a lime-based one  
- Cracking or bulging of brickwork

Brickwork Repair  
- Brickwork replacement to be minimised with loose broken or previously poorly repaired brickwork carefully pieced in with brick to match surrounding in terms of size, texture, colour, inclusions and variety. Bond to be carefully maintained along with pointing gauge in terms of bed and perpend dimensions

Pointing Repair  
- Loose, poor quality or inappropriate pointing to be carefully removed ensuring the integrity of existing brickwork arrises and faces. Once raked out to the extent required, likely c 20mm, to be repointed with a premixed lime mortar to match representative local sample in terms of colour, texture, aggregate, consistency and depth. Once semi cured pointing to be rough brushed and washed to expose aggregate and leaving the pointing semi recessed

Once brickwork and pointing repairs are complete facades to be carefully and gently doff cleaned to ensure that excessive dirt or other buildups are reduced but patination of age is maintained.
