Charlton Brown Architecture & Interiors

Client
Redfrog Property

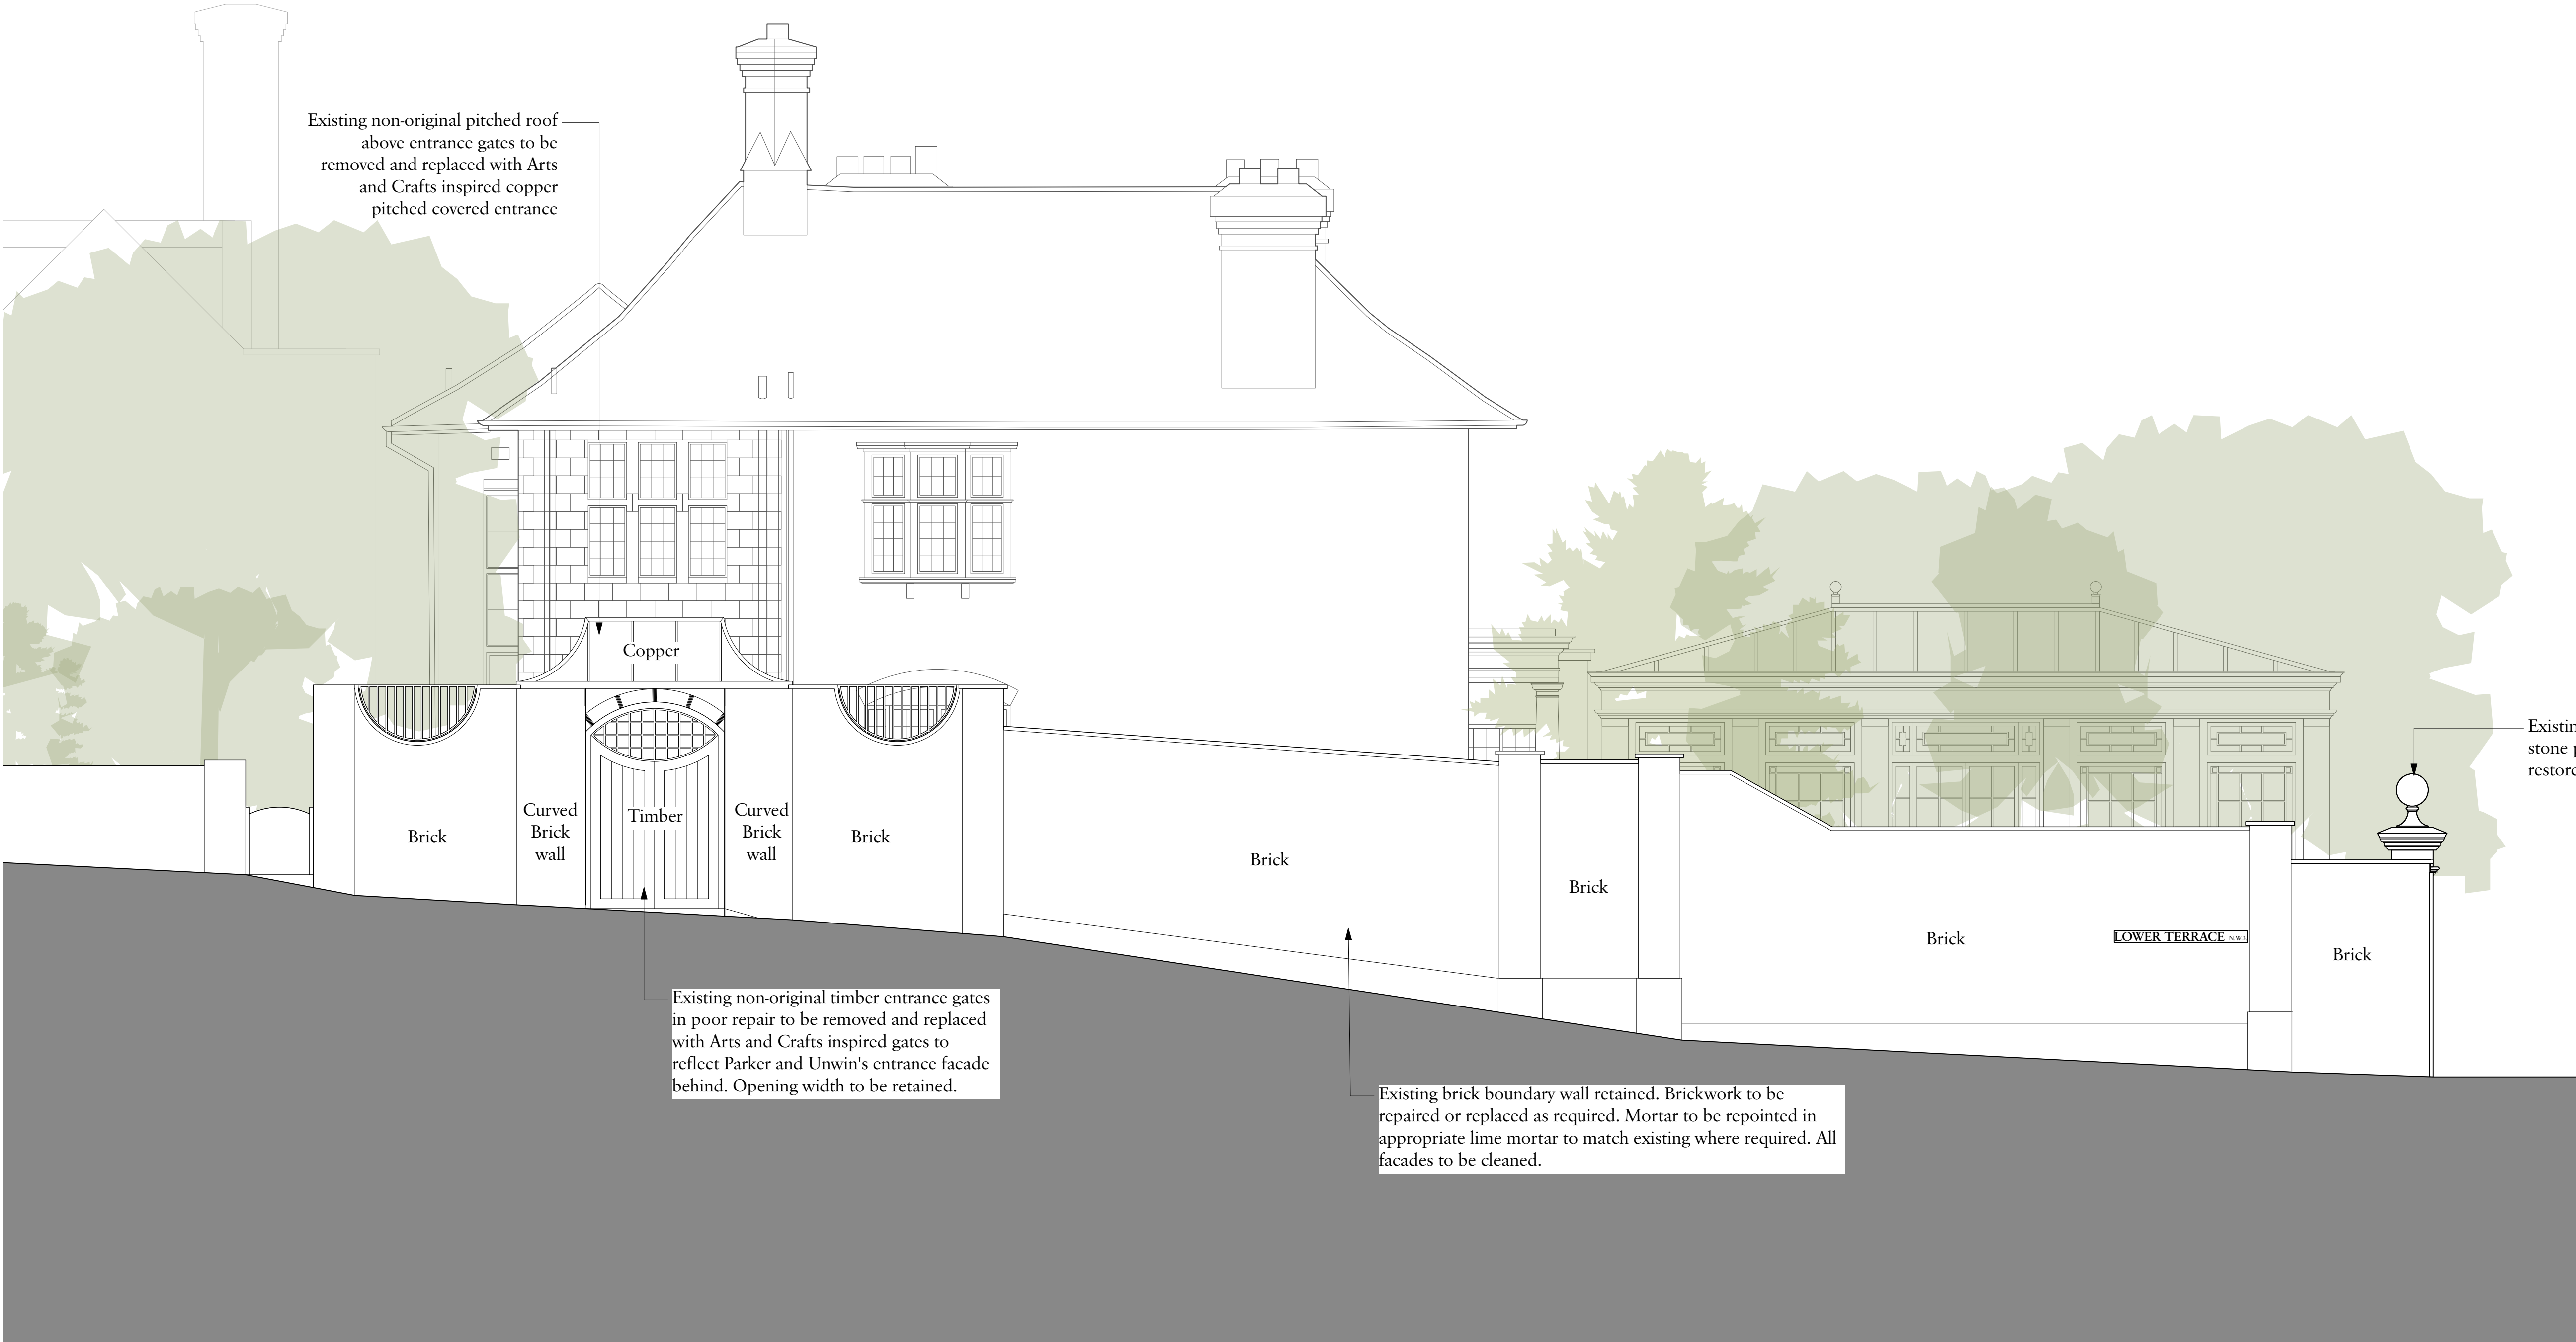
Existing Brickwork to be carefully assessed prior to undertaking works. To identify;

- Serious decay of mortar joints and bricks
- Spalling of brick faces due to frost action, particularly on parapets or chimney stacks, or the use of a cement mortar rather than a lime-based one
- Cracking or bulging of brickwork

Brickwork Repair

- Brickwork replacement to be minimised with loose broken or previously poorly repaired brickwork carefully pieced in with brick to match surrounding in terms of size, texture, colour, inclusions and variety. Bond to be carefully maintained along with pointing gauge in terms of bed and perpend dimensions

Pointing Repair

- Loose, poor quality or inappropriate pointing to be carefully removed ensuring the integrity of existing brickwork arrises and faces. Once raked out to the extent required, likely c 20mm, to be repointed with a premixed lime mortar to match representative local sample in terms of colour, texture, aggregate, consistency and depth. Once semi cured pointing to be rough brushed and washed to expose aggregate and leaving the pointing semi recessed

Once brickwork and pointing repairs are complete facades to be carefully and gently doff cleaned to ensure that excessive dirt or other buildups are reduced but patination of age is maintained.
