## Charlton Brown Architecture & Interiors

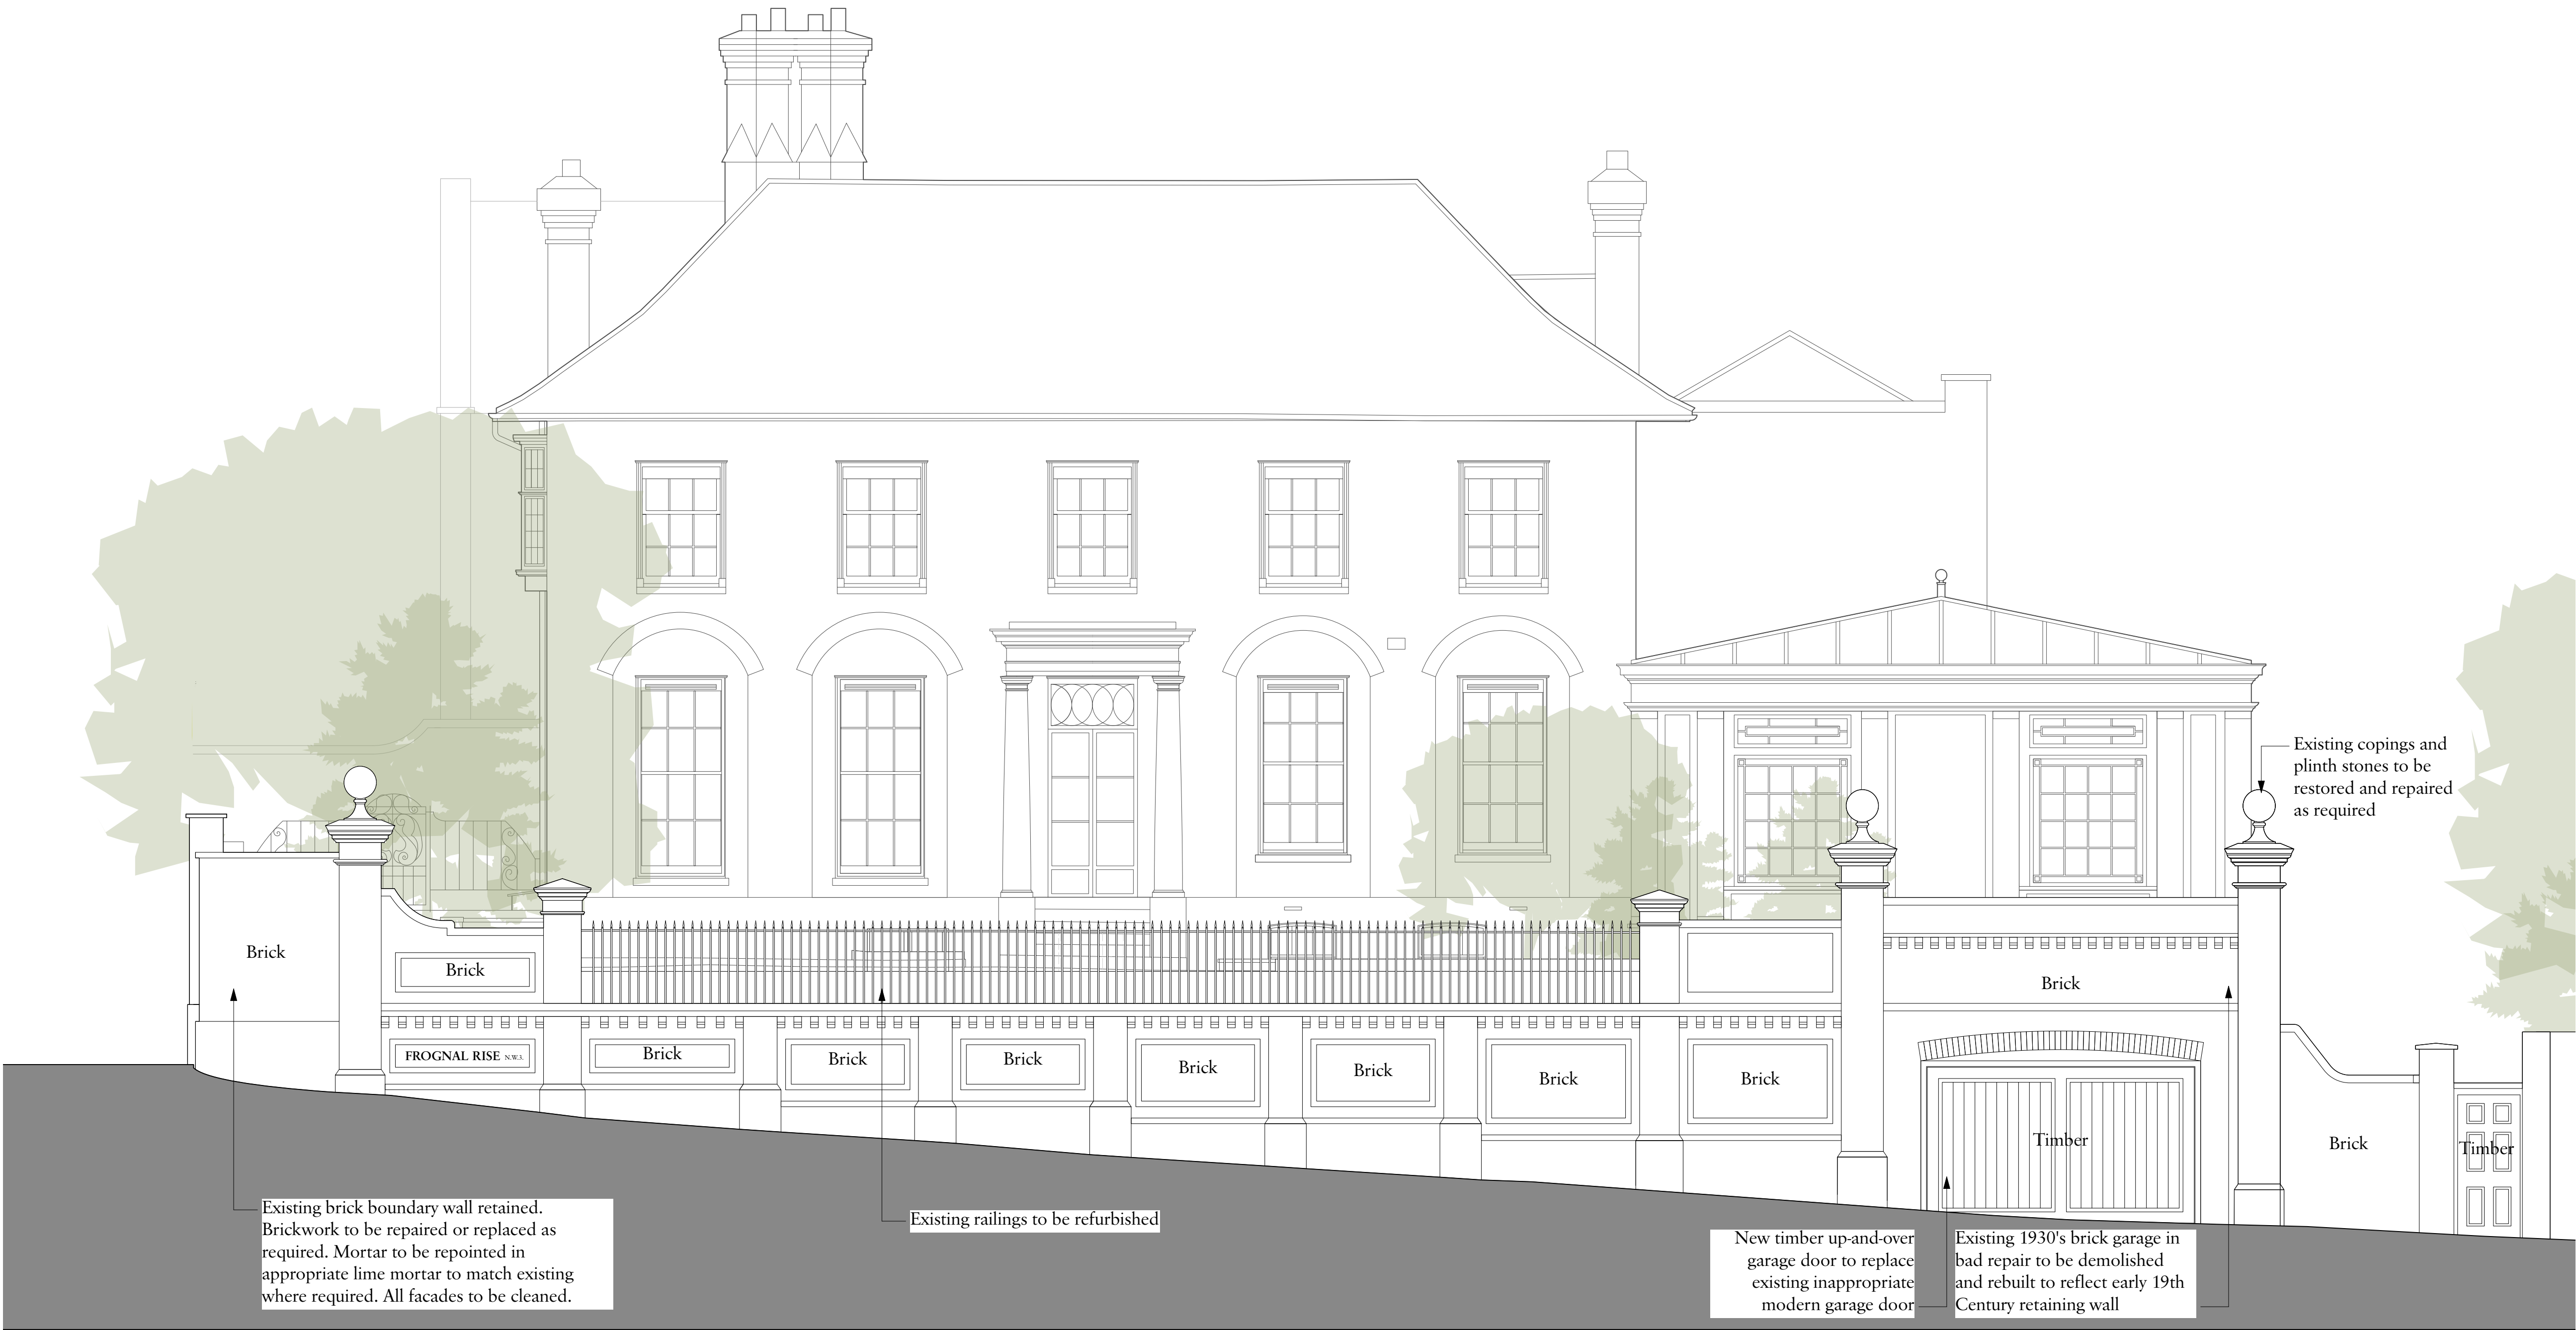
Existing Brickwork to be carefully assessed prior to undertaking works. To identify;

- Serious decay of mortar joints and bricks
- Spalling of brick faces due to frost action, particularly on parapets or chimney stacks, or the use of a cement mortar rather than a lime-based one
- Cracking or bulging of brickwork

**Brickwork Repair**

- Brickwork replacement to be minimised with loose broken or previously poorly repaired brickwork carefully pieced in with brick to match surrounding in terms of size, texture, colour, inclusions and variety. Bond to be carefully maintained along with pointing gauge in terms of bed and perpend dimensions

**Pointing Repair**

- Loose, poor quality or inappropriate pointing to be carefully removed ensuring the integrity of existing brickwork arrises and faces. Once raked out to the extent required, likely c 20mm, to be repointed with a premixed lime mortar to match representative local sample in terms of colour, texture, aggregate, consistency and depth. Once semi cured pointing to be rough brushed and washed to expose aggregate and leaving the pointing semi recessed

Once brickwork and pointing repairs are complete facades to be carefully and gently doff cleaned to ensure that excessive dirt or other buildups are reduced but patination of age is maintained.
