2014/1016/P 10a Oakhill Avenue: Application for one large new house.

I am commenting on this application in respect of its impact on trees and biodiversity/sustainability.

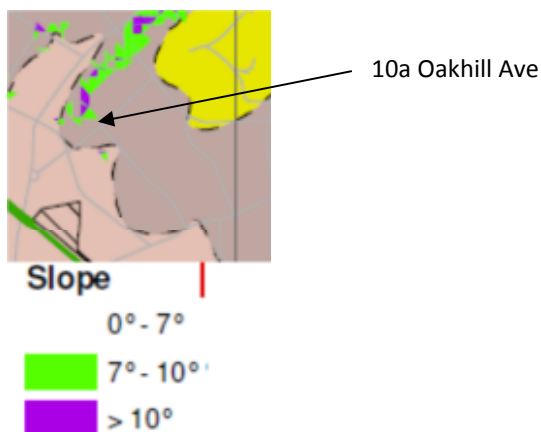
From Arup's 'Camden Geological, Hydrogeological & Hydrological Study: Figure 16 Slope angle map', it is clear that 10a Oakhill Avenue (virtually opposite Greenaway Gardens) is not far from a 7° slope, if not actually on it.

From: BASEMENT IMPACT ASSESSMENT SCREENING REPORT: 'LAND STABILITY'  
Page 4: 'Beyond the western site boundary the ground slopes down more steeply, towards a valley of the headwaters of the River Westbourne, down which Heath Drive runs. Although the slope angle there could not be properly assessed, the Camden Slope Angle Map [Figure 16 of the Arup report] shows angles, in that vicinity, of between 7° and 10° and, locally, >10°. These slope angles are, however, outside of the site and some 20m from the existing building footprint.'
