THE ELMS FITZROY PARK LONDON N6 6HS
PRELIMINARY DESIGN & ACCESS STATEMENT
FOR THE REINSTATEMENT WORKS

FINAL VERSION

Alan Power Architects Ltd
13 Needham Road
London W11 2RP
Tel: 020 7229 9375
Email: alan@alanpowerarchitects.co.uk

August 2013

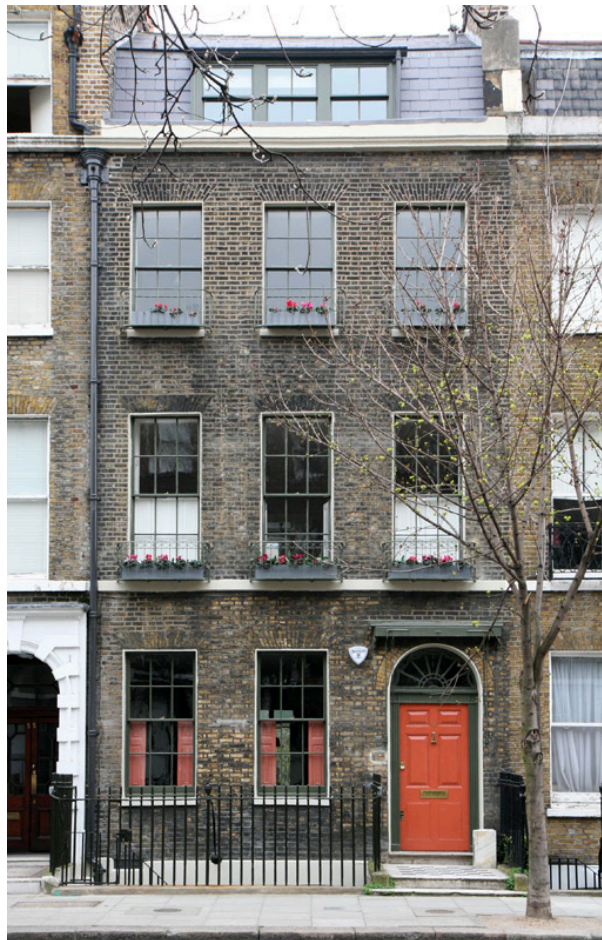
Illustration 4.01 the front elevation of 56 Doughty Street London WC1N 2LL

- g) A Grade II listed house at 56 Doughty Street London WC1N 2LL was granted planning permission and Listed Building Consent September 2009 by Camden for alterations and extensions including some new replacement windows, which were painted black, as were all the windows, as this was considered to be the historically correct finish to a house thought to have been constructed at the turn of the 19th century. The front elevation of 56 Doughty Street is shown at illustration 4.01
