PROPOSED WORKS

REFER TO (19) SERIES DRAWINGS FOR EXTENT OF DEMOLITION WORKS, REFER TO (99)1000 FOR METHOD STATMENT. NOTE: All existing rooms to be decorated, any retained existing doors to be refurbished.

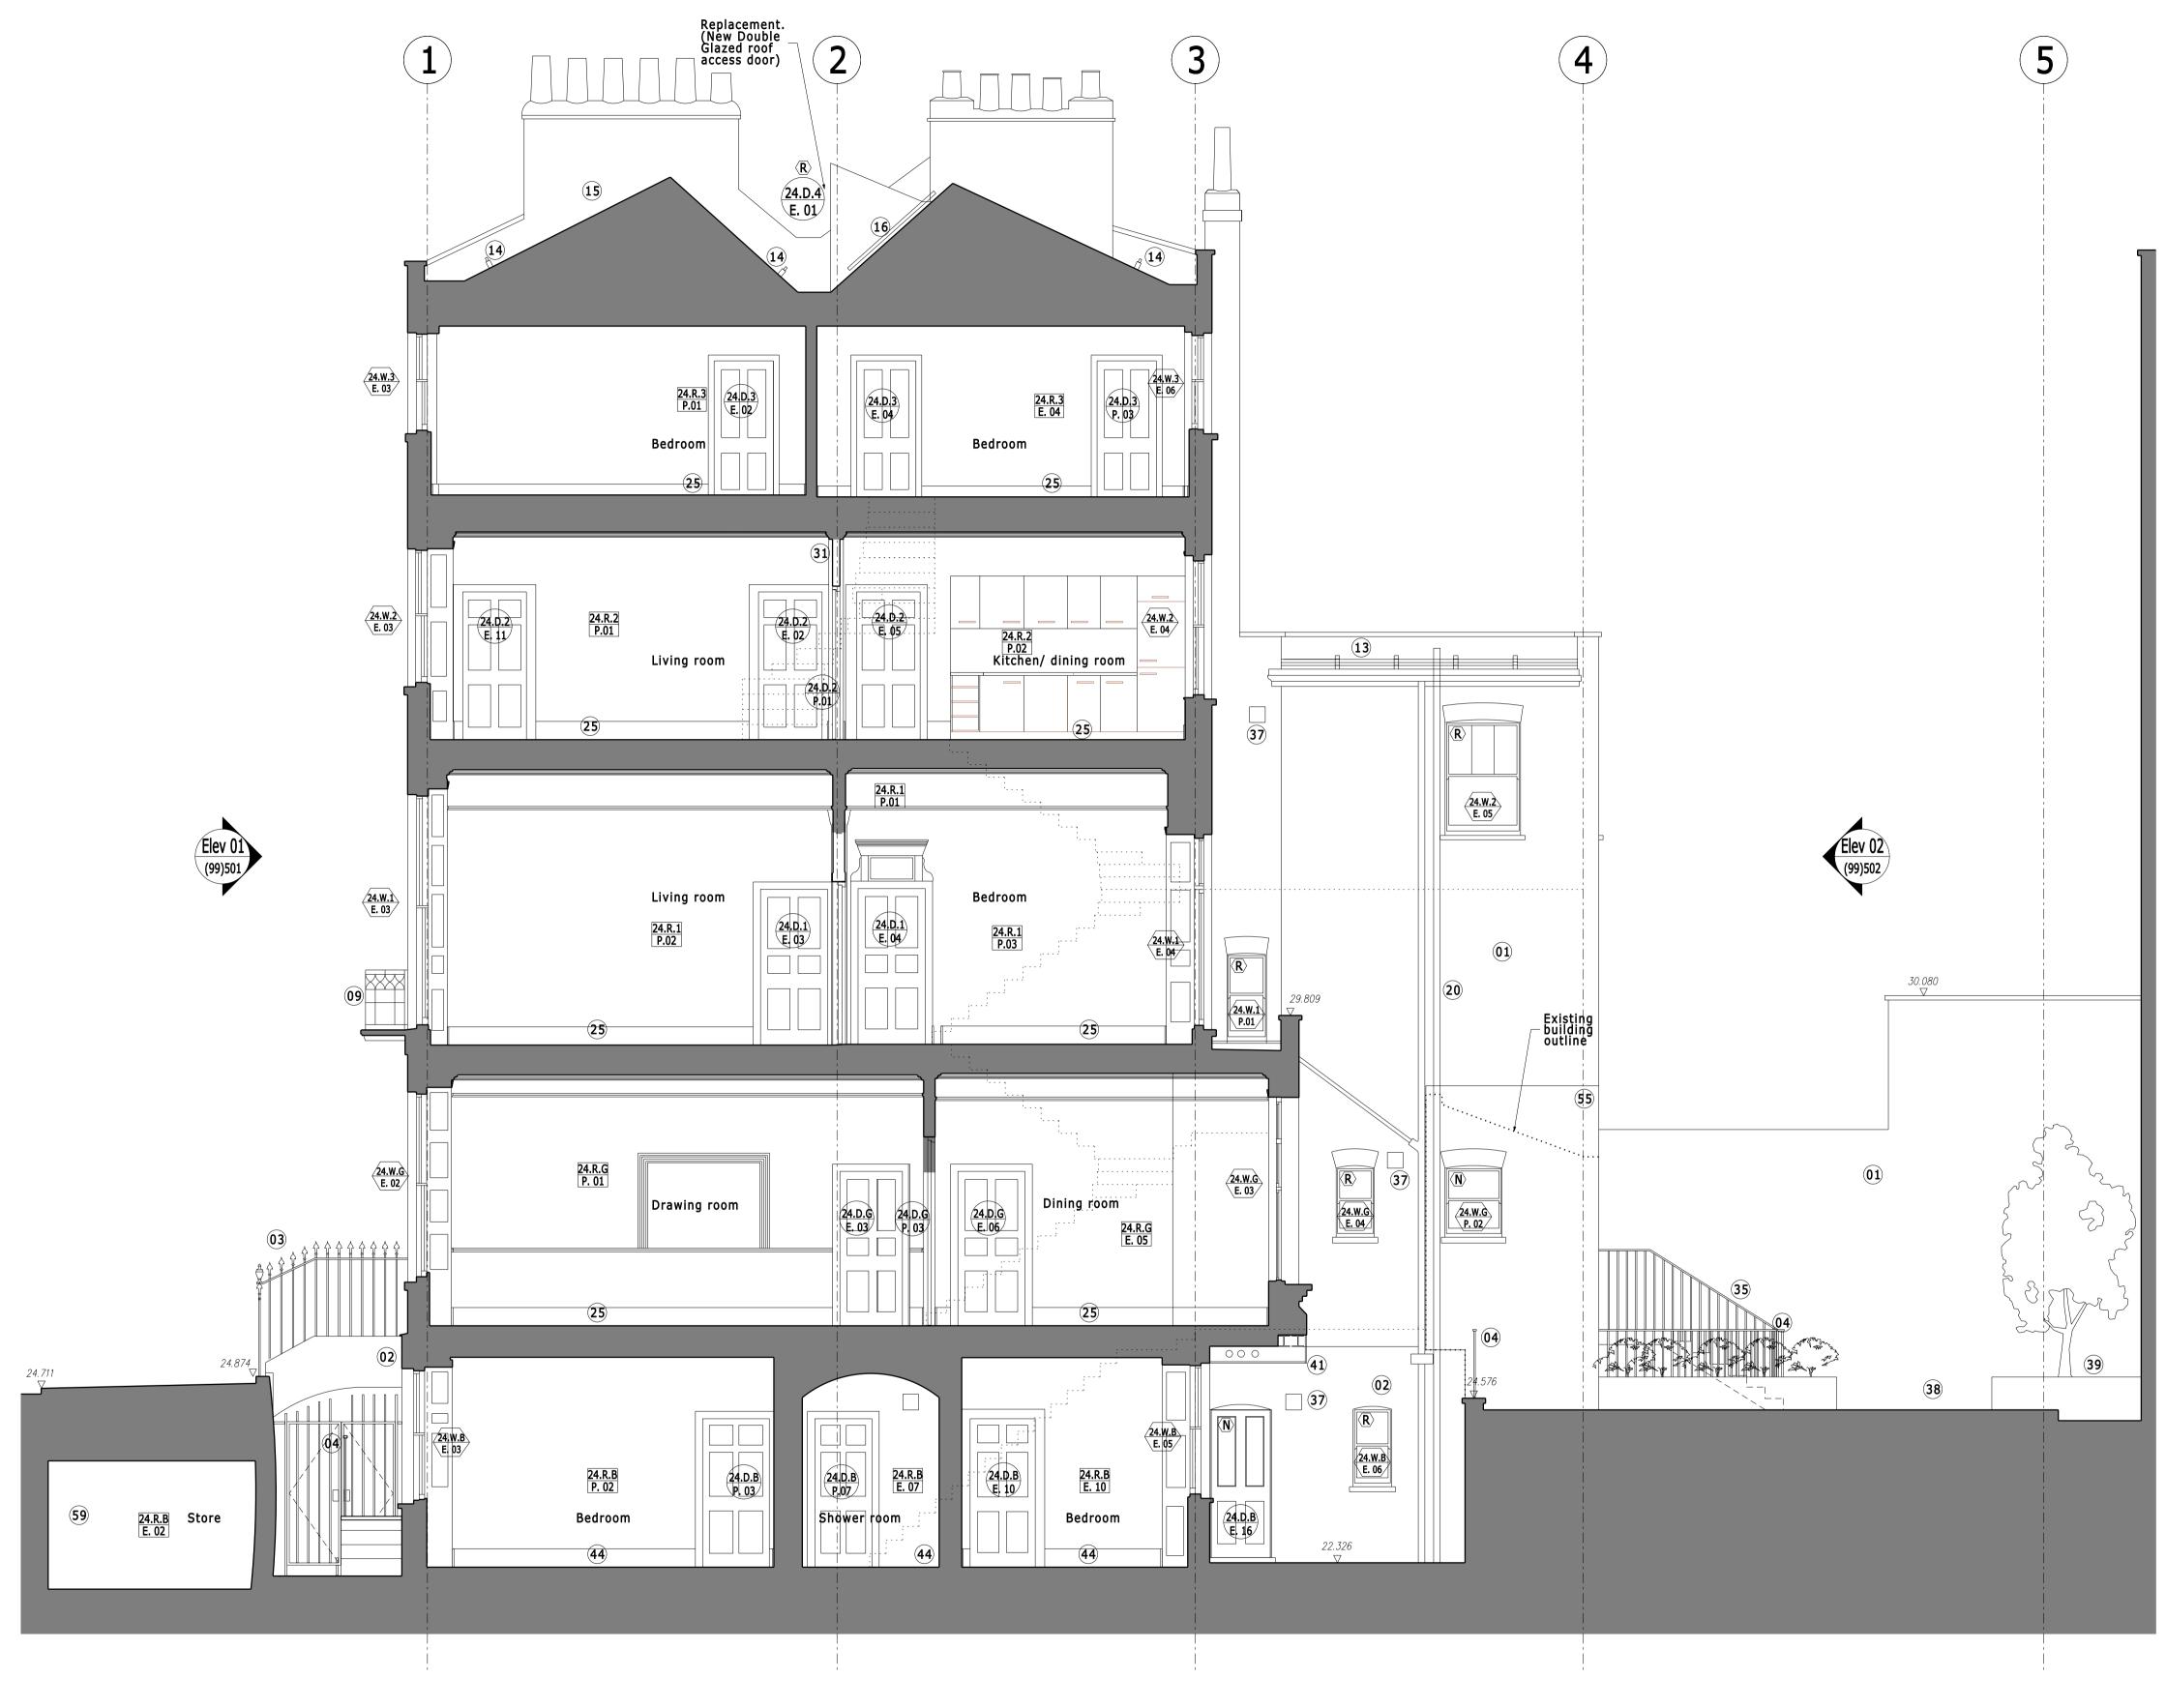
- 01. Repair existing brickwork and pointing as necessary.
- Repair and clean existing render and decorative stucco (substrate to be repaired as necessary). Repaint as existing.
- 03. Refurbish existing cast iron railings, repaint black to match existing. 04. New galvanized steel railings painted black to match existing metalwork
- 05. Existing vaults to be repaired as necessary and a cavity drain membrane installed to waterproof internal walls & floor.
- 06. New Cavity Wall with reclaimed bricks to match as close as possible existing.
- 07. Selected Cast Stone coping. Existing opening bricked up, bricks to match as close as possible existing.
- 09. Repair & refurbish existing balcony, repaint.
- 10. New manhole. 11. Water butt.

- 12. New Rooflight & Access hatch.
- 13. Existing lead Roof to be repaired and refurbished as necessary.
- 14. New mansafe access system.
- 15. Existing roof to be completely renewed and renovated. Existing tiles to be reused where possible. New tiles to match existing.
- 16. New Photovoltaic panels.
- Drip to be introduced to chimney stack capping to stop saturation of brickwork
- 18. Existing metal access ladder to be removed and all disturbed surfaces to be made good. Access to be only by Estate Maintenance with proper safety equipment.
- 19. New SVP penetration. Existing painted cast iron drainage pipes to be retained were suitable.
 New painted Cast iron drainage pipes as necessary.
- 21. Satellite dish.

- Refurbish existing stair and balustrade with new decoration, provide new carpet and or runner and fittings.
- Refurbish existing hardwood doors and upgrade to fire-rated doors where required, replace or refurbish existing door hardware where required.

- Install new fire rated paneled door and door set to match existing doors.
- 25. Take up existing floorboards for new services and leveling works to floor where required. Replace back with existing or new floorboards where required. Provide new selected carpet finish over.

- ${\bf 26.} \ \, {\bf Retain} \, \, {\bf \&} \, \, {\bf refurbish} \, \, {\bf existing} \, \, {\bf stone} \, \, {\bf floor}.$
- 27. Timber panelling to replace obsured Georgian wired glass.

- 41. New sofitt to match existing render and conceal new pipework.
- 42. Repair missing railing and paint black to match existing.
- 43. New coir barrier matting.

- 44. New basement slab. 45. Replace existing entry phone system with new.
- 46. New entry phone system.
- 47. Replace existing letter box with new. 48. New letter box.

- 49. New remotely operated window. 50. Apply selected obscure film.
- 52. Area to reuse stone slabs from basement level.
- New brick wall and foundation to support vault above, bricks to match as close as possible existing.

- 59. Sprayed concrete structural repair to vault.
