AS APPROVED

AS PROPOSED

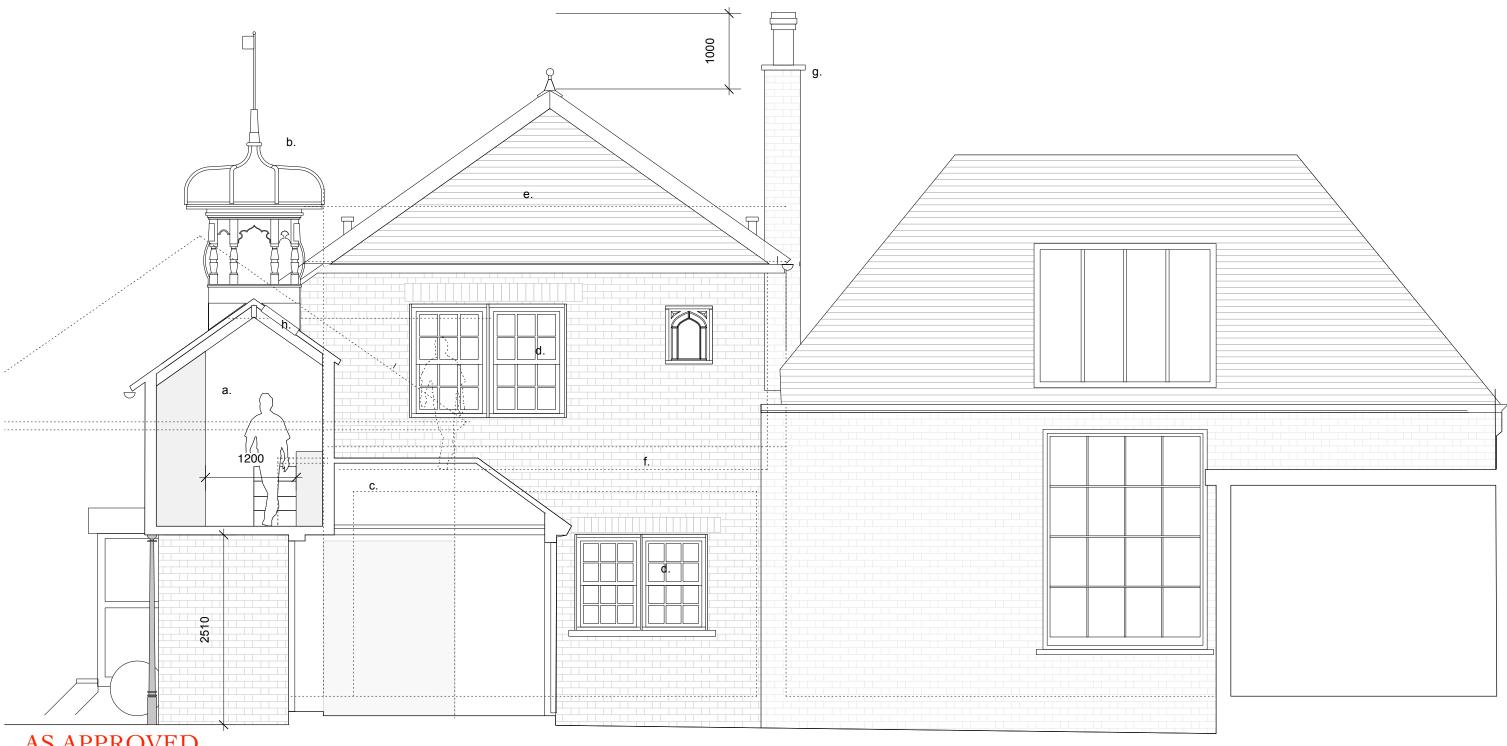
1st floor internal linking passage between buildings, salvaged red stock brick structure supported by reclaimed cast iron pillars Salvaged 19th Century timber and lead cupola, echoing those already in existence in the studios complex of similar age, style and construction. Partial demolition to roof of existing ground floor linking passage, rest retained Purpose made new sash window, profiles and molding to match existing Half hipped pitched roof, angle and clay tiles to match existing adjacent.

Re-build existing poor quality modern extension in salvaged red stock brick, plan area to extend to the full size of the building footprint below, incorporating the previous lean-too roof and 1st floor conservatory.

existing chimney raised, as previously granted.
doublepitched roof of 1st floor corridor, exposed timber roof structure with insulation above, clad inclay tiles to match existing adjacent

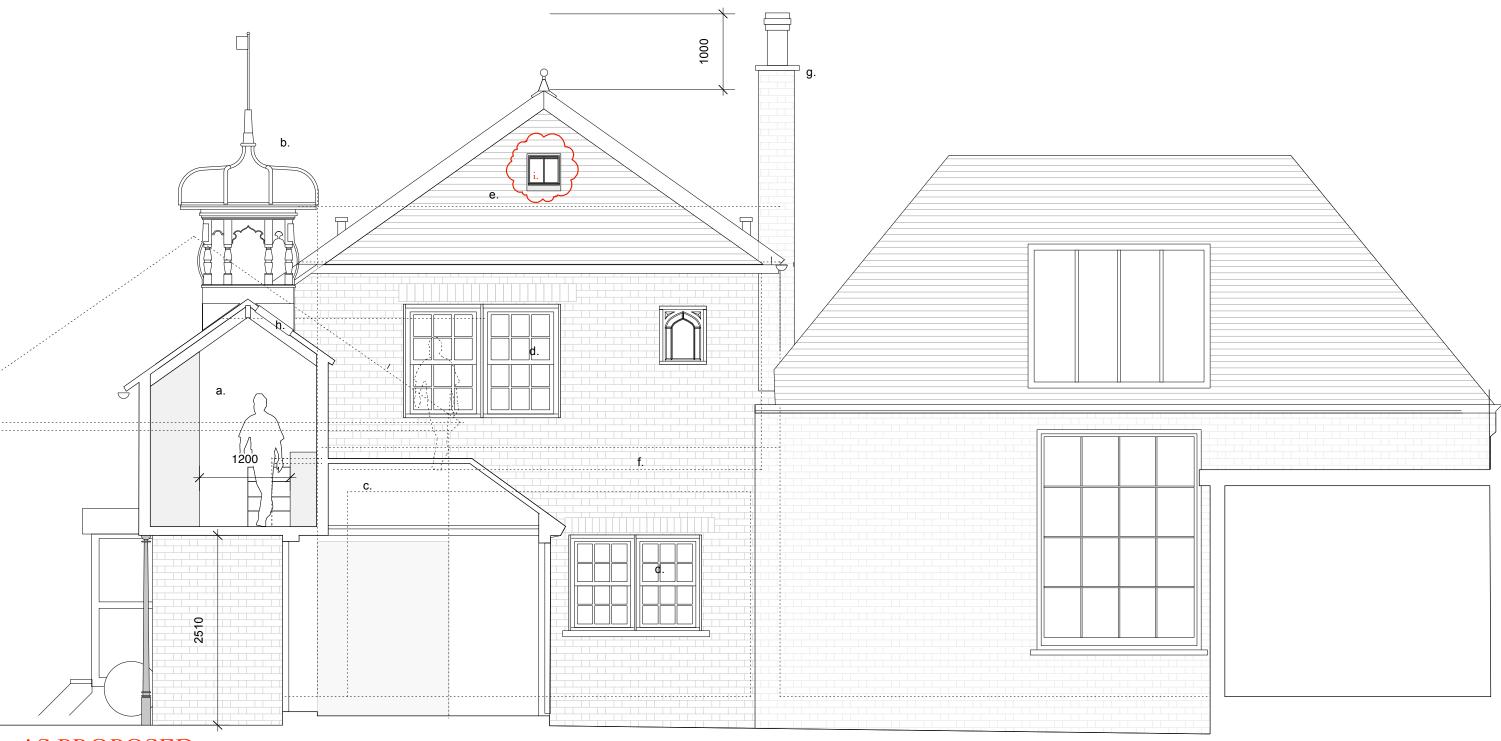
1st floor internal linking passage between buildings, salvaged red stock brick structure supported by reclaimed cast iron pillars Salvaged 19th Century timber and lead cupola, echoing those already in existence in the studios complex of similar age, style and construction.

Partial demolition to roof of existing ground floor linking passage, rest retained Purpose made new sash window, profiles and molding to match existing Half hipped pitched roof, angle and clay tiles to match existing adjacent.

Re-build existing poor quality modern extension in salvaged red stock brick, plan area to extend to the full size of the building footprint below, incorporating the previous lean-too roof and 1st floor conservatory. existing chimney raised, as previously granted.

doublepitched roof of 1st floor corridor, exposed timber roof structure with insulation above, clad inclay tiles to match existing adjacent

conservation rooflight set flush with tile [structural size 615 875h]
