## ST GILES CIRCUS

### LISTED BUILDINGS VISUAL STRUCTURAL REPORT

Consolidated Developments

029-S-REP-003

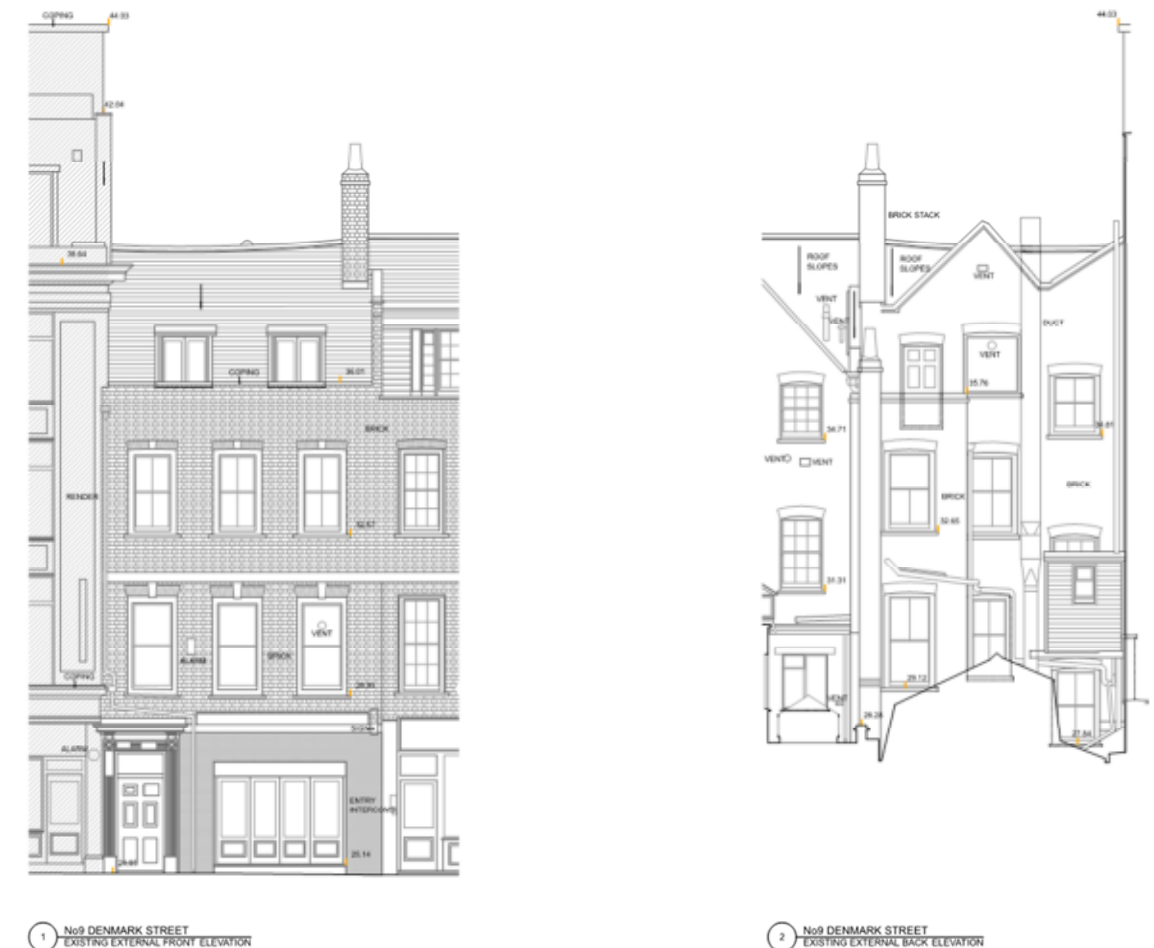
**Figure 2.2 Front & Rear Existing Elevations**

- 2.1.1 No. 9 is one of a pair of terraced houses that the Camden listed building register dates from c1686-89. The front and rear walls are 3 storey high masonry construction with 3 openings per floor. At the rear one of the openings connects to a later masonry extension that houses kitchen and bathroom areas. The party walls are of masonry construction with two chimney breasts on the party wall to No. 10 that extend the full height of the building.

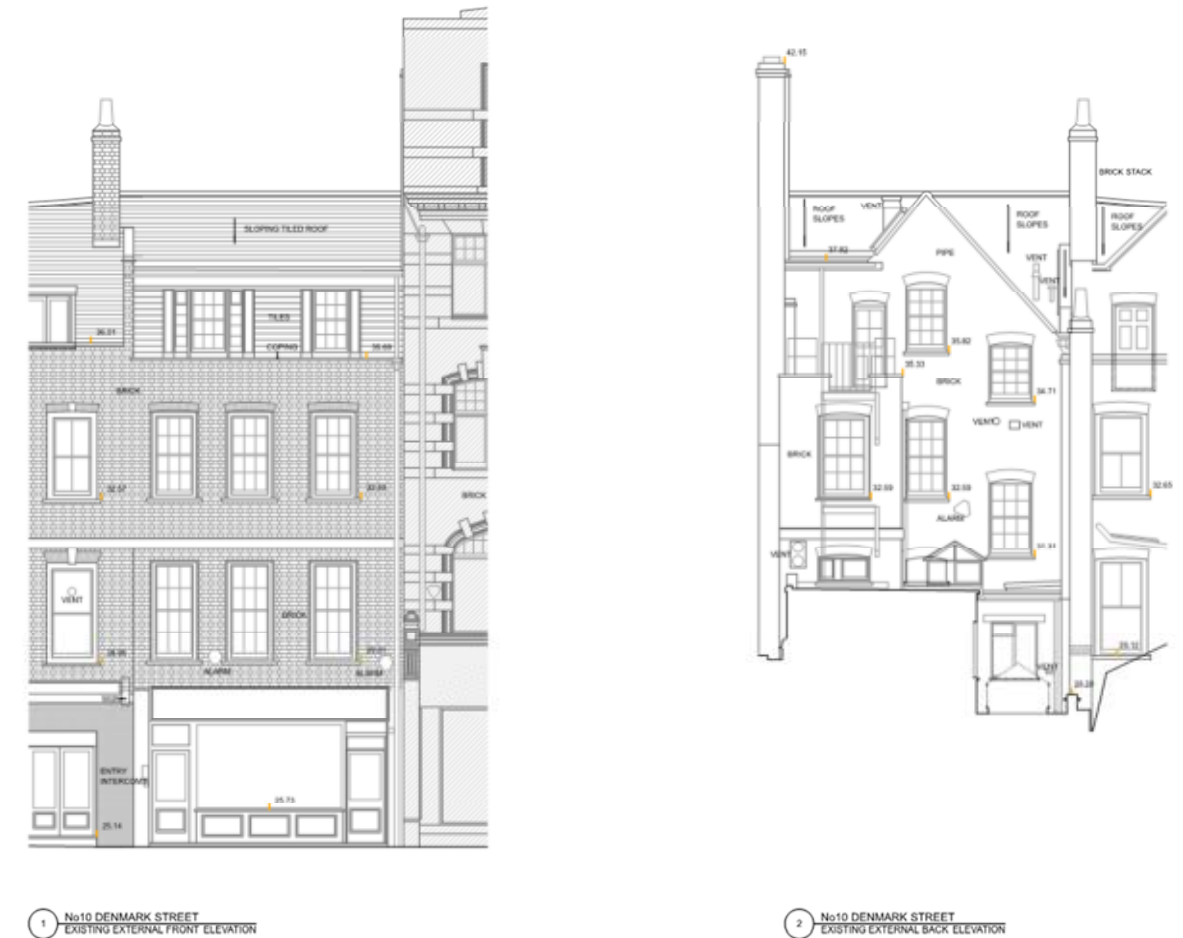
Figure 3.2 Front & Rear Existing Elevations

- 3.1.1 No. 10 is the second of a pair of terraced houses that the Camden listed building register dates from c1686-89. The front and rear walls are 3 storey high masonry construction with 3 openings per floor. At the rear one of the openings connects to a later masonry extension that houses kitchen and bathroom areas. The party walls are of masonry construction with two chimney breasts on the party wall to No. 11 that extend the full height of the building.
- 3.1.2 The floors are believed to be of timber construction, although due to modern floor finishes it was not possible to confirm the construction or direction of span. It is anticipated that timber joists span parallel to the front facade and are trimmed around the chimney breasts. At first floor level some of the internal walls have been removed and replaced with steel beams and columns.

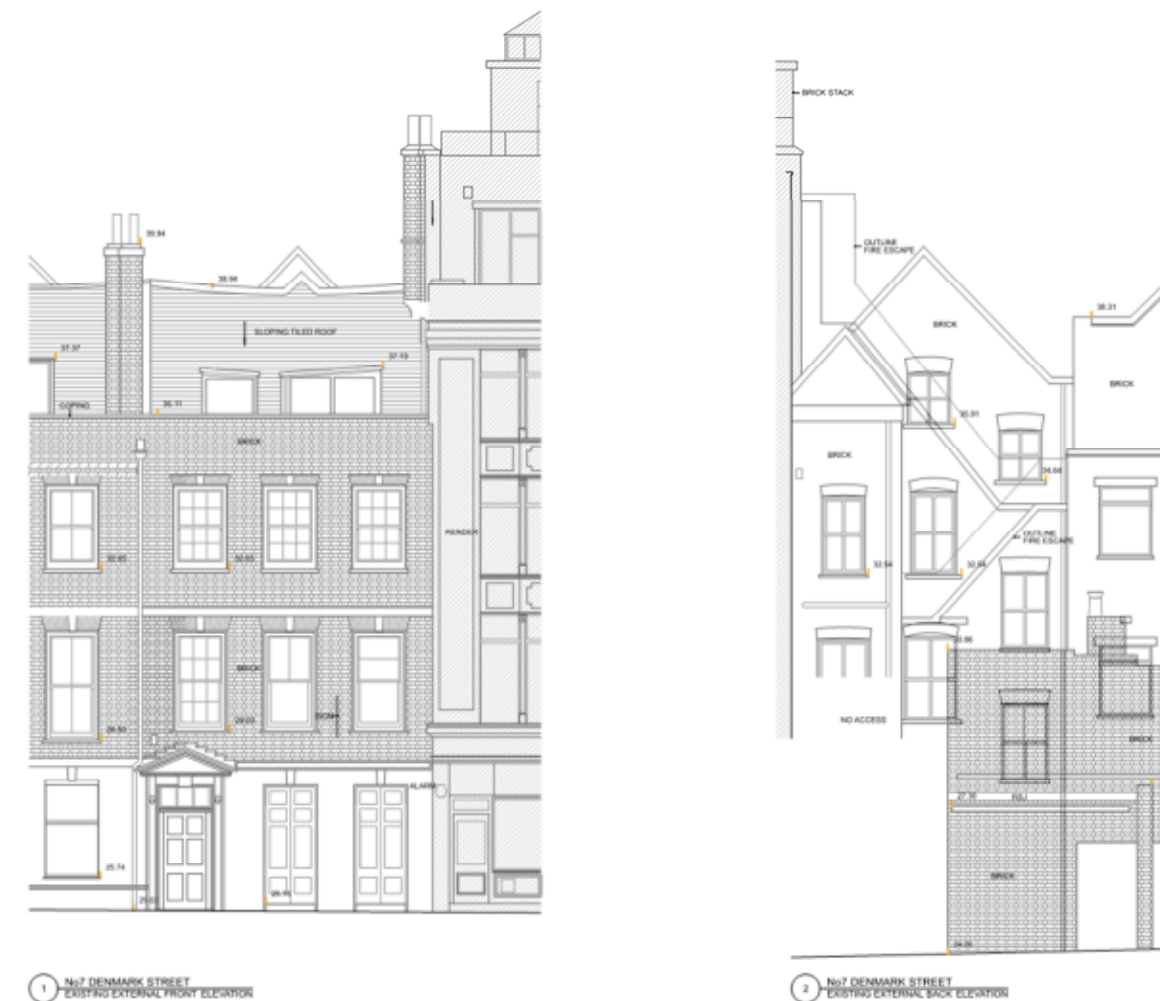
**Figure 4.2 Front & Rear Existing Elevations**

- 4.1.1 No. 7 is one of a further pair of terraced houses that the Camden listed building register dates from c1686-89. The front and rear walls are 3 storey high masonry construction with 3 openings per floor. At the rear one of the openings connects to a later masonry extension that typically houses kitchen and bathroom areas. The party walls are of masonry construction.
- 4.1.2 The floors are of timber construction, with floor boards observed to be running perpendicular to the front facade in the 1<sup>st</sup> floor front and rear offices. It was not possible to observe the direction of the floor boards in all the other spaces however it is to be expected that the 1<sup>st</sup>, 2<sup>nd</sup> and 3<sup>rd</sup> floors span in the same direction, with joists spanning parallel to the front facade and trimmed around the chimney breasts.

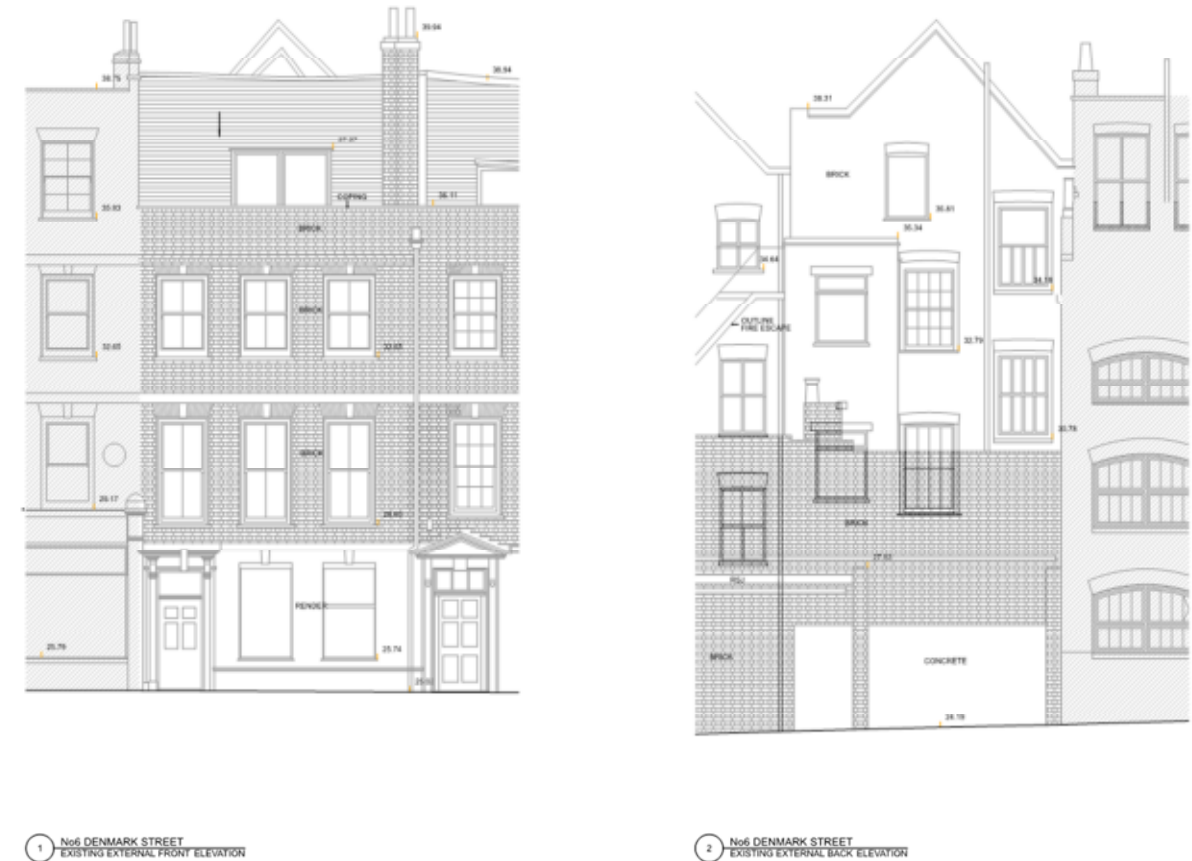
**Figure 5.2 Front & Rear Existing Elevations**

5.1.1 No. 6 is the second of a pair of terraced houses that the Camden listed building register dates from c1686-89. The front and rear walls are 3 storey high masonry construction with 3 openings per floor. At the rear one of the openings connects to a later masonry extension that houses kitchen and bathroom areas. The party walls are of masonry construction with two chimney breasts on the party wall to No. 7 that extend the full height of the building.
