This photographic Schedule of Condition has been undertaken as an agreed record of the structural condition of the Northern Line, Southbound Running Tunnel located adjacent the development site at 29-33 Chalk Farm Road. The inspection has been undertaken by Survey Associates and agreed with Tube Lines Infrastructure Protection Department. This document records the existing condition of the Running Tunnel and where possible, visible defects. The general condition of the surveyed area has been recorded photographically. The record photographs will be used for future comparison Survey of Condition inspections either during the construction phases of the adjacent development or once construction has been completed.

London Underground Northern Line Southbound Running Tunnel – Site Location Plan – NOT TO SCALE
SAL-1285 – 29-33 Chalk Farm Road – Camden Town – Northern Line, Southbound Running Tunnel – Condition Survey R0

Northern Line - Southbound Running Tunnel Defects Schedule

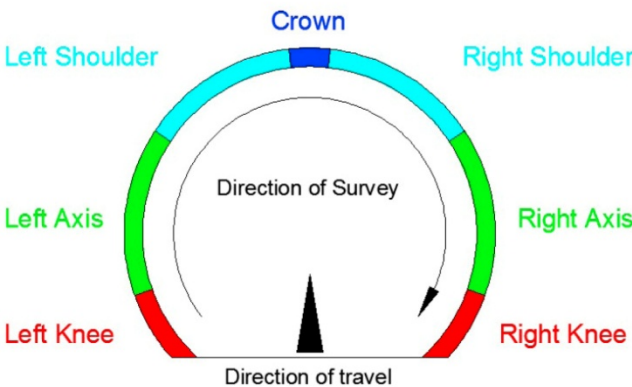
For the purposes of this SoC, the part of the tunnel of which is approximately 95 meters in length has been surveyed on a 'ring by ring' basis. The Southbound Tunnel Condition Survey was observed longitudinally in the direction of travel. The tunnel circumference is referenced and annotated in accordance with the sketch below.
