*Design, Access and Heritage
Statement*

*Lift installation and associated
works at Cecil Sharp House*

Cecil Sharp House 2 Regents Park Road, London NW1 7AY

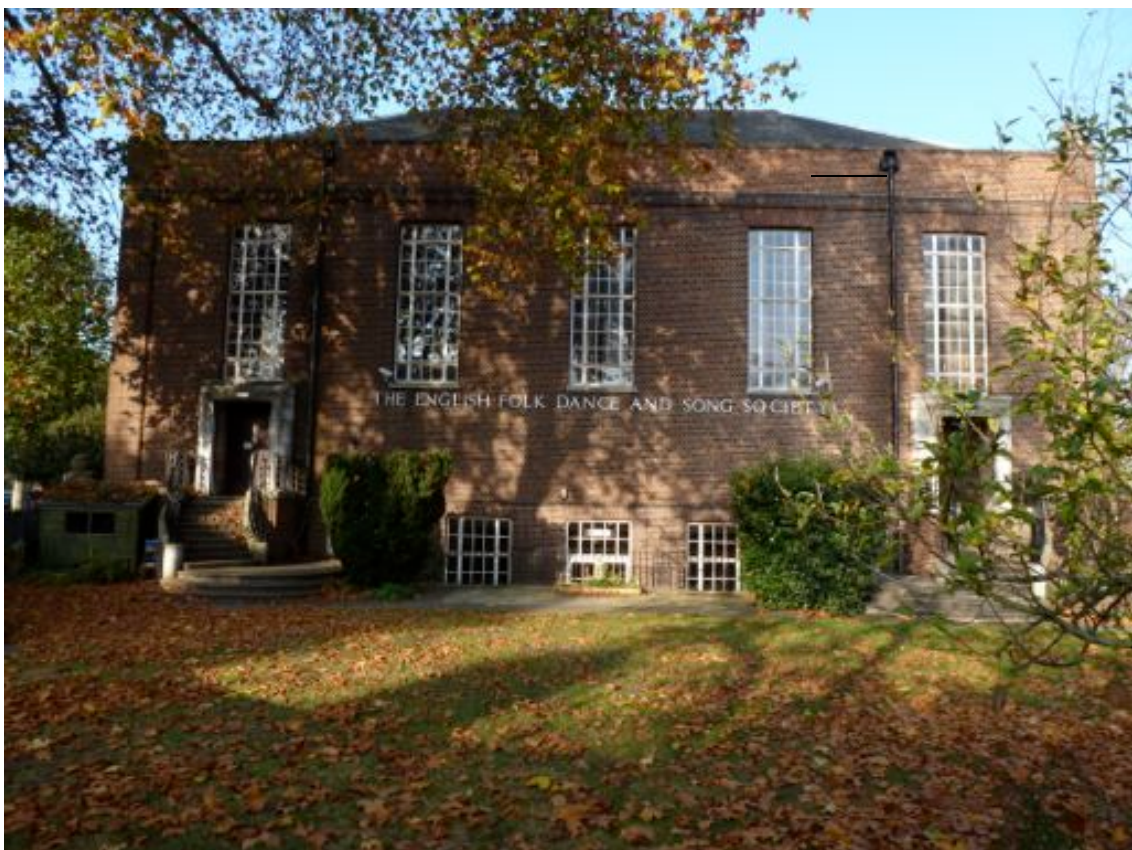
Fig.1 South East Elevation

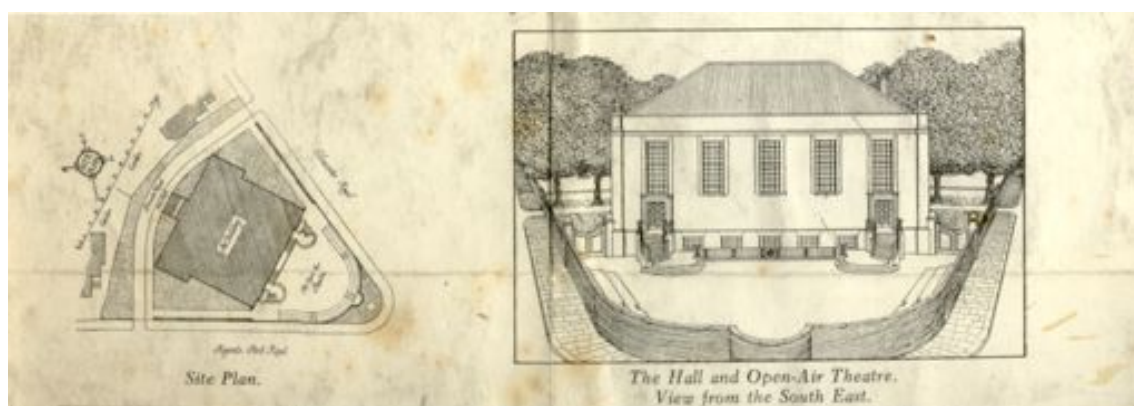
Fig 3. Original Design as built in 1930.

The format of the North elevation is currently dominated by the impression of regular symmetry; however this was not the case in the original building. Reviewing photographs from 1931, the North block comprising library, stair, administration and WC/ancillary space, makes plain its differentiated roles – the West end (formal library) and the East end (service quarters) -through the fenestration. The Library has full height windows with Juliet balconies to the right of the entrance, whereas to the left a simple window with raised cill is provided to the WC/Changing room corridor. The East elevation has paired windows to the ground floor WC's (Fig.2) and offices (first floor), whereas the Library windows to the West elevation (Fig.3) are single, wider and more formal versions without the ancillary soil pipework or boiler chimney. The West elevation's twin circular windows are part of an original provision on the first floor not repeated on the East. These add to the formal quality of the façade design facing Regents Park Road, the less important Gloucester Avenue having the Eastern service elevation.

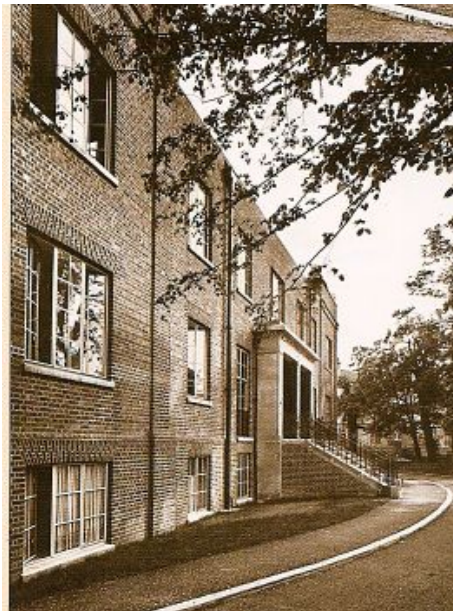
Fig.4 Original north elevation 1931 showing Portland stone entrance within a smaller scale central elevation.

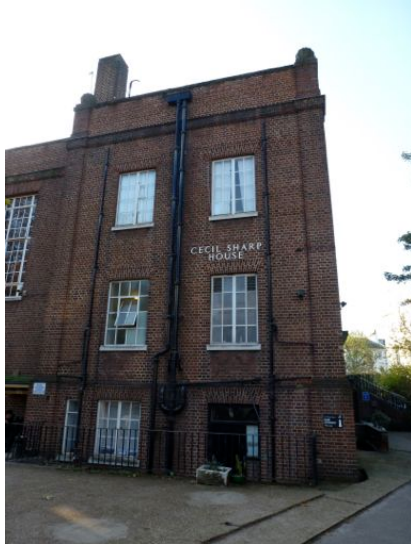
Fig.5 Eastern (service) elevation.

The 50's re-construction has in places exacerbated this difference between 'high' and 'low' functional expression, and has also erased it at the same time: see drawing CSH108 for comparison. An air intake at high level to the eastern end of the North elevation and the addition of escape stairs and pipe-work from the basement reinforce the nature of the Eastern service side of the block, whereas the regularising of the fenestration during the rebuilding has instigated a symmetry that was not original (dropping the cill to the male WC passageway for example, giving a formal, full height window to an informal space for the sake of external priorities). Such detailed differences are as subtle as the shallow depth of the window reveals, and in particular refer explicitly to the early English domestic architecture cited in the CAAC advice – that of establishing clear and unapologetic use of services where required, within an ordered and somewhat austere whole.

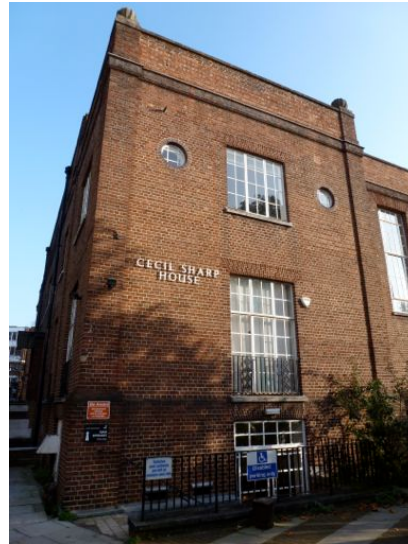
Fig.6 the formal Western (Library) elevation

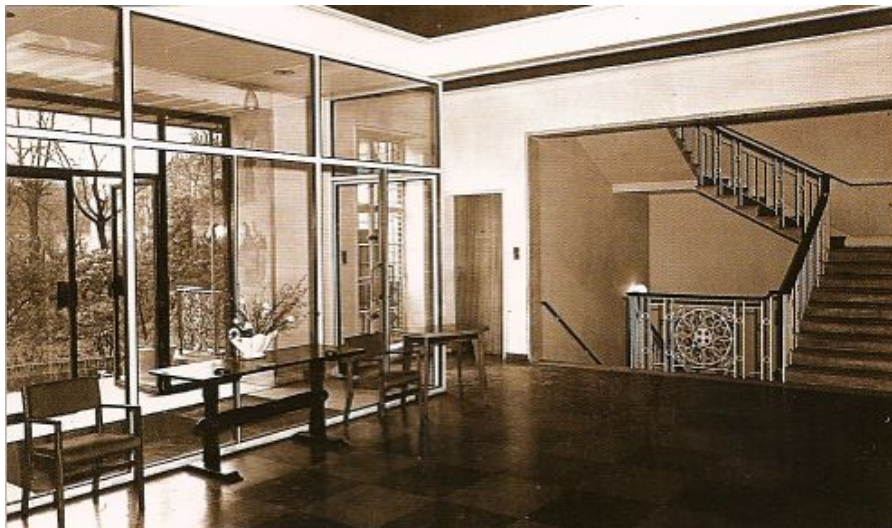
With the proposed lift lobby entering the protected stair zone through the timber door shown centre of fig 8. it is important to re-establish visual connection between visitor and reception desk to aid navigation, and to enhance the ability of staff to assist or support disabled users. The 1951 glazed installation remains in-situ, with some unsympathetic alteration, and when restored as per Fig 8. Provides a pattern for the replacement of the plasterboard partition screen and double doors with a steel framed fire glass screen. The contrasting colour scheme also contributes to the legibility of the space for visually impaired users, and its restoration will provide a striking impression for visitors to EFDSS.

Fig 8. The postwar reception screen.

The stair was fully reconstructed in 1951, retaining its place in an open reception area as originally conceived. The finely scaled glass and steel draught lobby was added, together with glazed entry doors, enhancing light levels and lending an ambiguous modernity to the space. Later fire regulation required the partitioning off of the stair from the reception to facilitate escape from upper levels directly into the draught lobby, which had the fine steel and glass entry doors replaced with aluminium and glass versions at some point.

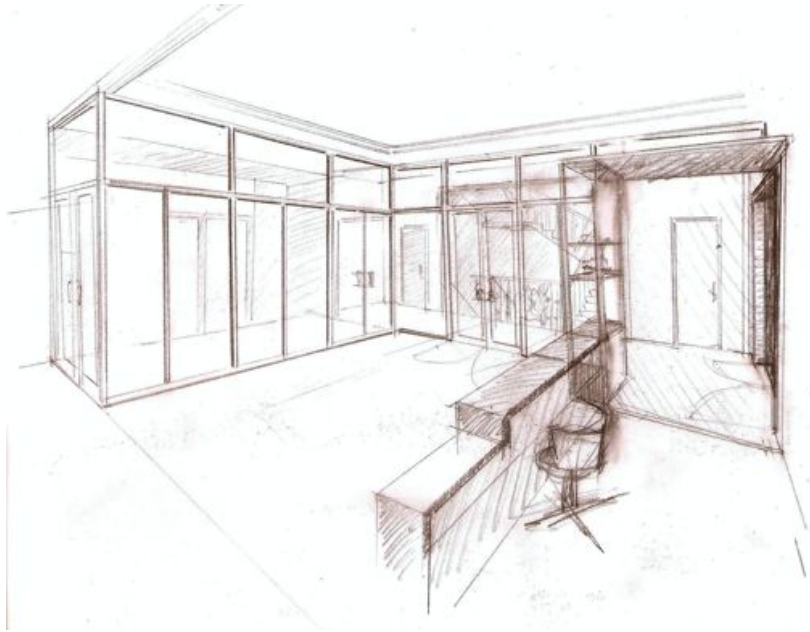
Fig 9. Impression of proposed Reception fire screen

Drawing CSH 202 indicates an integral display cabinet to allow for a shift in plane so that the screen lines through with the existing down-stand beam above for its full length, whilst stepping into the reception area at lower level to facilitate the opening of the double doors to Kennedy Hall. The cabinet forms part of a considered exhibition strategy to animate the reception with a changing programme of curated shows. The desk itself will be treated as a stand-alone piece of furniture, and conforms to DDA requirements for height, set back and useable space for both disabled visitors and staff.

We also discussed works to the main reception, primarily the replacement of the modern plasterboard partition that has been inserted so as to provide fire separation and a protected means of escape to the main staircase. Building Control has confirmed that separation is still required. Scheme A, consisting of a fully glazed partition from the underside of the existing downstand beam, in my view is the most appropriate solution. This would need to be realigned adjacent to the doors into the main hall but this could be incorporated logically into a glazed display case and the reception desk. I understand that you will prepare further detailed drawings for consideration.

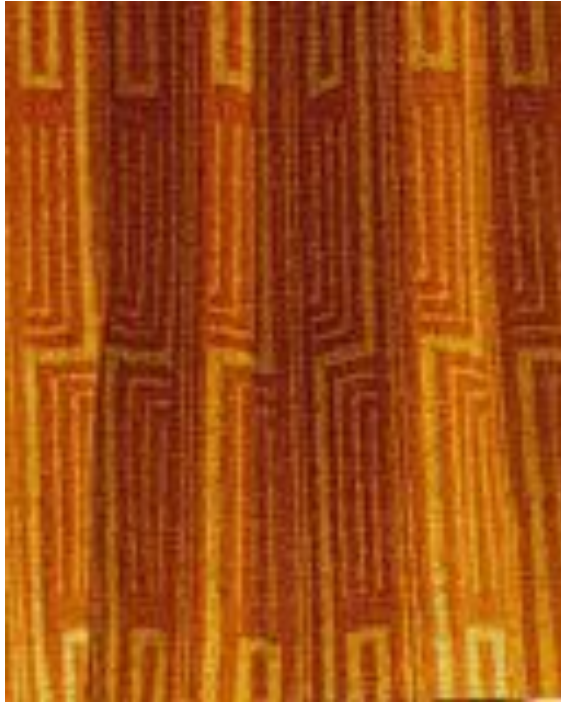
The device of utilizing a curtain, a re-edition of the original 1950 curtain fabric by Alec Hunter, to cover the edge of the shaft from view is used to mitigate the sight of the shaft at each level, in a manner sympathetic to the language of the window by utilizing the heritage of the house itself.

Fig 10. Curtain fabric commissioned for the 1951 refurbishment, design by Alec Hunter

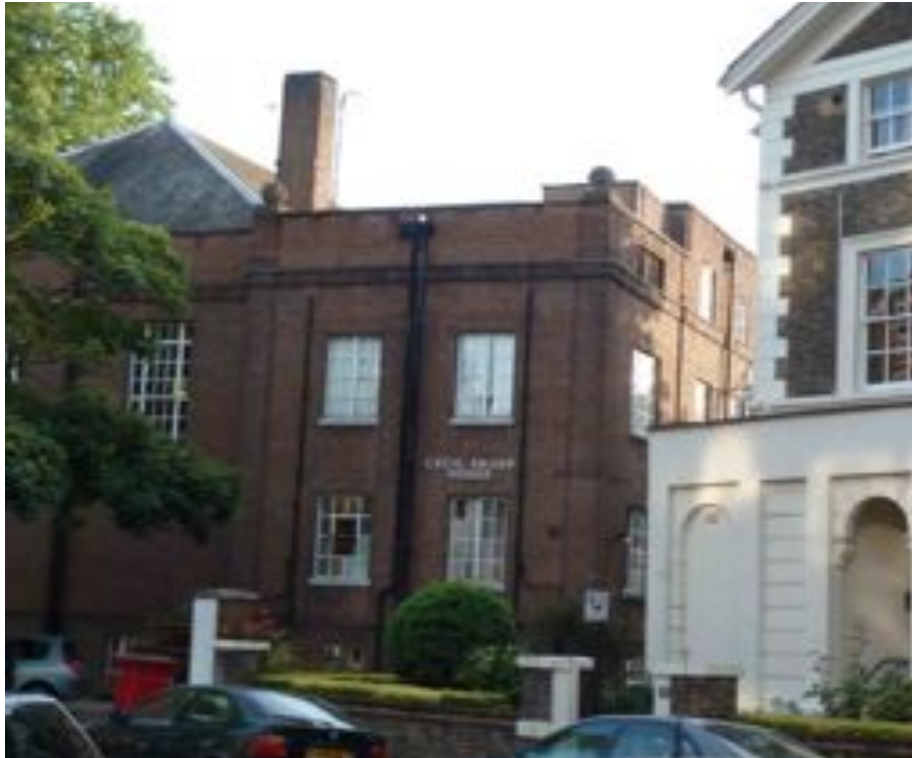
The lift overrun requires a dimension of 3.2 metres from top floor level to underside of the overrun roof covering. The raised top section of the shaft sits 280mm below the parapet of the second floor elevation, and within the line of the adjoining low parapet wall, allowing the existing parapets to be retained without alteration.

The materiality of the overrun enclosure is proposed as brick, utilizing salvaged bricks from the alterations to ensure an exact match, with coping stones and rebated corner detail to ensure the new rooftop addition is visually unobtrusive by maintaining a consistent detail language.

Fig 11. External visualization of lift overrun detailed in brick
