VIEW A GLAZED LOBBY (1950 - 2012 RESTORATION)

VIEW B

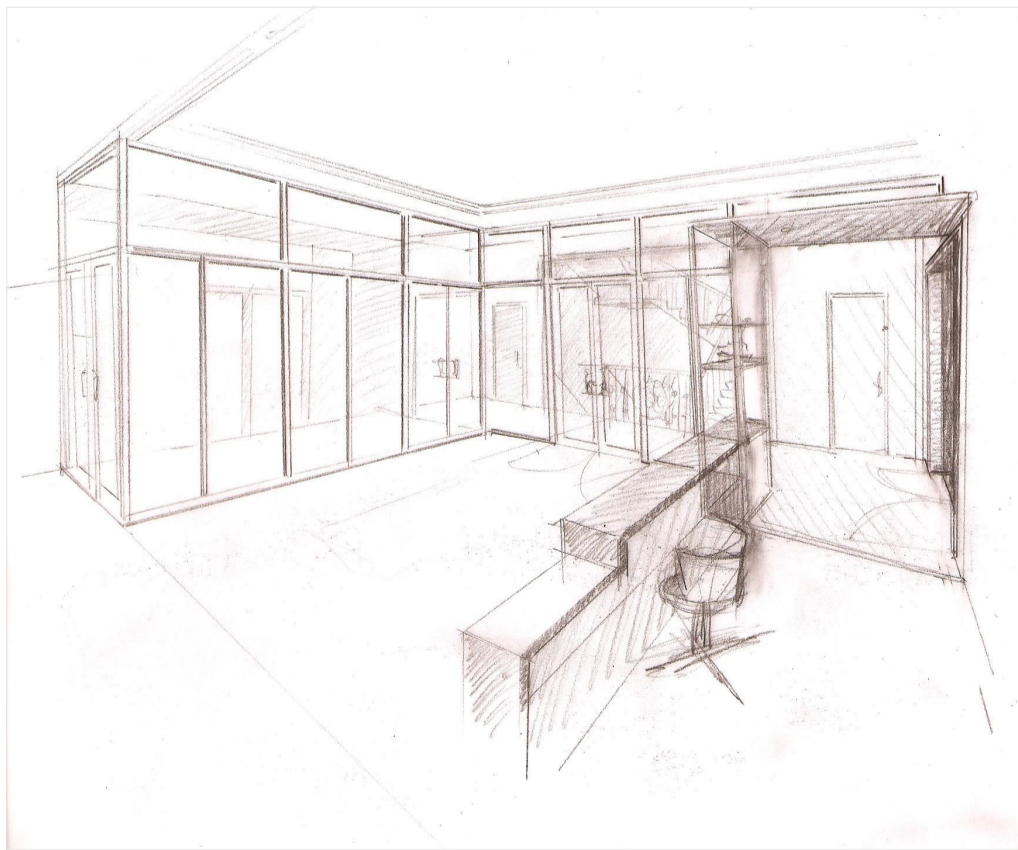
glazing divisions reinstated as per VIEW A to draught lobby - pattern extended as stair separation with double doors to match existing

Display 'vitrine' connects new reception desk to fire screen.

Upper section of screen to run along ceiling beam.

Lower section shifting horizontally to avoid Hall door opening.

Replace current aluminium glazed entry doors to match 1950 originals re-using existing original hinges and internal lobby door details.
