8 Pilgrims Lane

**Ground Movement Assessment Report:
New Basement Proposal**

by **RKD Consultant Ltd.**
On Behalf of :

Revision1: Issued: 1st November 2012

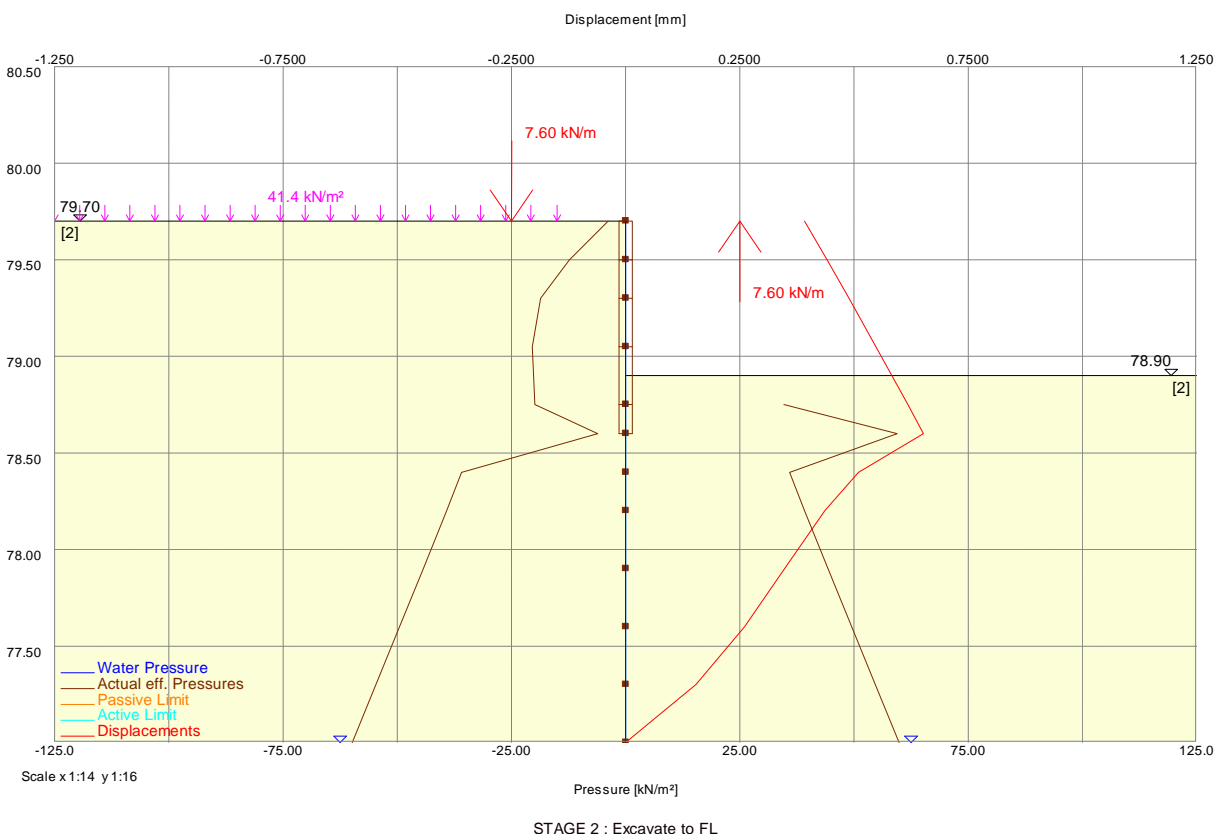
Figure 1: Shallow Underpinning: Horizontal Displacement on Excavation

Results for the FREW wall analyses for the shallow and deep underpinned walls and for the piled wall section are shown in Figures 1, 2, 3 below.

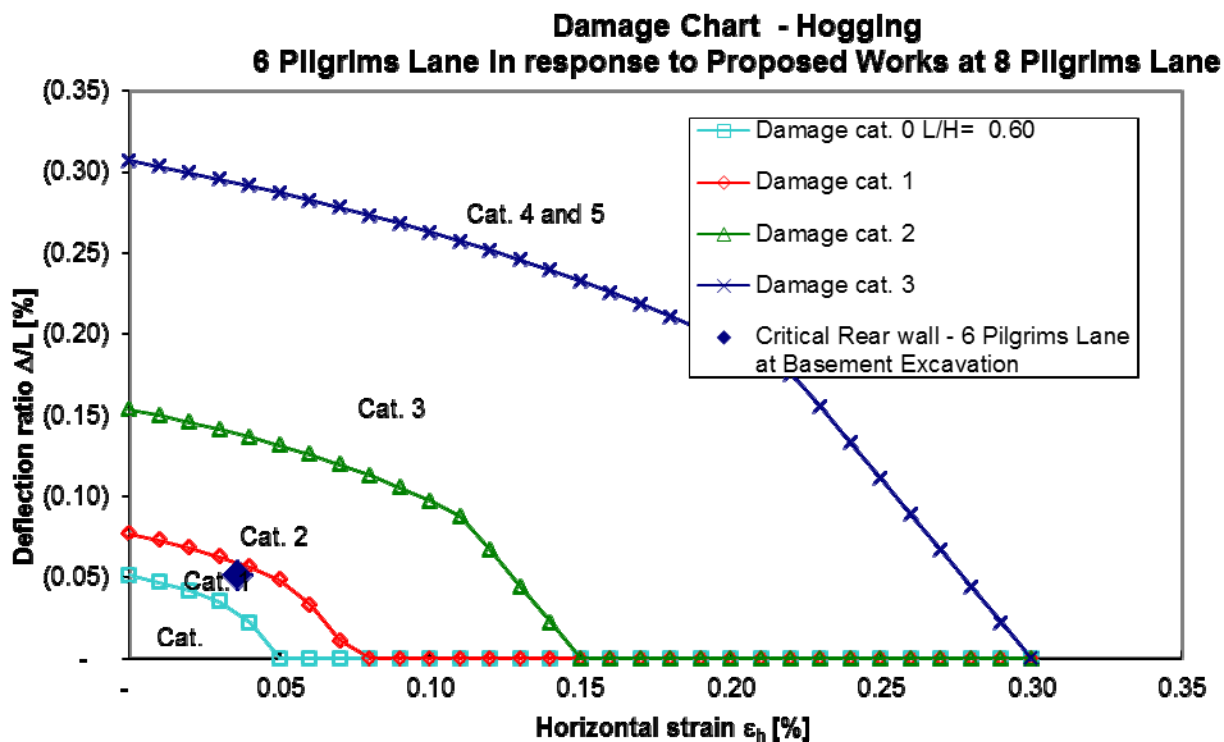
Figure 5: Damage Category Assessment for (critical) rear wall of number 6 Pilgrim’s Lane

The results for the worst case as described above are plotted in figure 5 below and this indicates that the local Damage Category is classified within (1) or ‘Very Slight’.

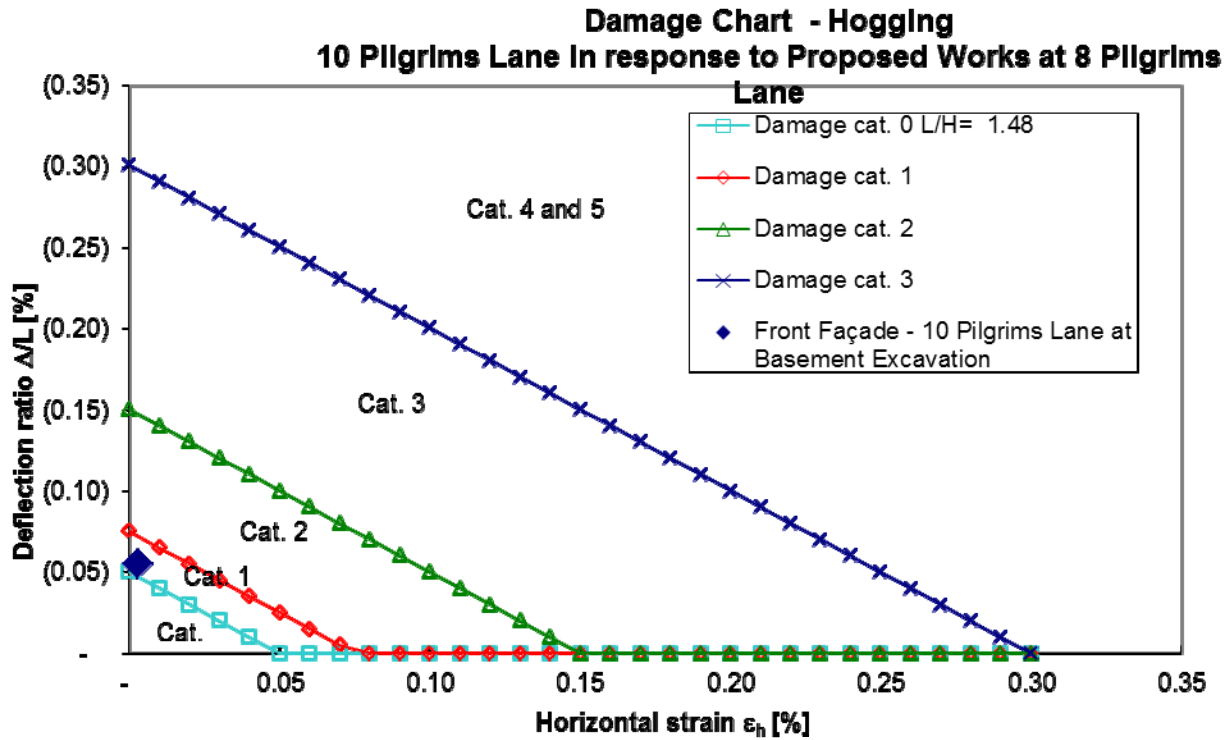
Figure 6: Damage Category Assessment for (critical) front façade of number 10 Pilgrim’s Lane

The Party Wall along the shallow section underpinning experiences a total settlement of 5.25mm as a direct result of the underpinning action and excavation and as already described. The settlement at the other end of the structure (distance L) is negligible. The relative deflection (Δ) is given by some value less than 5.25mm but is conservatively taken here as 5.25mm. This then gives, for the front façade, a deflection ratio of $5.25/9600 = 0.055\%$. The horizontal strain is calculated from the excavation phase only for the underpinned sections and so the shallow section gives a small value

of $0.25/9600 = 0.0026\%$. These results give a Damage Category of (1) or ‘Very Slight’ and as shown in Figure 6 below.

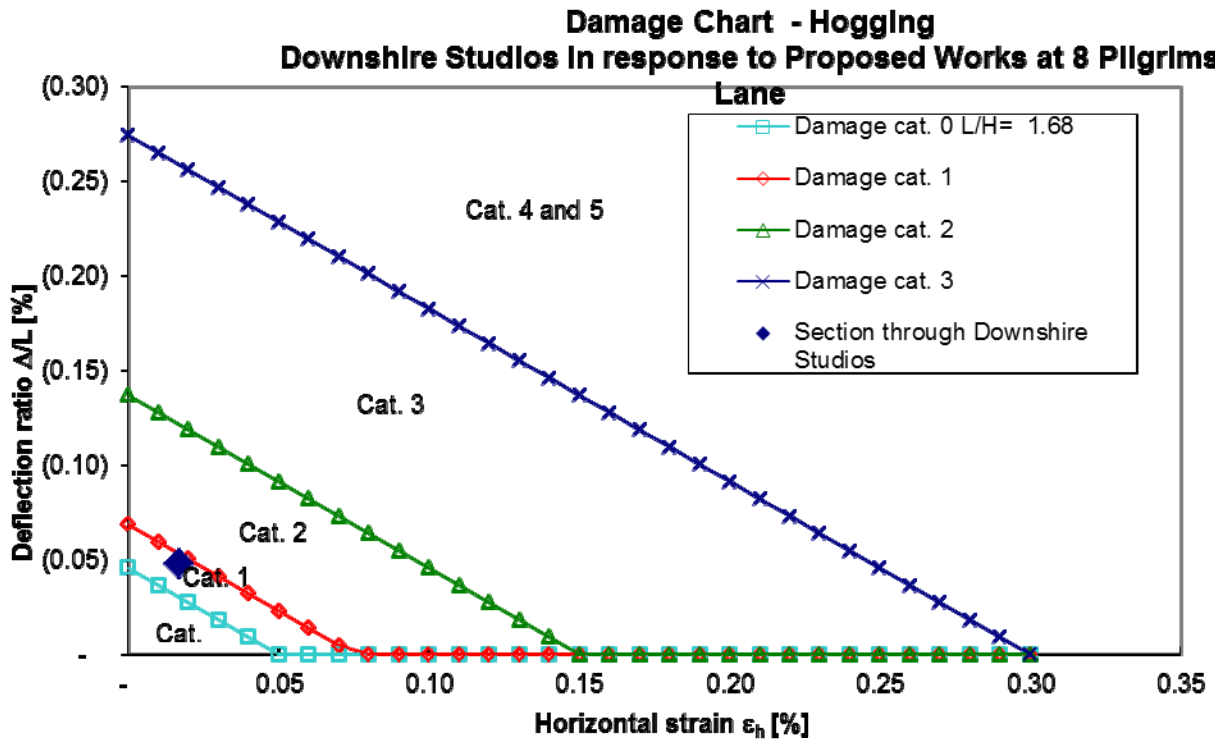
Figure 7: Damage Category Assessment for (critical) section through Downshire Studios taken away from the Site

The building geometry in this orientation is taken as $L = 8.4\text{m}$, $H = 5.0\text{m}$ (to eaves). L is measured perpendicularly away from the Site. The settlement at the other end of the structure (distance L) is negligible. The maximum relative deflection (Δ) is taken from the worst section contour curvature at the corner and as 4mm (worst case). This gives a deflection ratio of $4/8400 = 0.048\%$. The horizontal strain is calculated from the excavation phase only for the underpinned sections and so the deep section gives a value of $1.4/8400 = 0.017\%$.

The result for the Damage Category Assessment of Downshire Studios is given in figure 7 and this shows Damage Category (1) or ‘Very Slight’.
