albert street
stage c/d - planning application

application for planning & listed building consent

MR KARL ALLEN						
															113 ALBERT STREET						
															CAMDEN						
															LONDON						
															NW1 7NB						
															12 OCTOBER 2012						
		time	stage a	stage b	stage c	stage d	stage e	stage f	stage g	stage h	stage i	stage k	stage l				director	j brown	r bismore	s foster

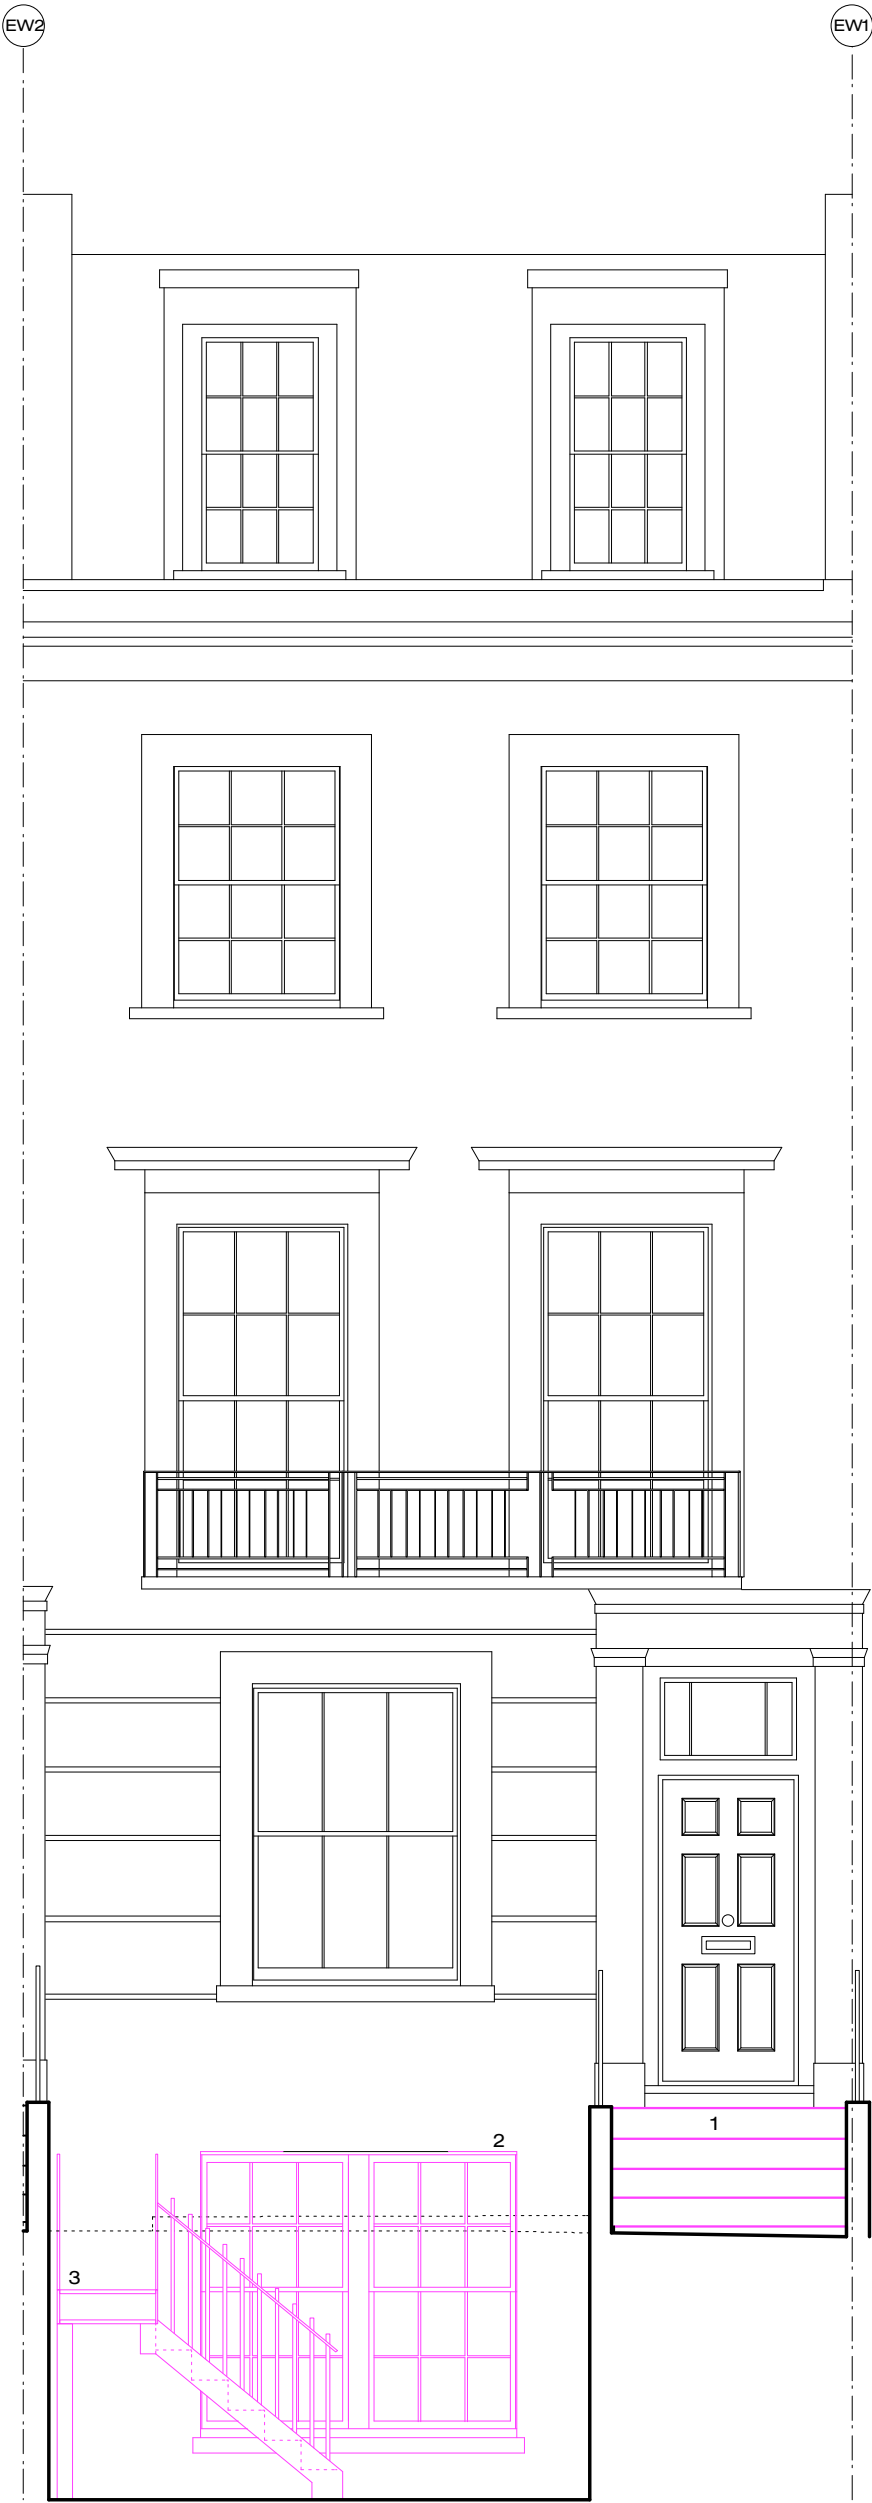
Front Elevation

- 20
Existing opening in side wall of closet wing enlarged to better connect the rear ground floor rooms. Wall head and nib retained.
- 21
Original cornice line reinstated along original rear wall.
- 22
New door opening made in lower ground floor spine wall. New door to match original four panel doors in style and proportion but have un-beaded panels as appropriate for a door to a small room on the lower ground floor.
- 23
Traditional stair envelope to lower ground floor re-instated to properly separate the rear rooms. Staircase balustrade restored.
- 24
Existing bathroom spanning second floor spine wall removed and spine wall reinstated to restore the original layout and room proportions.
- 25
Existing chimney breasts revealed by removing modern partitioning across recesses either side.

The changes to the front steps aim to improve the appearance of the front elevation restoring the formality of the original front steps. The increased quality of the replacement LGF windows will better match them to the windows above and
