albert street
stage c/d - listed building consent

application for listed building consent

MR KARL ALLEN									
															113 ALBERT STREET									
															CAMDEN									
															LONDON									
															NW1 7NB									
															05 OCTOBER 2012									
		time	stage a	stage b	stage c	stage d	stage e	stage f	stage g	stage h	stage i	stage k	stage l					director	j brown	r behmore	s foster

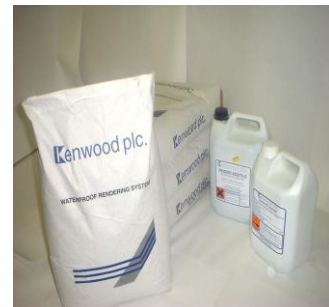
The wall plaster in the areas shown, will be replaced using the Kenwood plc specialist rendering system. Kenwood premix waterproof rendering system is factory produced and consists of specially blended dried sands, cement, lime, and aggregates along with polypropylene fibres to reduce shrinkage.

Additionally salt inhibitors and waterproofers are added, to combat the ground salts and allow replastering immediately after the damp course installation.
