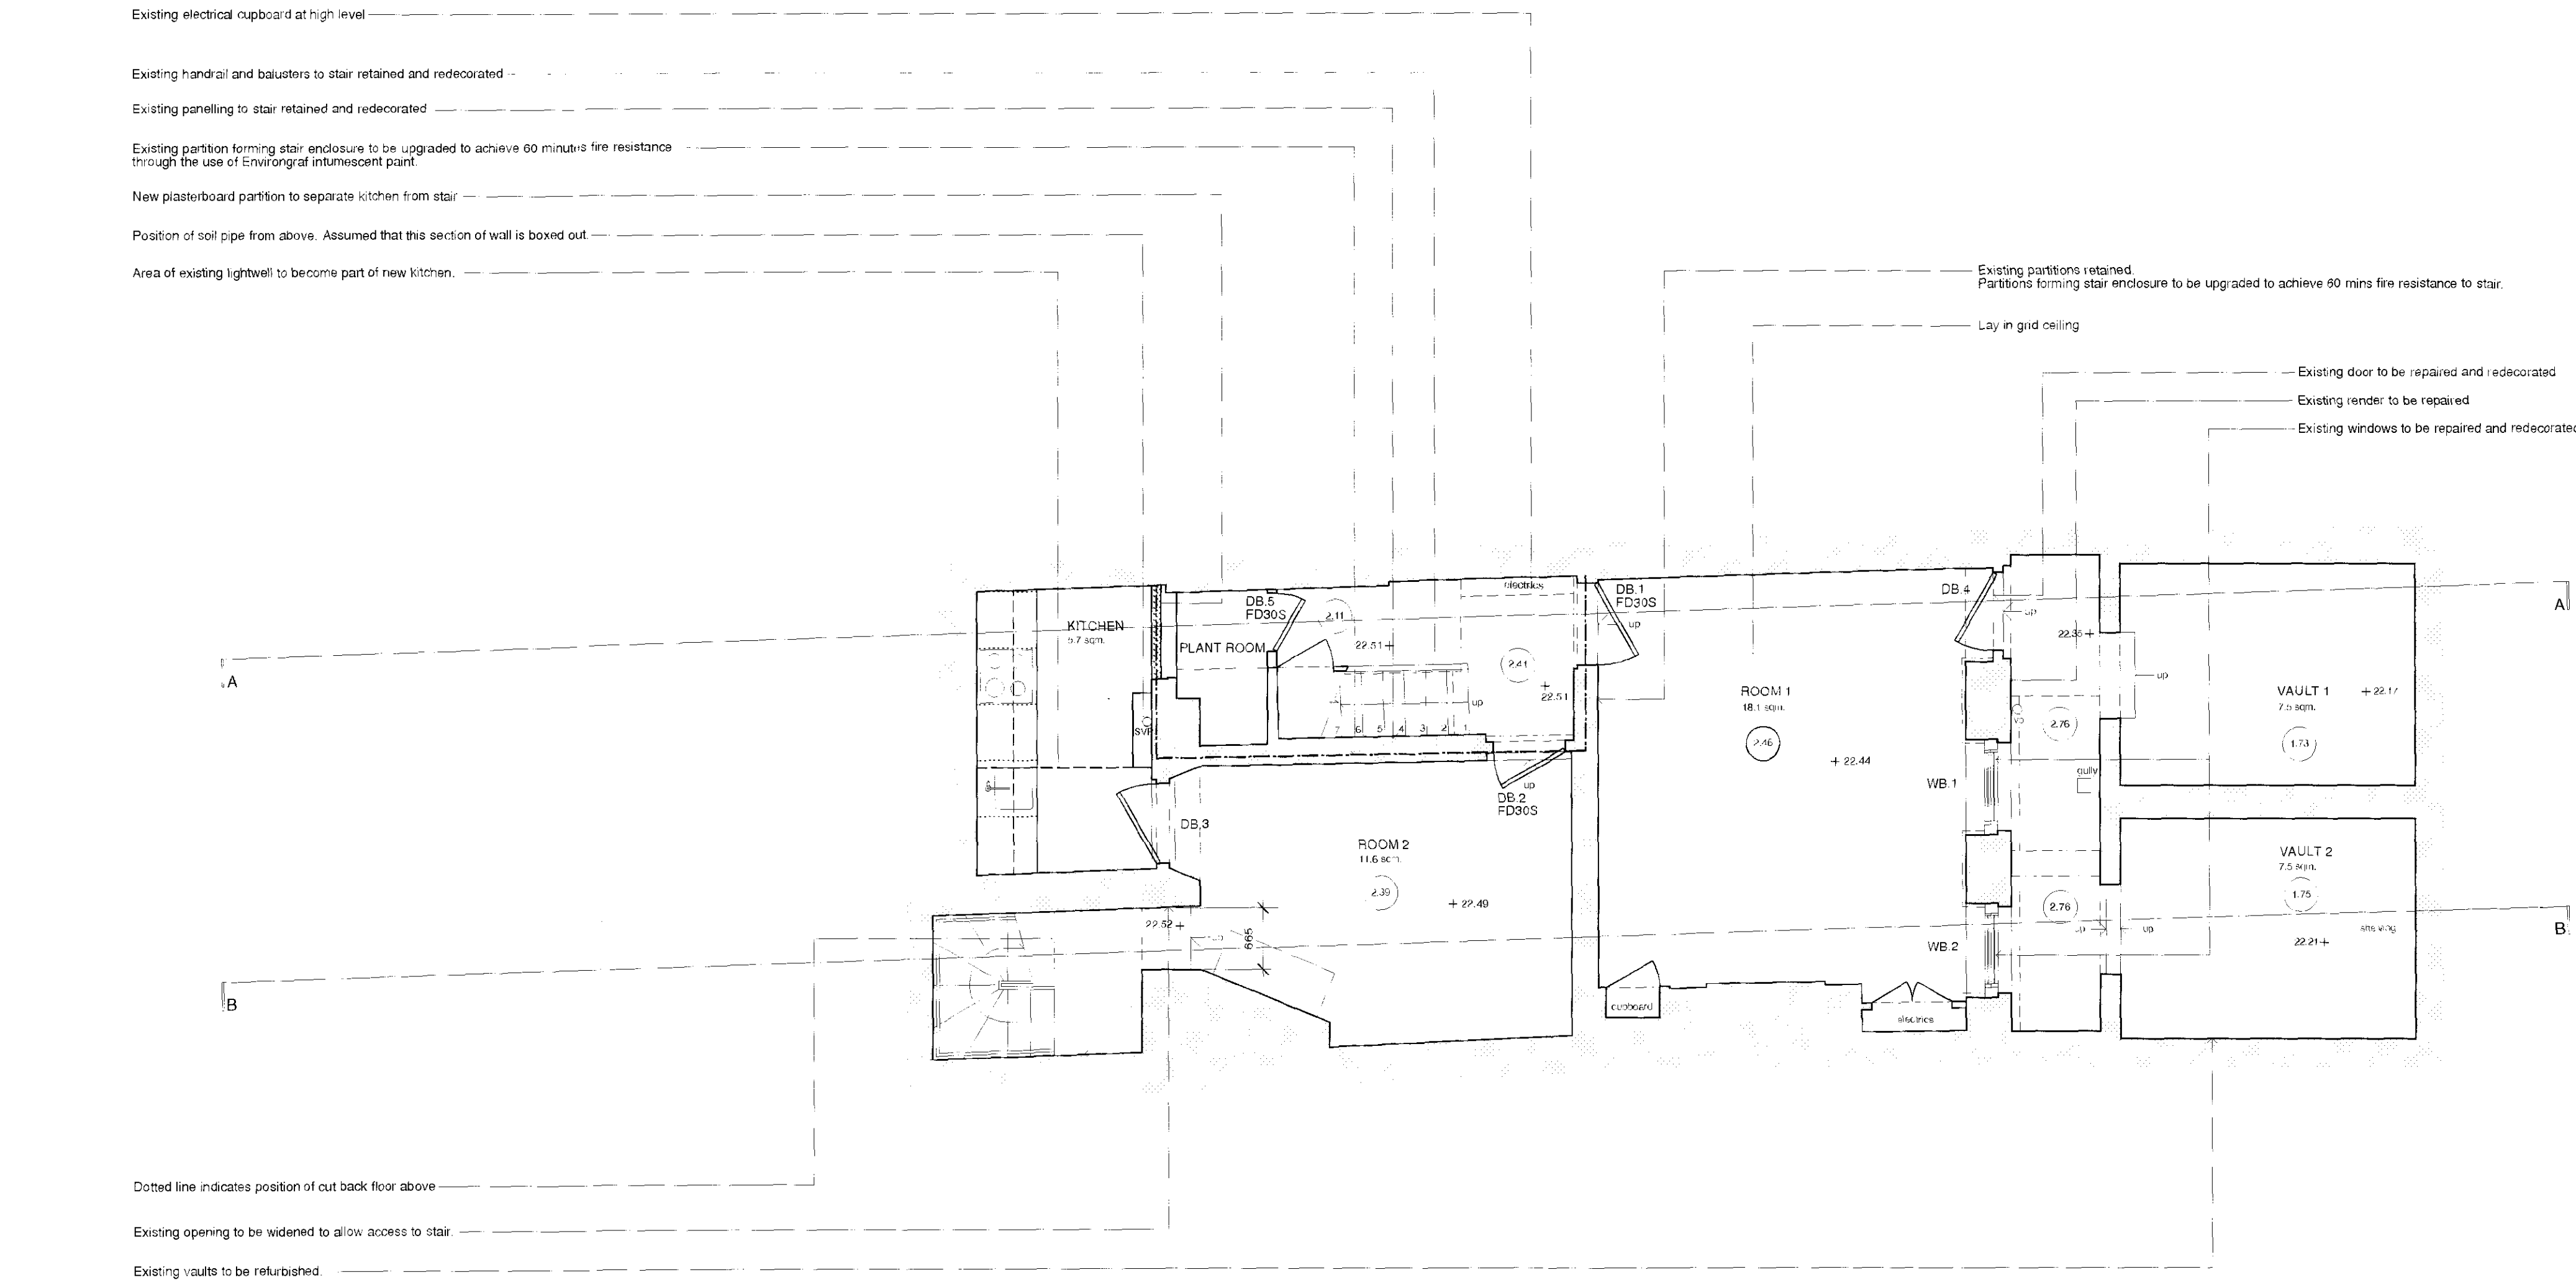
DOORS AND WINDOWS	
DB.1 - Existing timber door and architrave to be retained, made good and redecorated. Door to be upgraded to FD30S.	
DB.2 - Existing timber door and architrave to be retained, made good and redecorated. Door to be upgraded to FD30S.	
DB.3 - New timber door door to match design of DB.2, FD30S.	
DB.4 - Existing timber external door to front lightwell. To be retained, made good and redecorated.	
DB.5 - New timber door to new opening, FD30S.	
WB.1 - Existing sash window to be retained, made good and redecorated.	
WB.2 - Existing sash window to be retained, made good and redecorated.
