SPECIFICATION

EXISTING BUILDING FABRIC

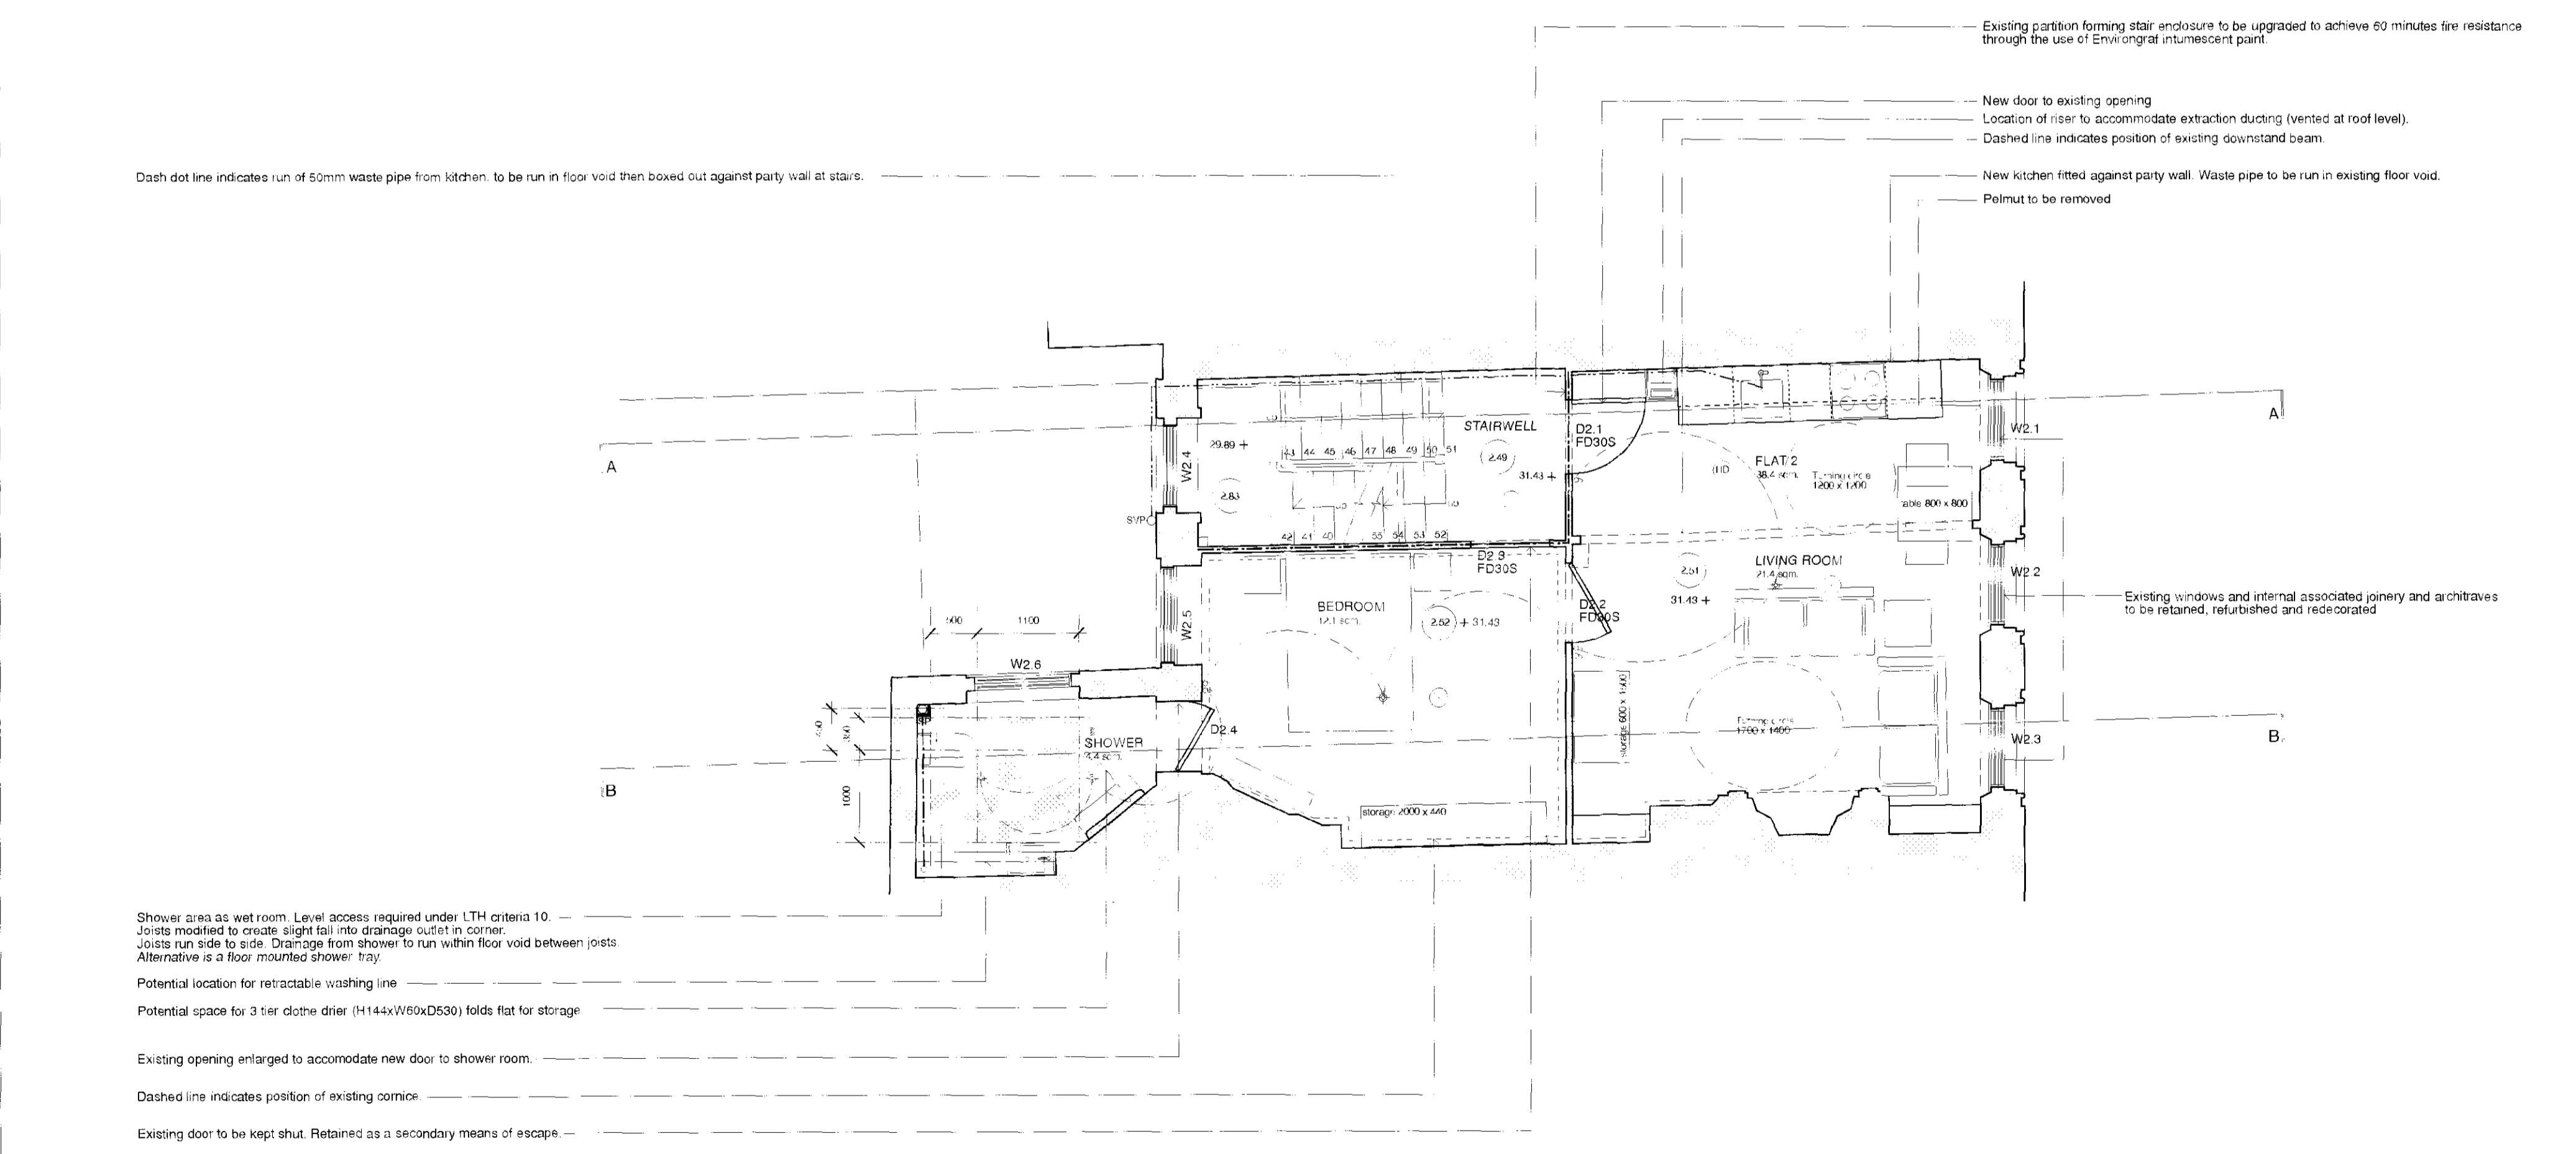
Note: all windows to be retained and refurbished if possible. Each window to be assessed on site with Conservation Officer. Any windows deemed to be beyond repair to be replaced with like for like sash window.

- DOORS AND WINDOWS**
- D2.1 - New timber door to existing opening. FD 30 S. Door and architrave to match design of D2.3.
 - D2.2 - Existing timber door and architrave to be retained, made good and redecorated. Door to be upgraded to FD30S.
 - D2.3 - Existing timber door and architrave to be retained, made good and redecorated. Door to be upgraded to FD30S.
 - D2.4 - Existing timber door and architrave to be retained, made good and redecorated.
 - W2.1 - Existing sash window to be retained, made good and redecorated.
 - W2.2 - Existing sash window to be retained, made good and redecorated.
 - W2.3 - Existing sash window to be retained, made good and redecorated.
 - W2.4 - Existing sash window to be retained, made good and redecorated.
 - W2.5 - Existing sash window to be retained, made good and redecorated.
