♂ X)11 syle architects lim.tec	revisions PEVIA_01.07.11_Position of services revised. Note on the resistance to common stair partitions added.	Chern Chern	Dr0[i∞Ct	drawinç title	date drawn by	revision
Chair 1, gravesians on site prior to commencement of the work ing gravesia where we have a quantity in any way the isothesis are to be in the fact where it is commenced.	PEV B 14.02.12 Drawings roward in the win advice facts ved from Building Costrol. REV 0 05.03.12 Charana and then's REV 0 12.07.12 Revised to Plancing and Lated Building ISsue				June 11 BM scale checked b	D / drawing
de andre de timers tro from dealing, idraving la copyright depande to be Vec in conjunction wet estructural engineers dravings and specification de-tet Serve Listever Evendent W15 at 0 if optimized estructural engineers dravings and de-tet Serve Listever Evendent W15 at 0 if optimized estructural estructural estructural estructural estructural de-tet Serve Listever Evendent W15 at 0 if optimized estructural est		FOR APPROVAL _i Lorna Williams	44 Great Russell Street London WC1B 3PA	Third Floor Plan As Proposed	1:50@A1 RW	178.204

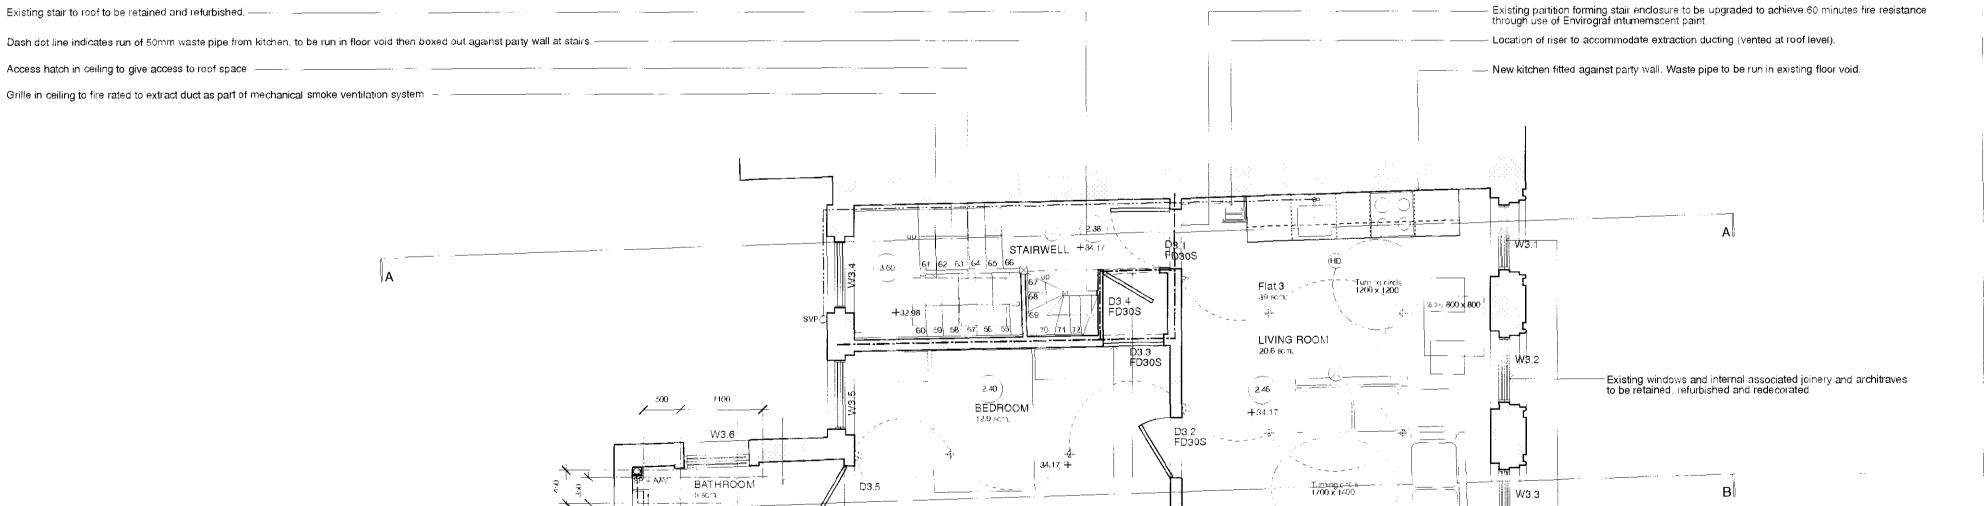
B 4			รtorage 2000 x 440		
Third Floor bathroom to have bath. Layout does not comply fully with LTH criteria 14 Provision for shower drainage to be installed under bath so that, if bath was removed shower room would comply with LTH criteria 10. Joists modified to create slight fall into drainage outlet in corner. Joists run side to side. Drainage from shower to run within floor void between joists.	l 				
Existing hearth to be retained.					
Existing door to be kept shut. Retained as a secondary means of escape.	·	· ······		Existing hearth to be retained.	
opening territed in externing paratients permit essentially interne of essential paratients and
