Re: Parliament Hill Management Ltd: 30 Parliament Hill, London, NW3 2TN

Please find enclosed our Arboricultural survey for the above property. As agreed at our meeting on 5th July 2011 we have removed any reference to Heave or the requirement for additional investigations from the main body of the report and included that information for your attention within the cover letter.

1. Case Details

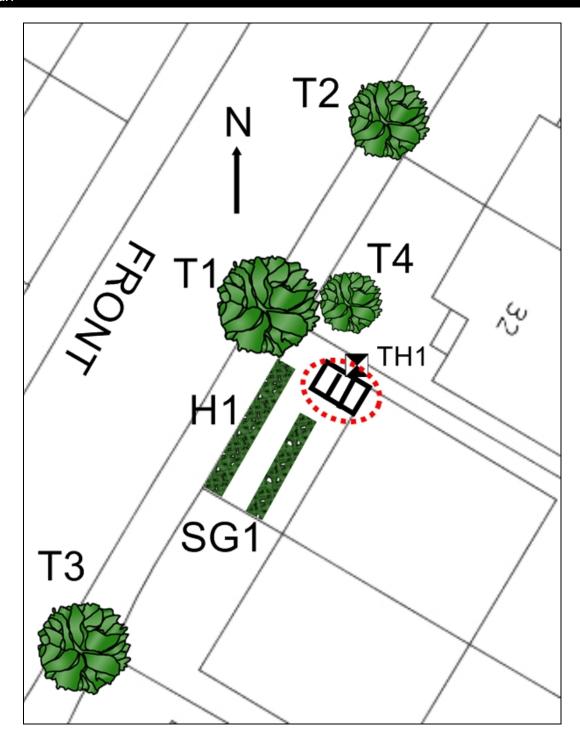
7. Site Plan

Please note that this plan is not to scale. OS Licence No. 100043218

Functionally active roots recovered from below foundation depth in TH1 have been formally identified as Leguminoseae and *Tilia* spp. The most likely origin of the roots is T1 (False Acacia) and T2 (Lime).

Such circumstances confirms the potential for T1 (False Acacia) and T2 (Lime) to influence soil volumes and to contribute to the damage observed.

Although no roots were found from T4 (Mulberry), due to its size and location to the damaged area of the property, it is likely to be a contributory factor.
