R G SERVICES

On-Site Timber Engineering

Strengthening and repairing timber beams.

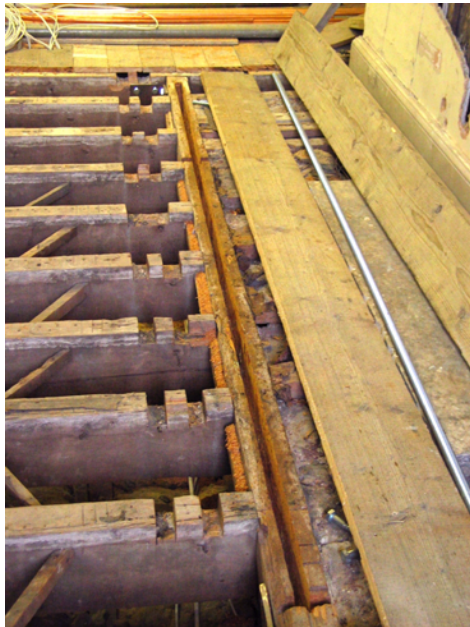
Reinforcement of hearth trimmer using slot method without damage to joist joints

If it is necessary to work within the original floor depth then strengthening above or below the floor is not an option.

To strengthen a member by fixing steelwork to the vertical faces of a beam would mean destroying the original joints of any interconnecting members and invariably damaging the ceiling.

Reinforcing timber beams using the steel reinforced slot technique solves these problems and has been used with great success on many projects for more than thirty years.

Access to the member is only required from above which, in most cases, means no more than lifting floorboards.

The strengthening method involves forming a slot along the length of the top face of the beam and embedding into the slot steel bars bonded into position with epoxy resin.

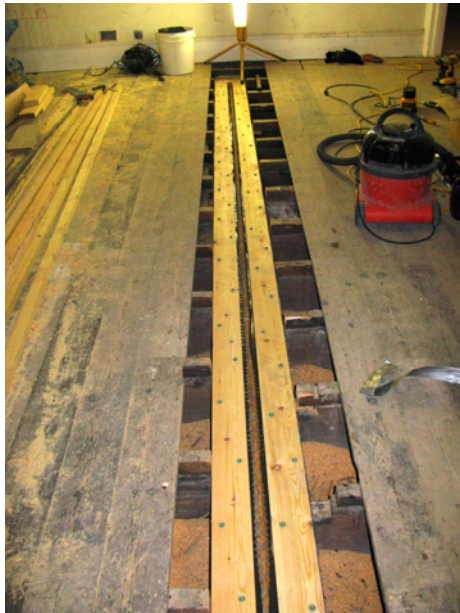
Reinforcement bars inserted into slot and bonded into position with epoxy resin.

The bar lengths, size and location are designed for each member and depend on clients design requirements.

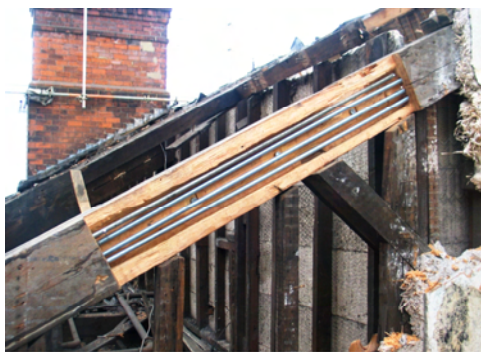
Repair of fire damage to rafter of principle roof truss.

The use of steel reinforcement bar and epoxy resin is not limited to the strengthening or repair of floor beams. It can be used in most situation where a structural member has failed, decayed or suffered some loss of strength and replacement of the member is not possible, desirable or economical.

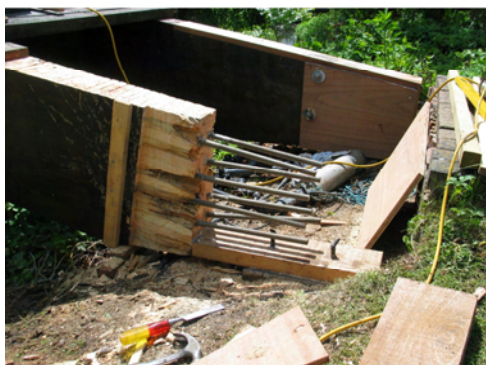
Repair of stringers on public footbridge.
