Our ref: J04105A/DN/1

Re: 139-143 YORK WAY, LONDON

Further to your instruction we have completed the additional fieldwork at the above site and present our findings as follows.

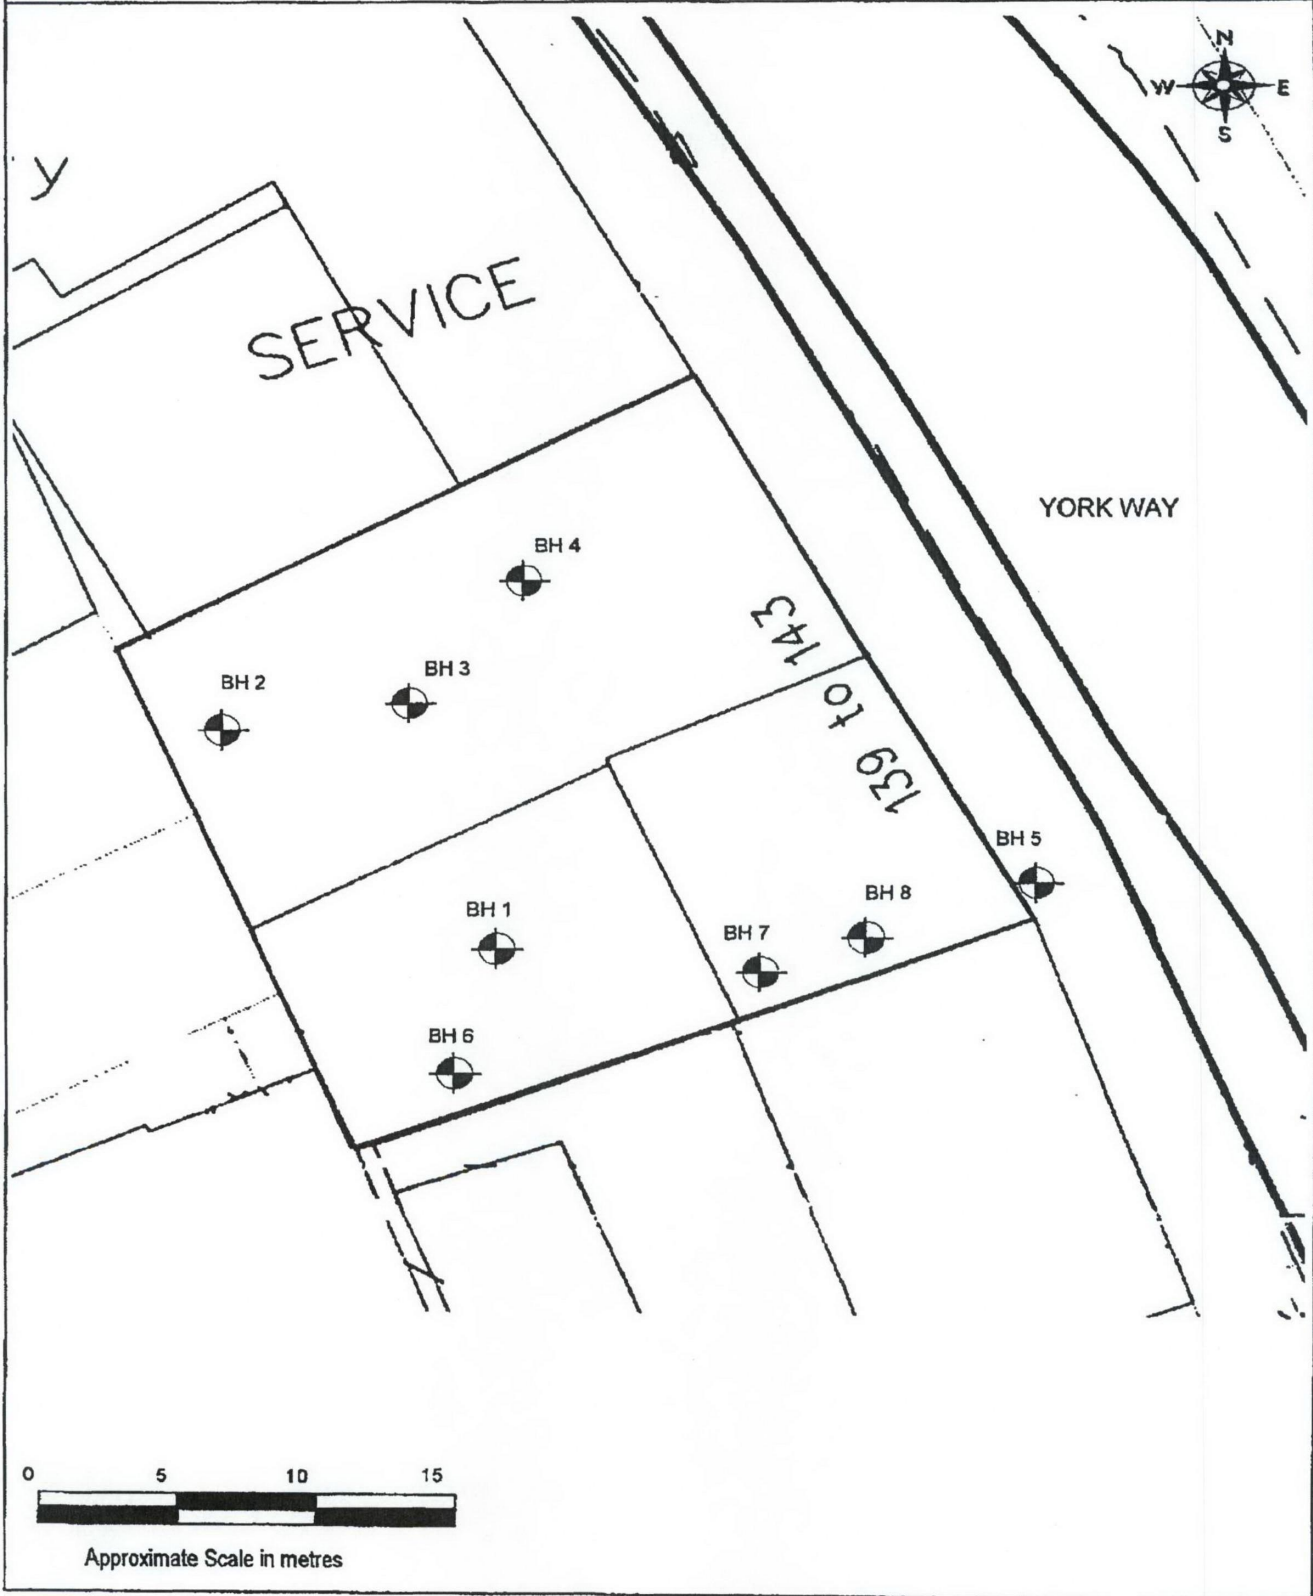
Sheet
1 / 1

Depth (m)	Sample / Tests	Water Depth (m)	Field Records	Level (mOD)	Depth (m) (Thickness)	Description	Legend	Water
0.80-1.00	D1				0.35	Concrete		
					0.35	Made Ground (firm brown silty sandy gravelly clay with brick, concrete and slate fragments)		
					0.95			
					1.30	Firm becoming stiff brown and grey mottled slightly fissured silty CLAY		
					2.00	Complete at 2.00m
