APPENDIX 1

ARCHITECTS BASEMENT PLAN (REDUCED)

Lower ground floor

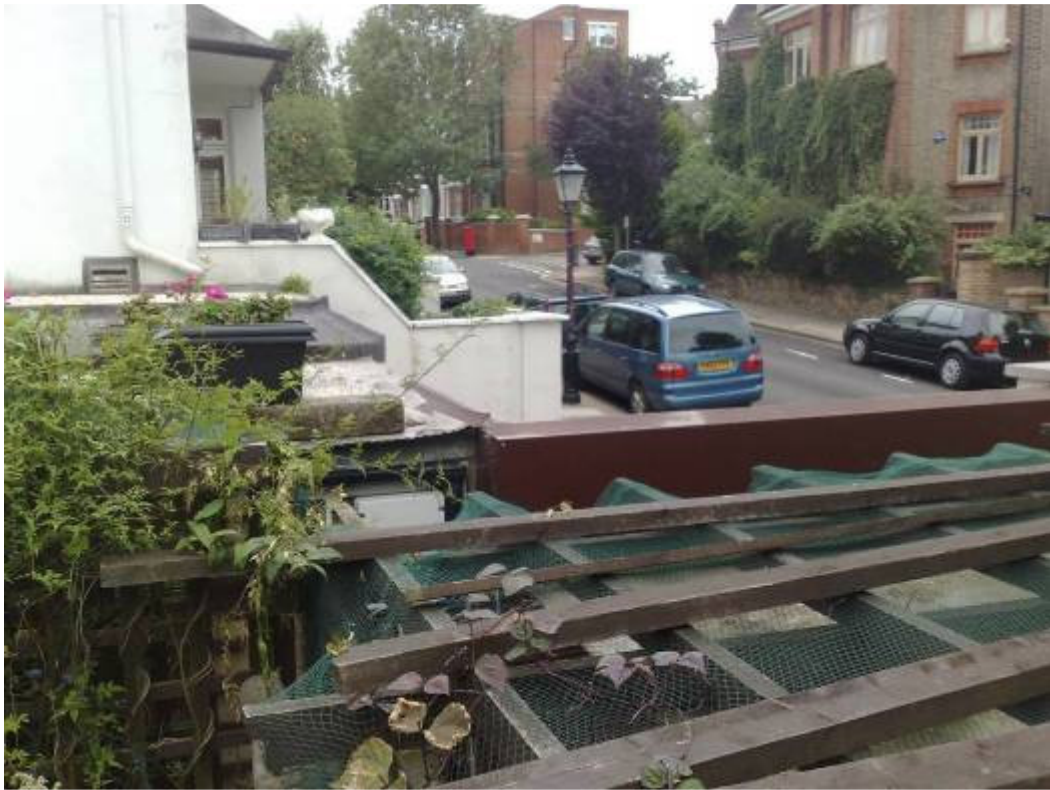
| Photo No. | 9 | Date: | September 2009 |

| Description: | Roof/Trellis over the fourth parking space | | |

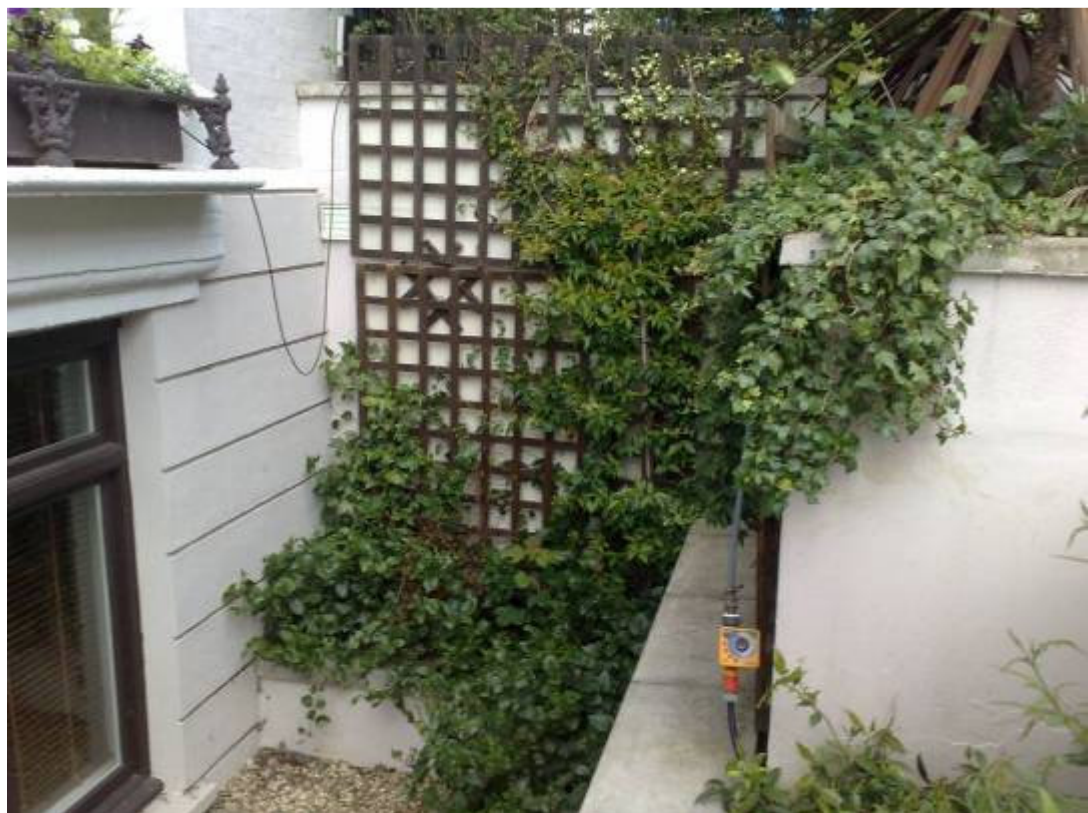
| Photo No. | 12 | Date: | September 2009 |

| Description: | Photograph of the lightwell facing Denning Road | | |

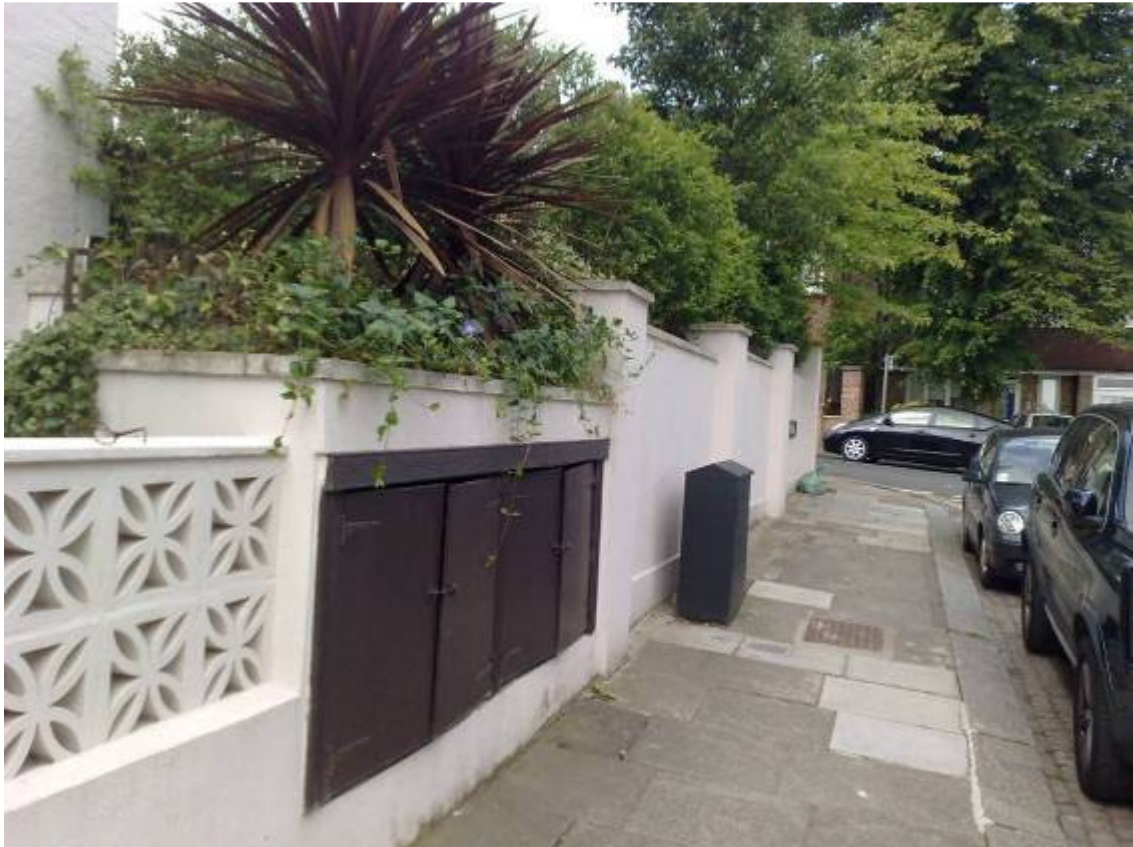
| Photo No. | 13 | Date: | September 2009 |

| Description: | Existing boundary wall facing Denning Road | | |
