# STANTON WILLIAMS

**Introduction**

In January 2009, Argent and Stanton Williams presented to the London Borough of Camden and English Heritage a proposal to modify the approved design of the Northern Elevation of the Eastern Transit Shed.

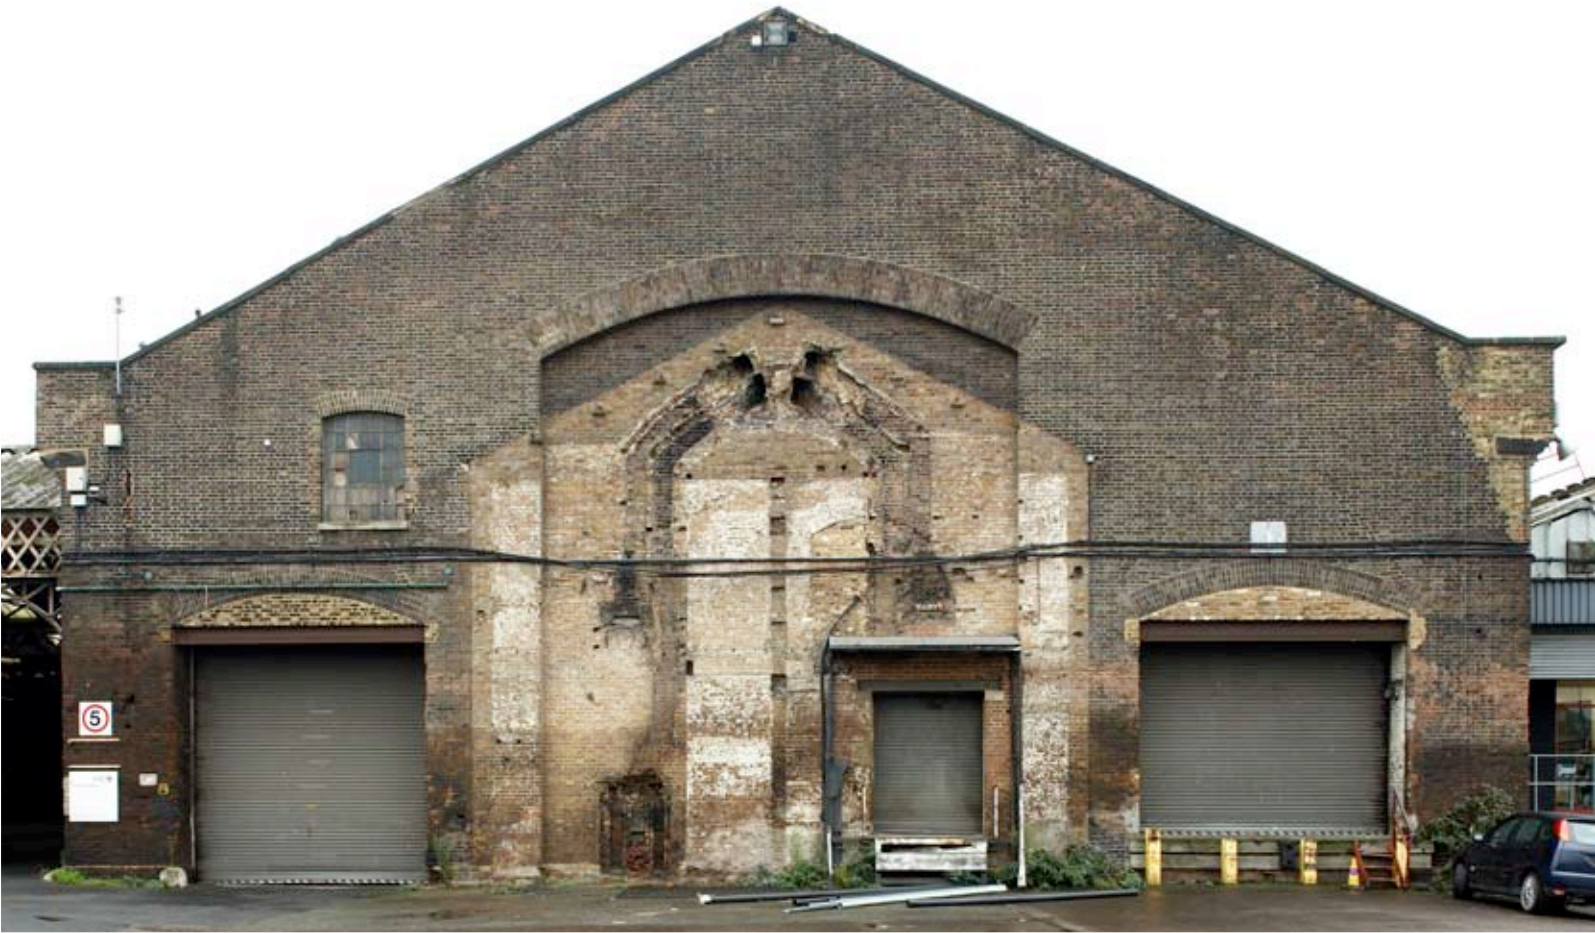
Existing North Elevation showing chimney ‘nostrils’. Copyright Carl Drury

Similarly the removal of a smaller ancillary building which once abutted the Eastern Transit Shed’s north elevation, visible on the 1850 Humber Plan below, has revealed layers of history including the outline of this building, a fireplace, flues and chimney nostrils, all clearly evident in the overall composition. Retaining these features will form a rich contrast when juxtaposed with the new University of the Arts Studio Buildings.

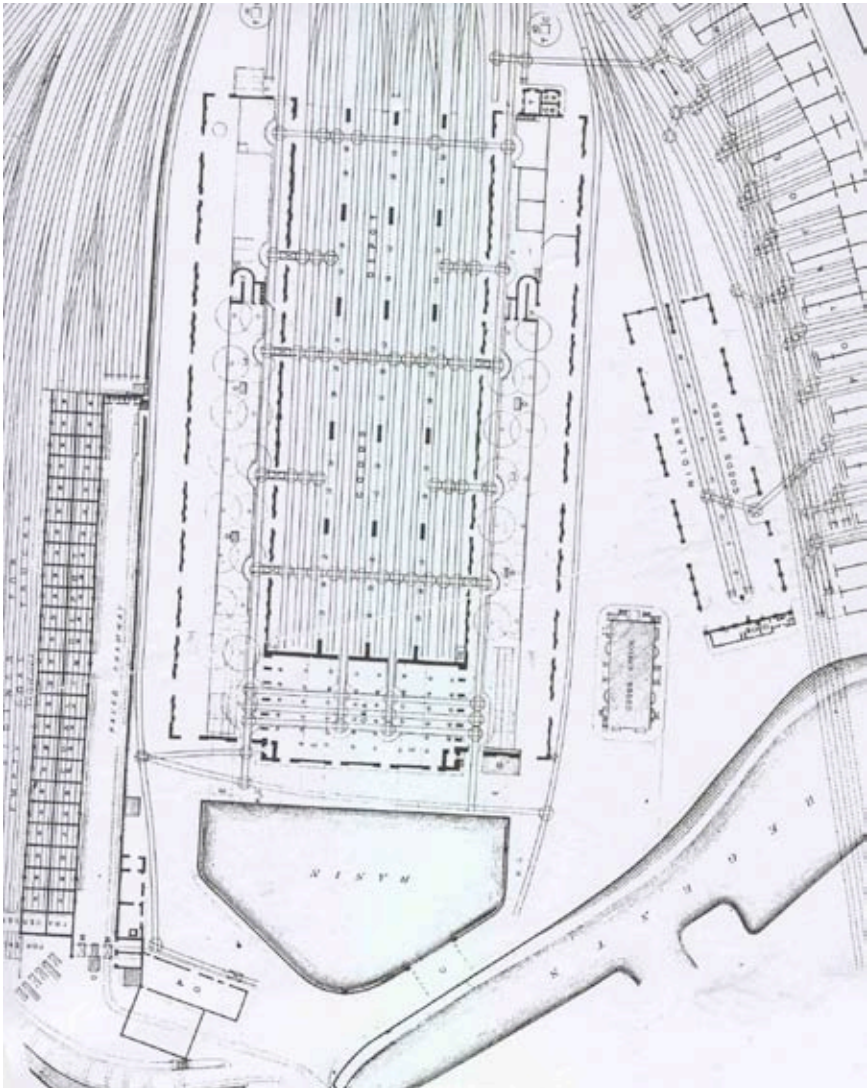
1850 Humber Plan

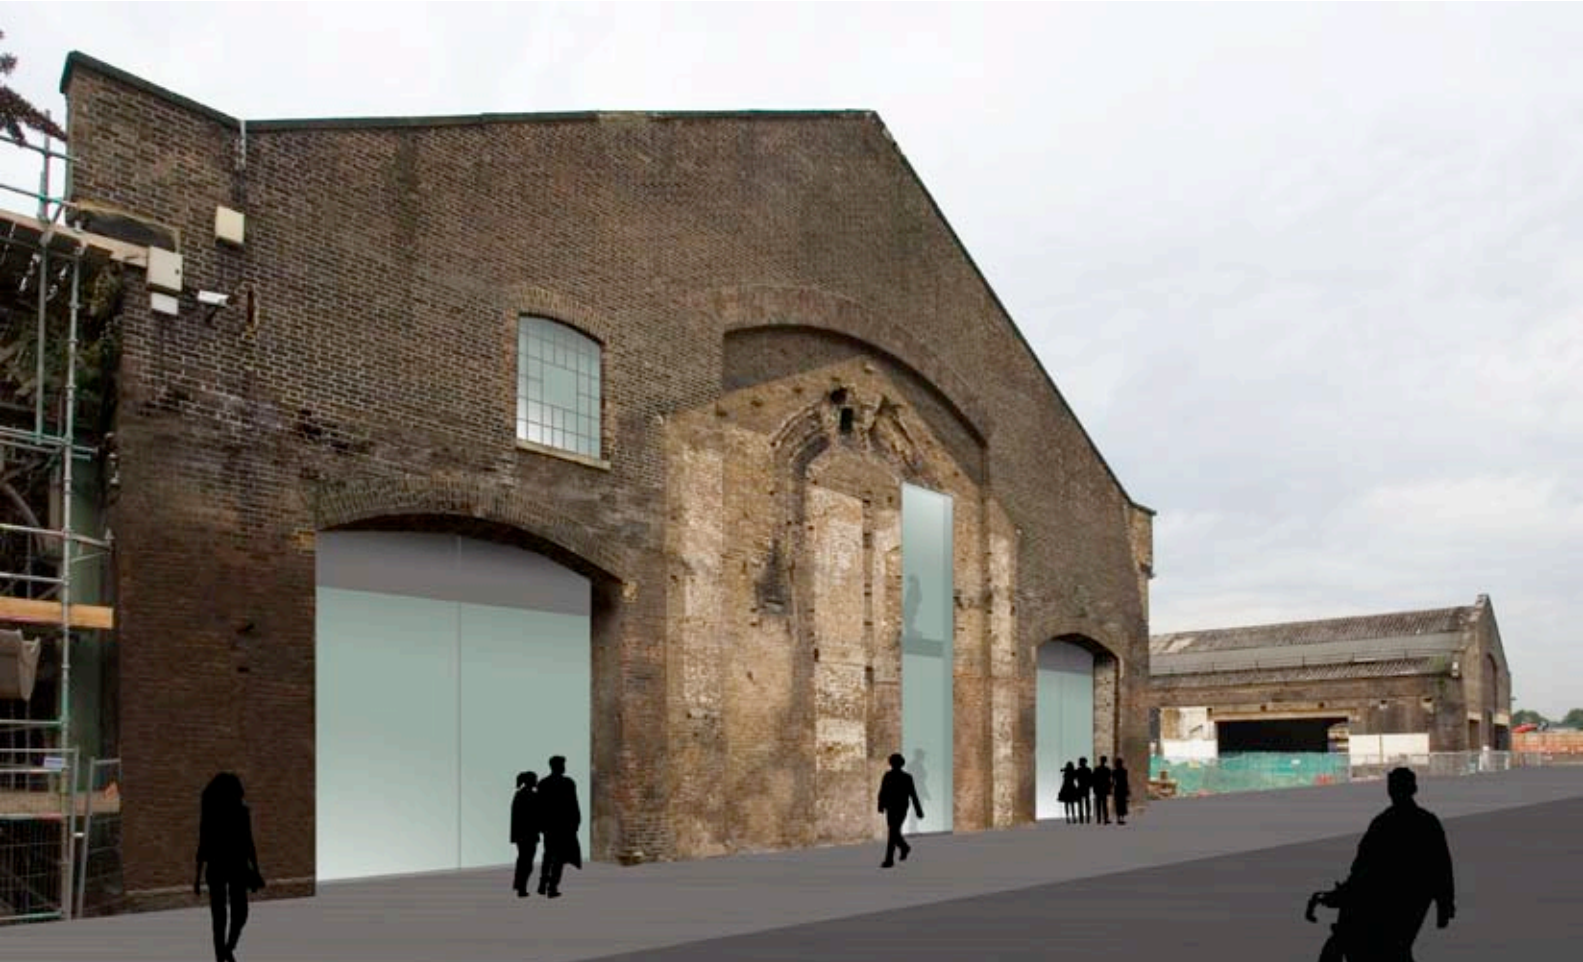
Proposed North Elevation to Eastern Transit Shed - Preliminary sketch image

The new proposal, set out in the image below and the submitted drawings, seeks to retain much of the historical scarring from the building’s evolution. The two side arches will be reformed as per the existing Reserved Matters approval 2007/5228/P and Listed Building consent 2007/5230/L, locating the glazing on the inner wall face to reveal the wall depth and to suggest that these were originally open and not blind arches.

In a change to the approved scheme, the larger blind brickwork arch will now be mostly retained, along with remnants of the fireplace, chimney flues, a new smaller vertical, glazed opening will be inserted. In contrast to the two side arches, the proposed double glazed unit will sit flush with the exterior brickwork face, with complimentary detailing to maintain the same architectural language as elsewhere on the building. A metal acoustic separation panel will sit within the window recess, between the glazing and the first floor concrete slab.

It is considered that the proposed changes to the central arch glazing will respond better to the geometry and the historic grain of the elevation, whilst maintaining appropriate daylighting for the uses inside.

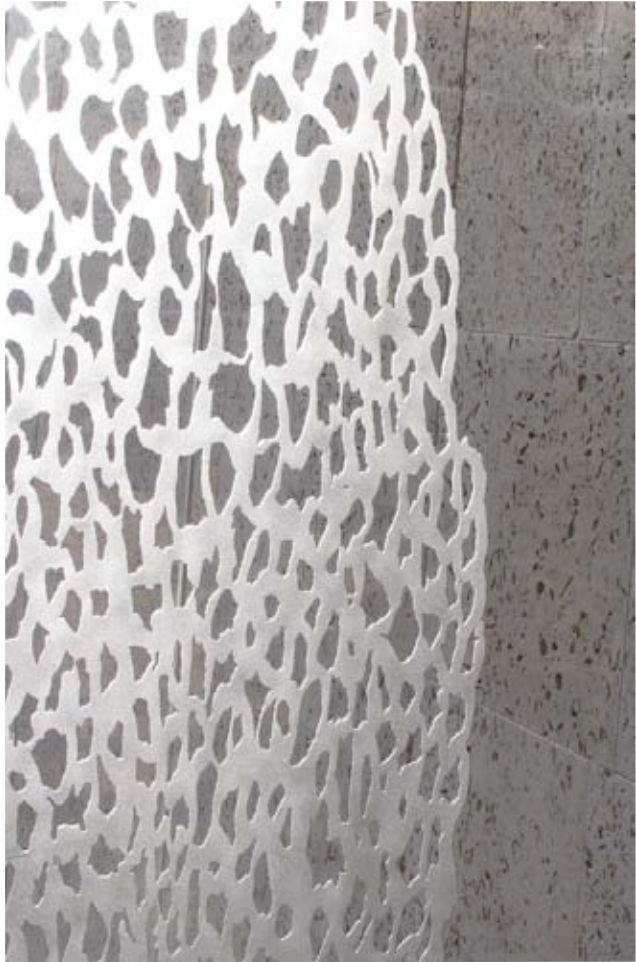
Example of 'Roche' etched design onto glass. Copyright Susanna Heron, Artist

In order to augment the intrinsic qualities of the northern elevation of the Eastern Transit Shed and to add further interest at street level it is proposed that the fixed glazing within the arches, to either side of the vertical slot window, may incorporate a glazed art form. This could take the form of decorative etched glass panels. An example of such etching is shown for reference below.

Utilisation of a translucent form would allow glimpses of internal movement and activity while retaining privacy appropriate to adjacent uses. The glazed art form will be designed to respond to the site-wide arts strategy and the specific qualities of the building, users and location. It has the potential to encompass an abstract form or take inspiration from the context of the King’s Cross industrial landscape and activities.

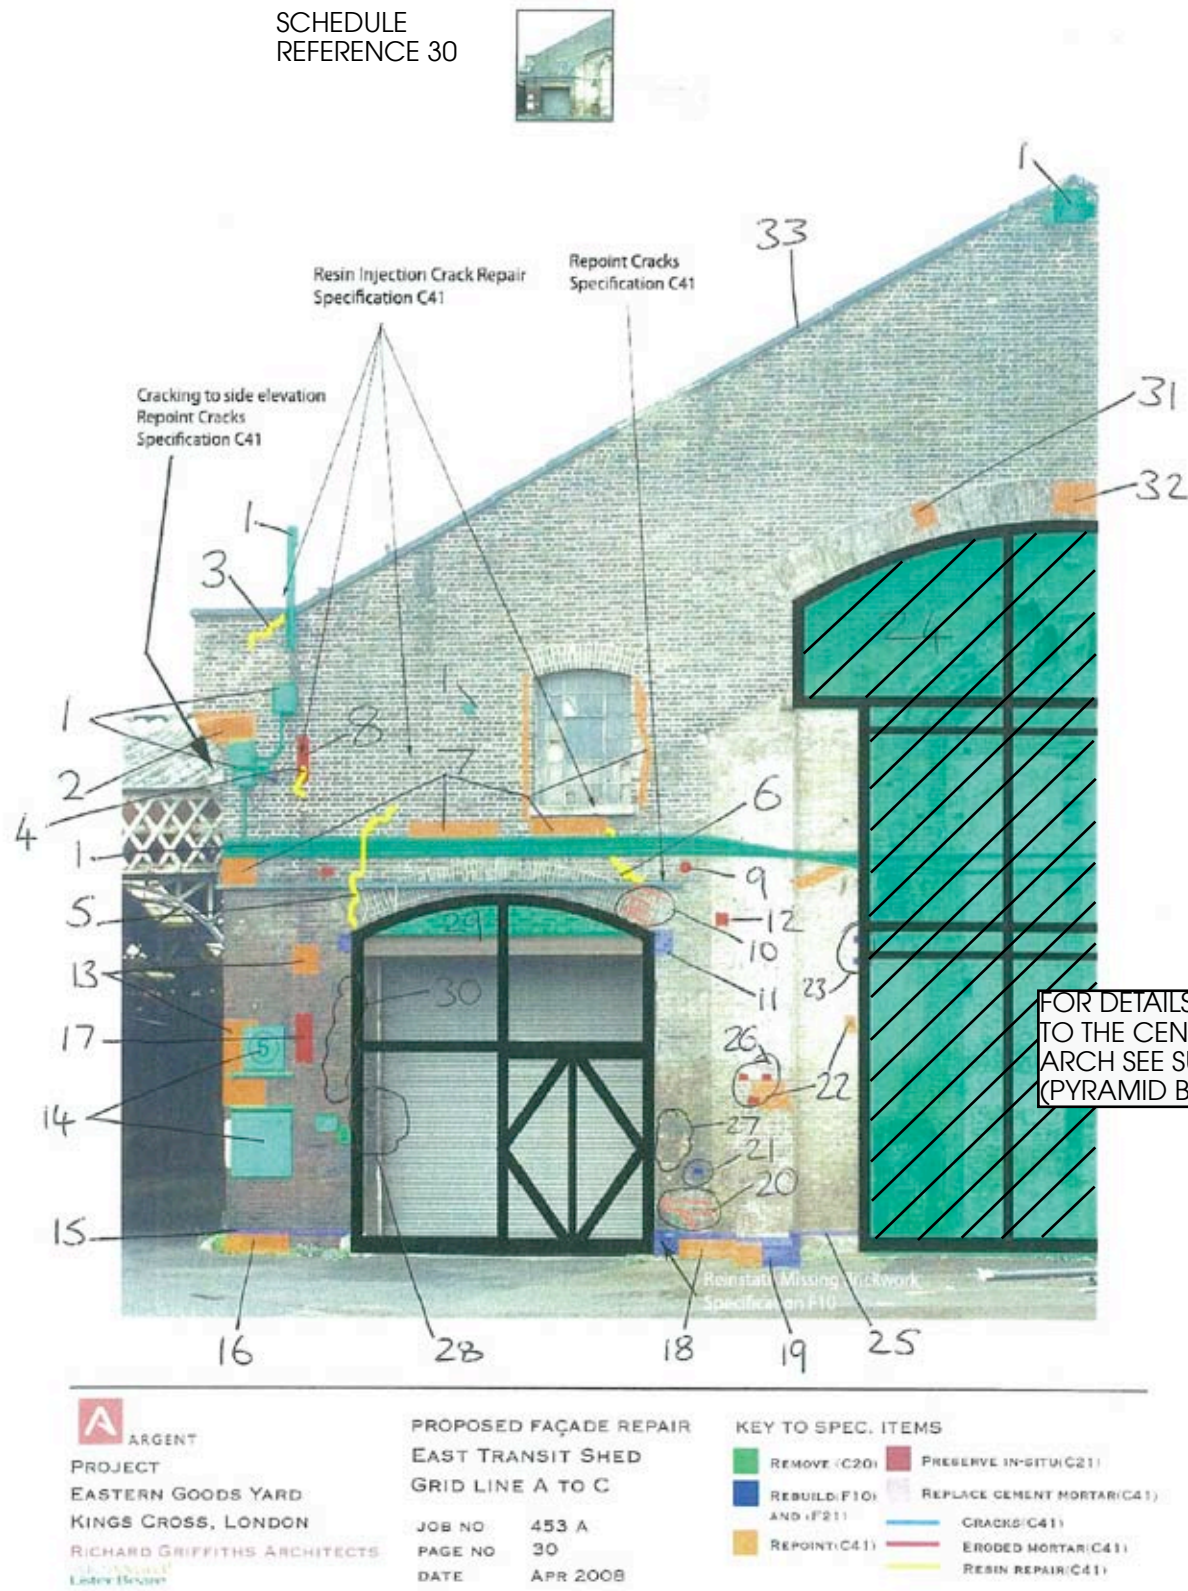
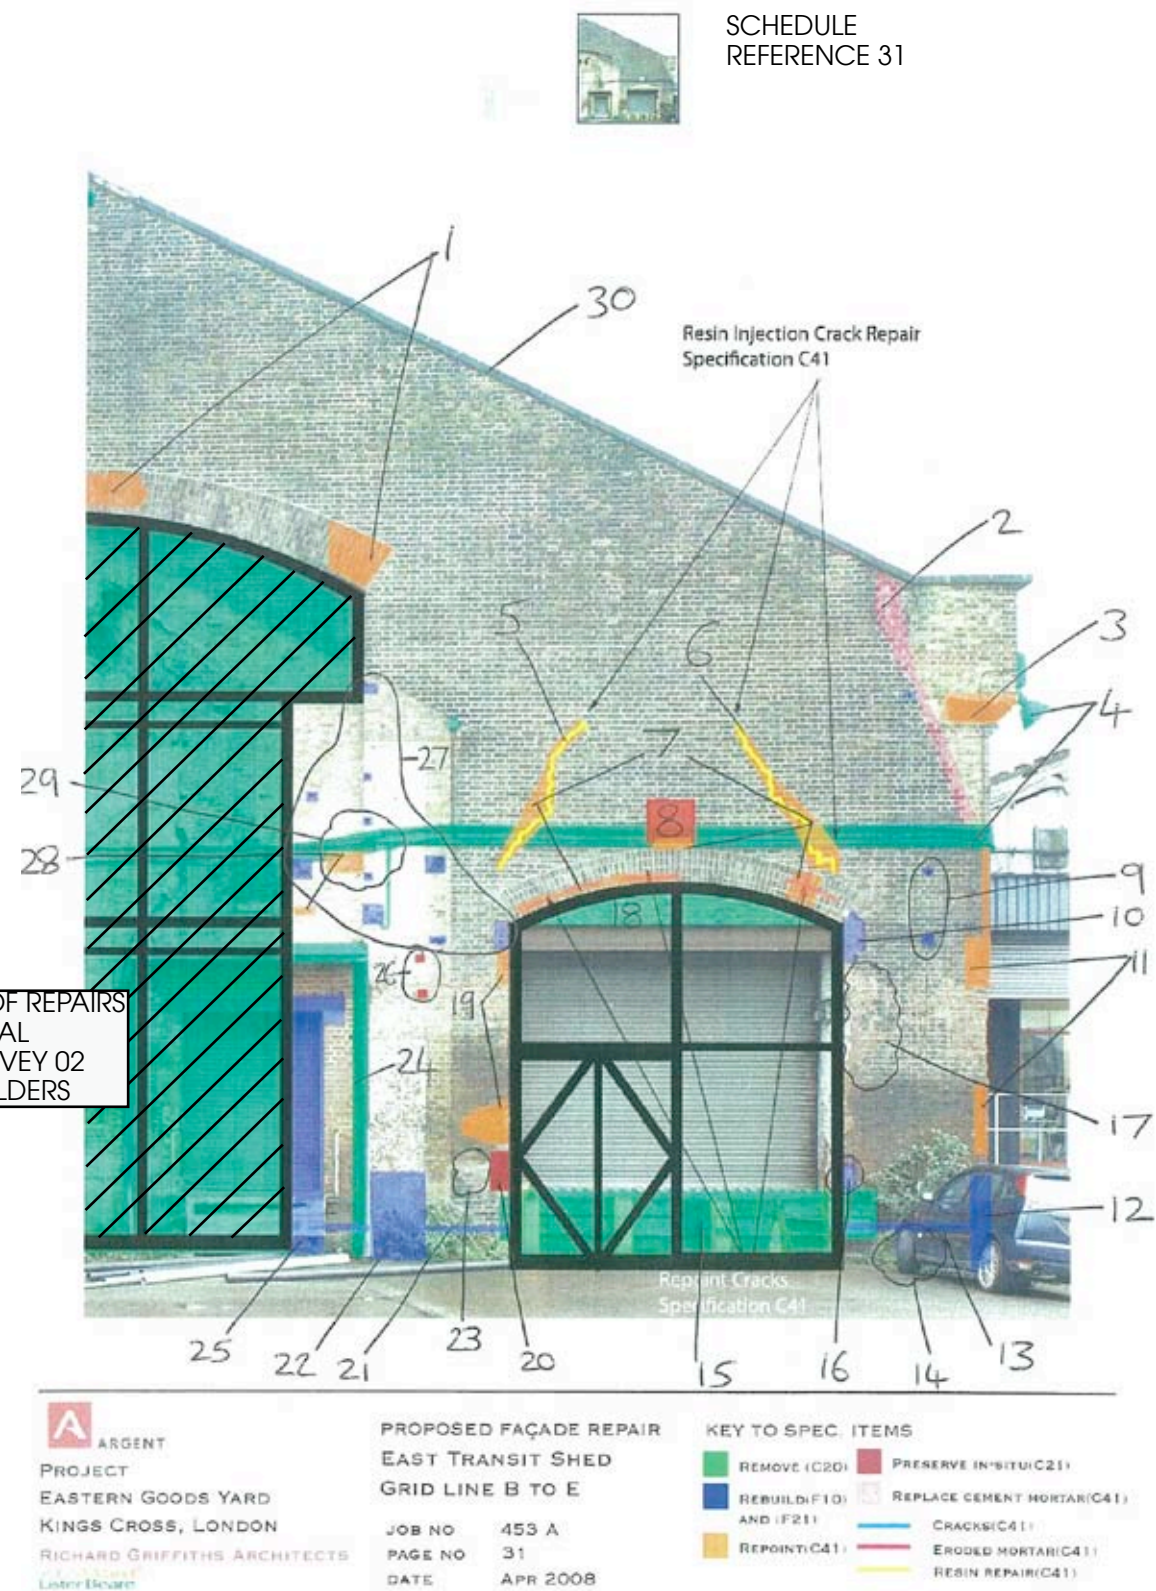
NORTHERN ELEVATION OF EASTERN TRANSIT SHED  
RICHARD GRIFFITHS SURVEY 01:  
PROPOSED FACADE REPAIR (OUTSIDE OF CENTRAL ARCH)

Appendix D includes drawings which detail the proposed areas of repointing and repair work to be completed on the northern façade of the Eastern Transit Shed. Survey 1 with associated schedule by Richard Griffiths Architects shows the repair work proposed outside of the existing central blind arch. Works to the area within the central arch, which includes the brickwork previously to be removed under the original Reserved Matters approval and Listed Building Consent, is shown in a separate drawing (Survey 2) by Pyramid Builders Ltd. Principally the works will involve repairs to and repointing of existing brick features and ‘scars’ on the façade to ensure that the façade is safe and structurally sound.

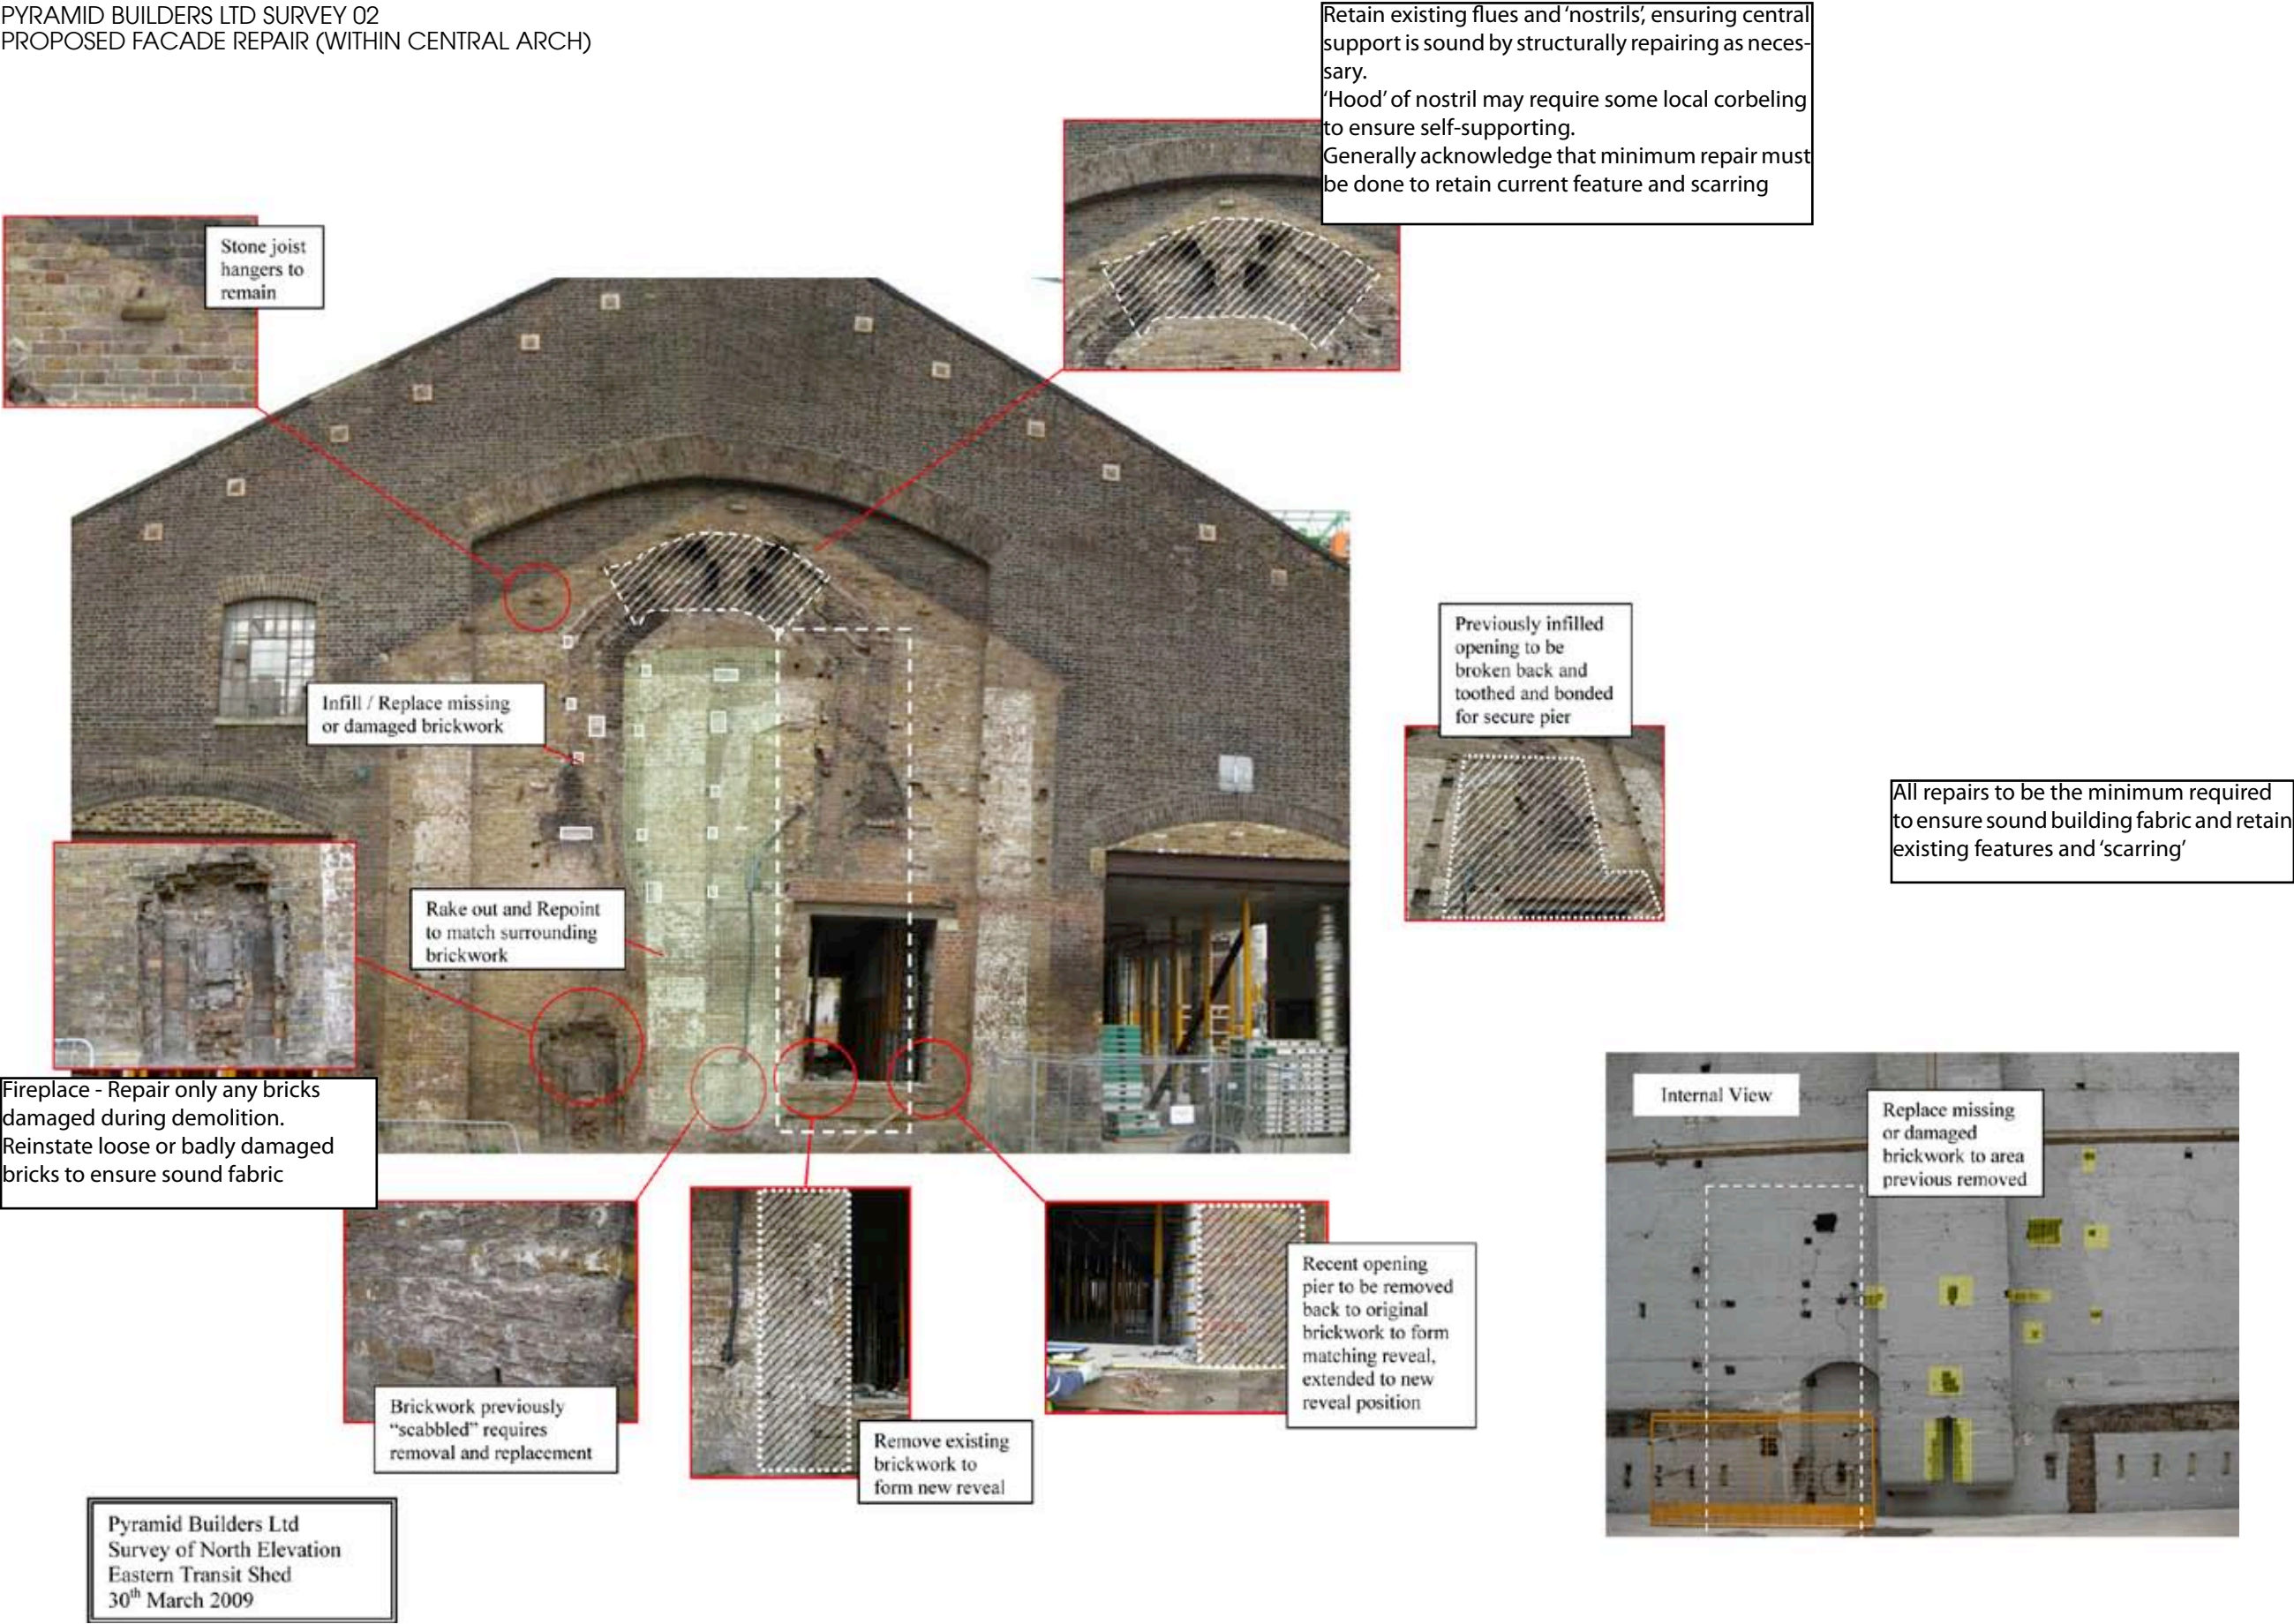
PYRAMID BUILDERS LTD SURVEY 02  
PROPOSED FACADE REPAIR (WITHIN CENTRAL ARCH)
