**POTENTIAL LOSS OF DAYLIGHT TO NEARBY DWELLINGS
FOLLOWING PROPOSED BUILDING WORK
AT DELANCEY STREET & PARKWAY, CAMDEN**

**by Paul J Littlefair MA PhD CEng MCIBSE MSLL
Principal Lighting Consultant**

31 October 2007

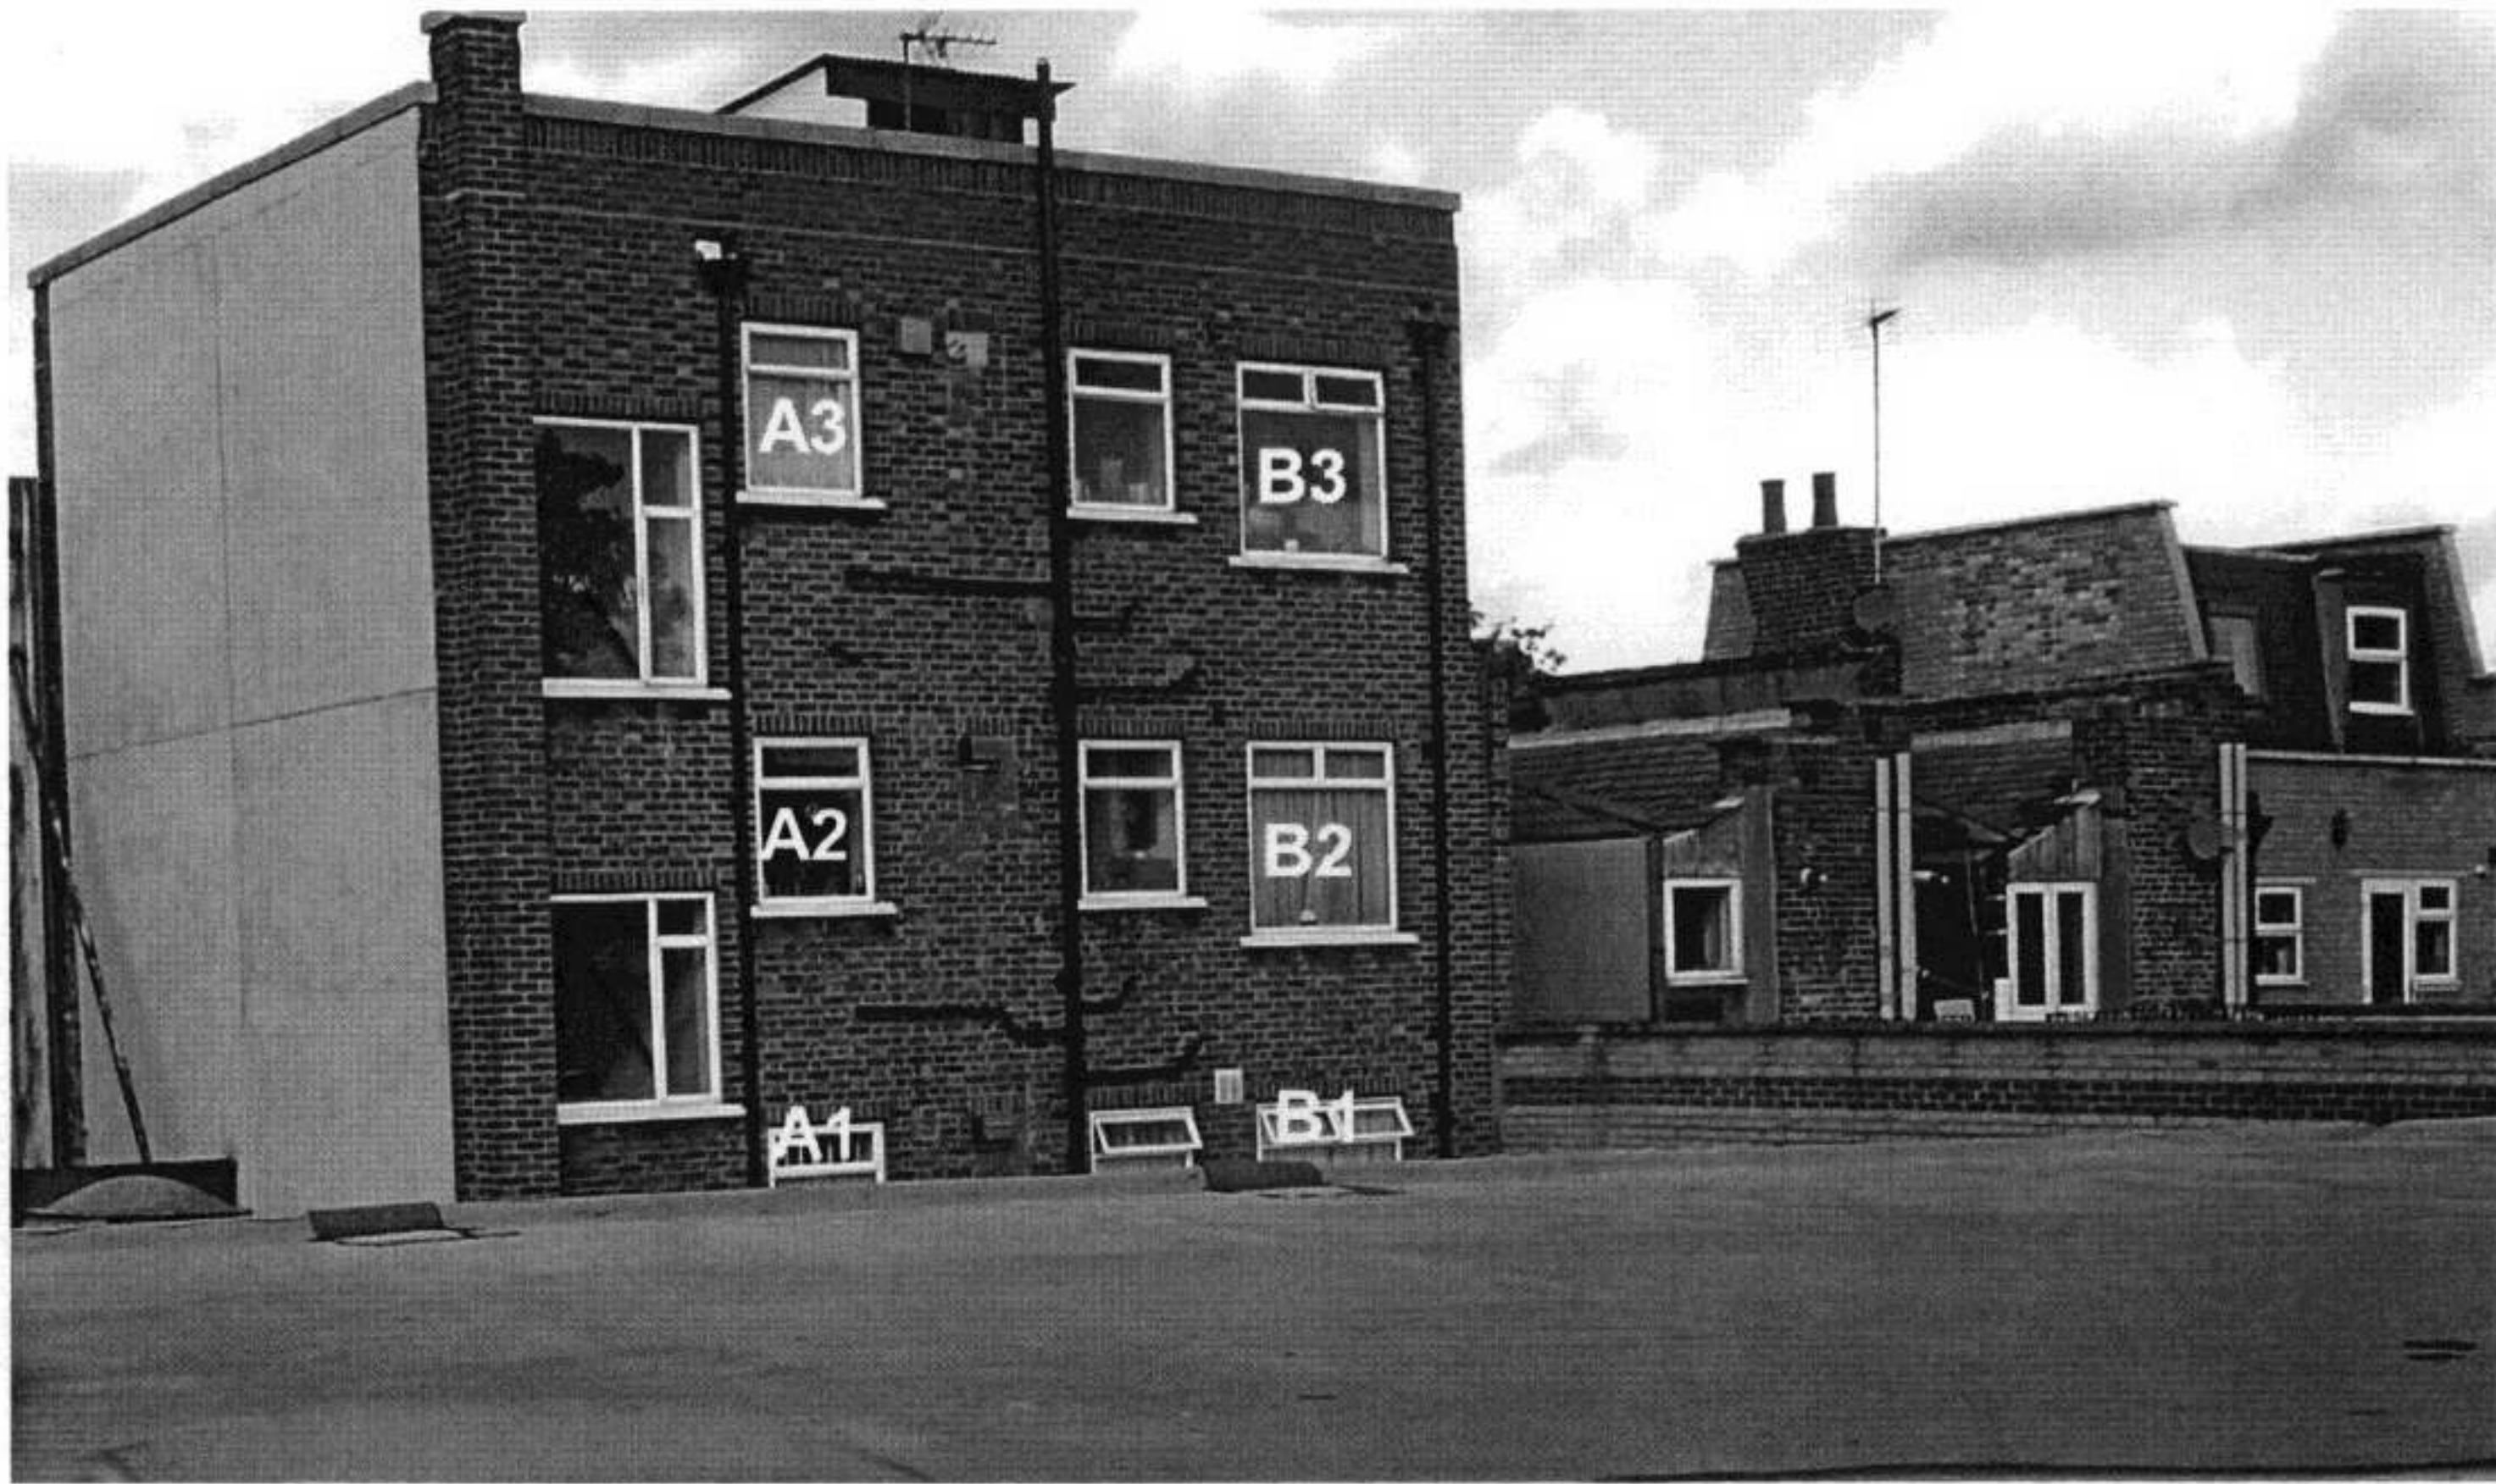
Figure 2. 103 Parkway showing the windows evaluated.
The flat roof of the garage is in the foreground

3.2 103 Parkway has flats on its upper three storeys. On each floor, four windows face SE towards the garage site. See Figure 2 for window numbering. Two of these are a bedroom (B) and a kitchen (A) and these have been evaluated for the potential loss of light. The other windows are to stairs and bathrooms and need not be analysed. Table 1 shows the effect of the garage redevelopment on 103 Parkway.

The table shows the vertical sky component for each window, with the existing garage and its redevelopment. The windows are numbered from the bottom of 103 Parkway from left to right along the façade (SW to NE) (columns: A & B).

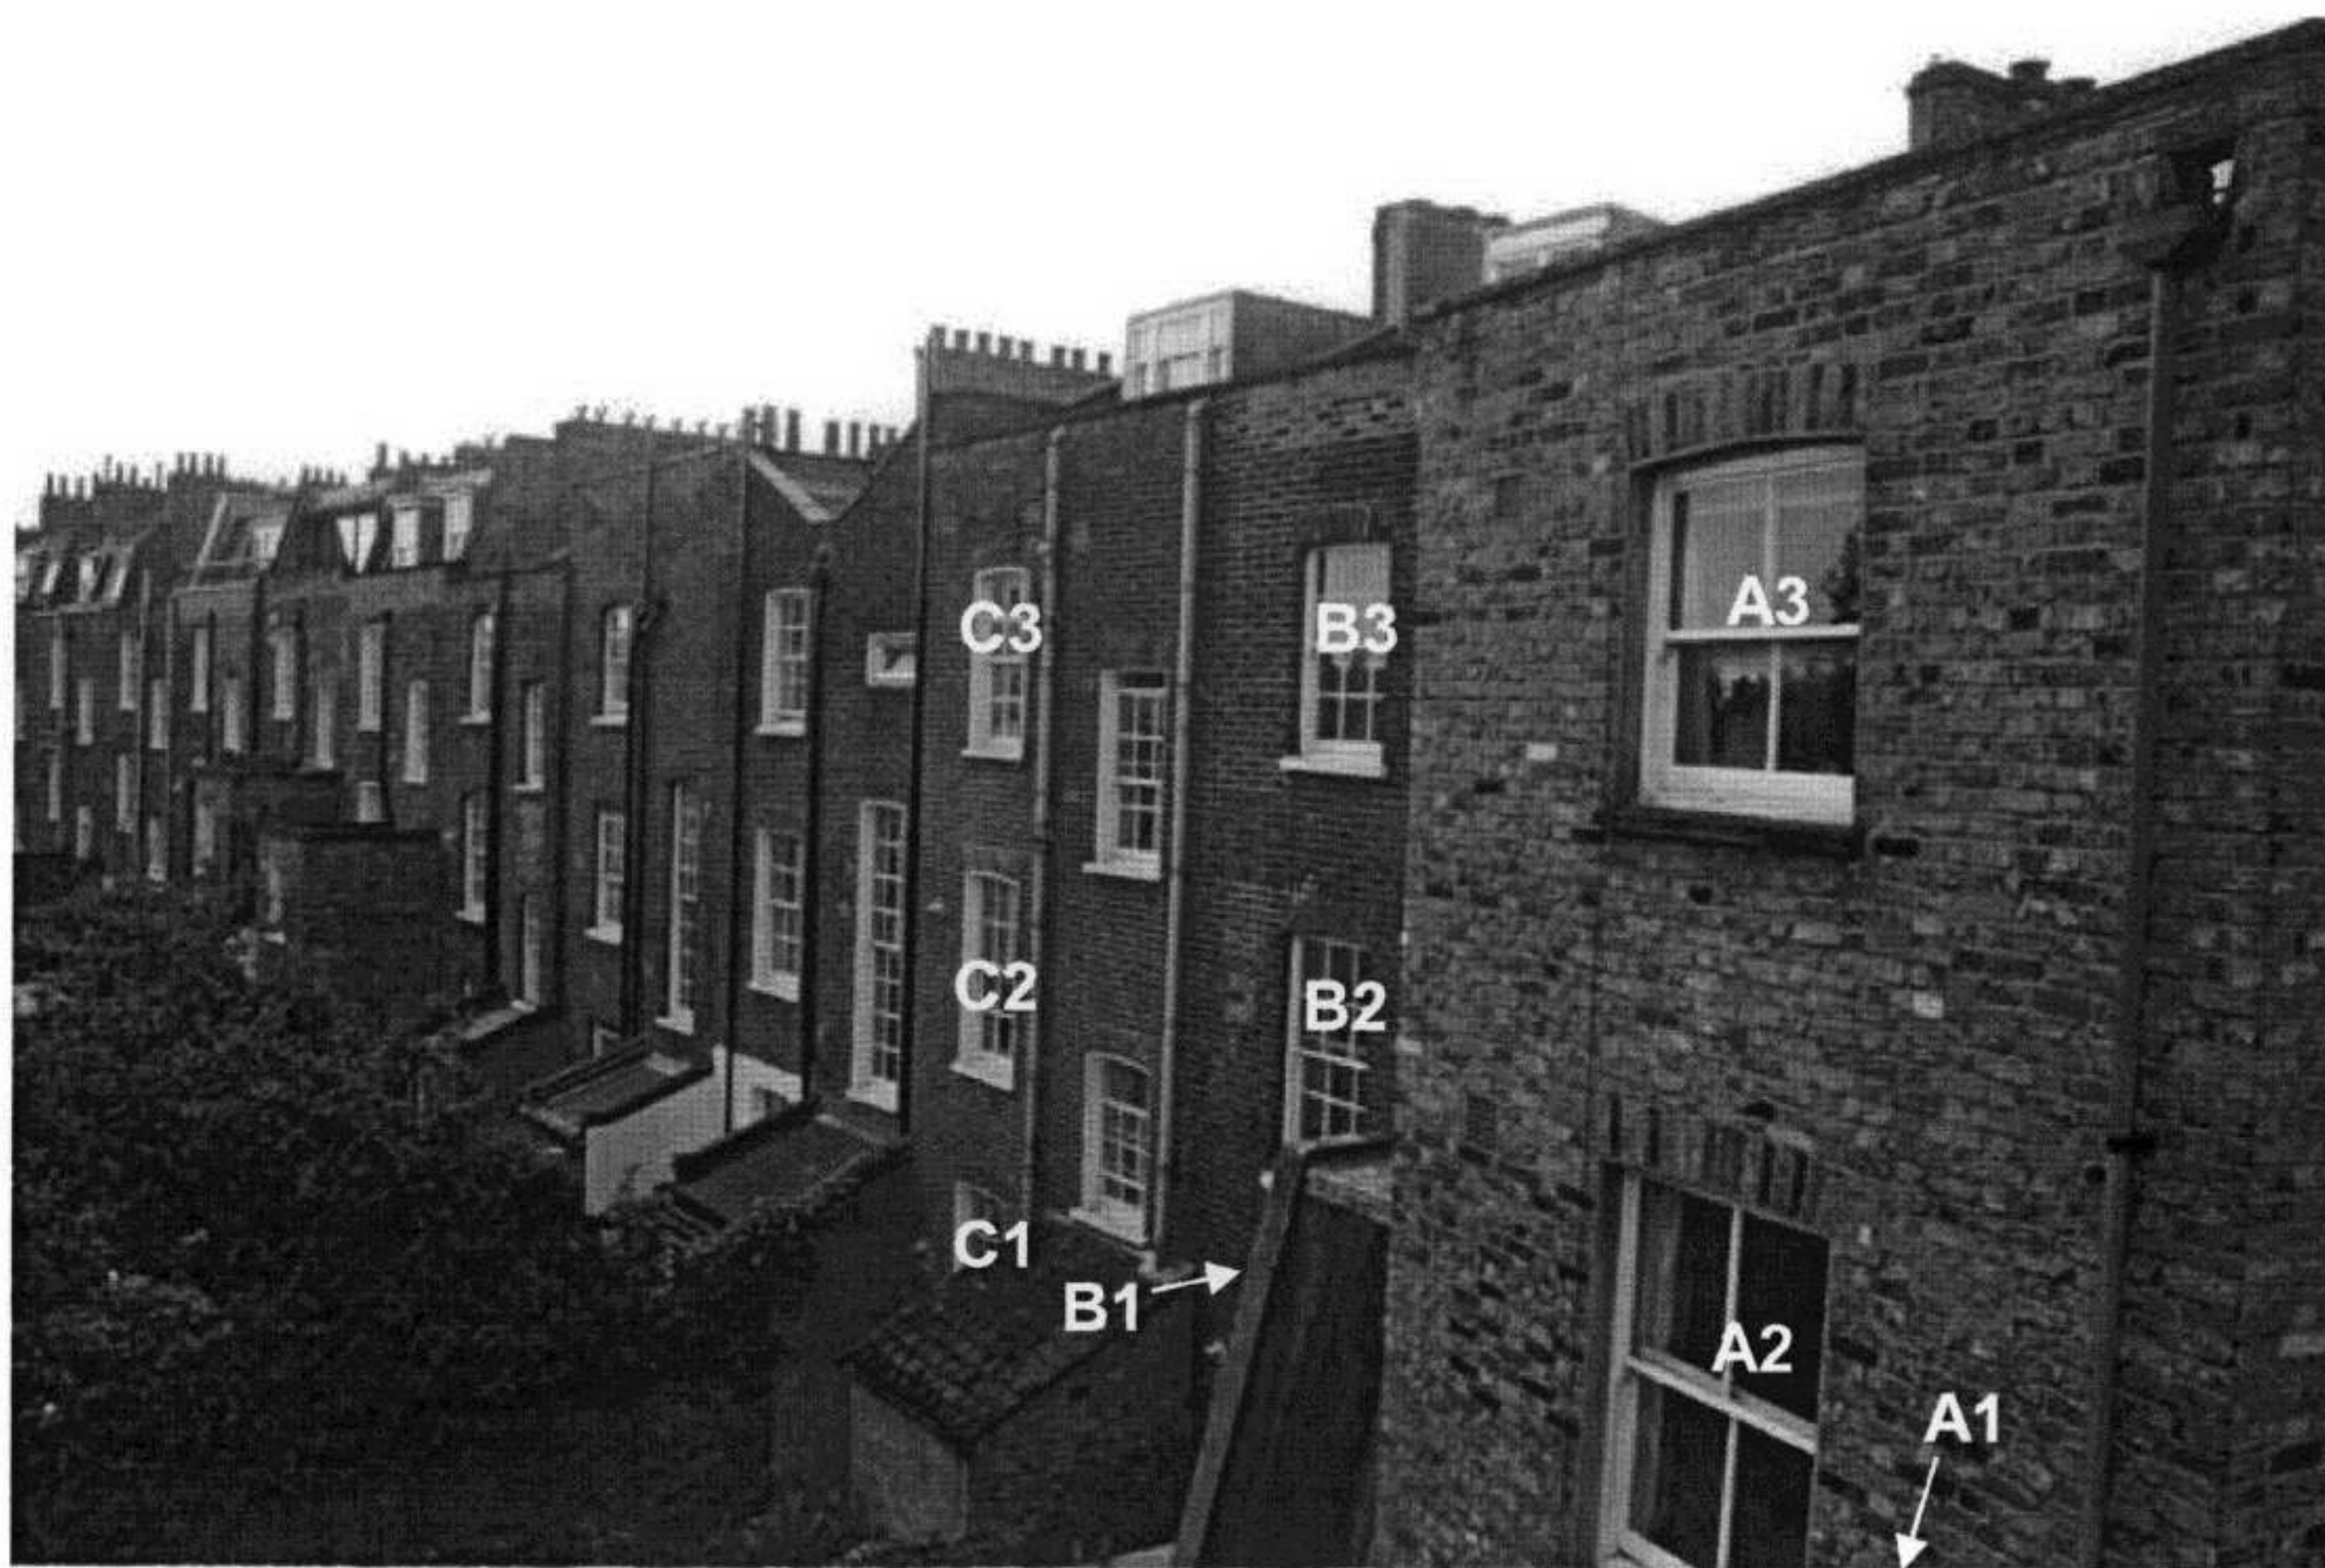
Figure 3. Delancey Street terrace, with the rear extension of No.84

3.5 84 Delancey Street has a rear extension of bedrooms/living rooms in its three storeys. One window on each floor faces the development. The adjacent two properties (Nos. 82 and 80) also have three habitable rooms on their rear façades. In between the window columns for these two houses are stairs, with rear extensions of variable height. See Figure 3 for window numbering. The dormer windows at roof level will have a large vertical sky component and will not be adversely affected by the proposed development.
