Block
Architecture

Design & Access
Statement

Vine Cottage,
Gayton Road
Hampstead.

Issued: 15.10.07
Ref: VC.082_DAS

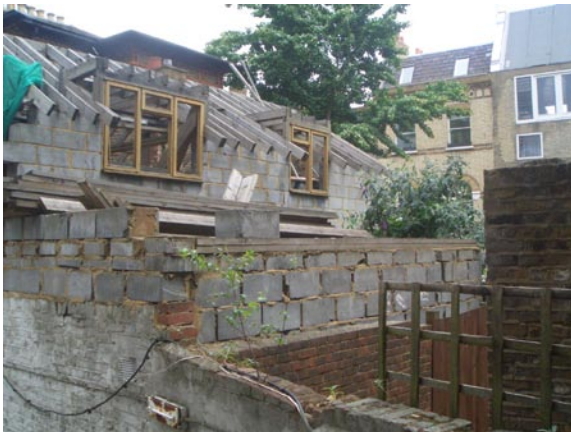
Detail photograph of rear of property

The existing building is part single storey and part extension with a street façade to 2 storeys above ground level plus the apex of the pitched roof. The footprint of the building is L-shaped with an adjoining single storey extension to the south side. The buildings' main facade faces perpendicular to Gayton Road and, if completed, would have presented a rather blank frontage to the street with a solitary small window at ground floor level.

The site has a planning history dating back to 1999. The most recent application dated 2003 was approved for the construction of an additional storey, however this was not completed. What construction there is of very poor quality and the building currently stands in a state of dilapidation. As a result we believe that the building has a negative impact on the character and appearance of the street and surrounding Conservation Area.

The rear of the building currently trespasses on the neighbouring owners land where the single storey construction has been built on top of the party wall. We understand that this has been done without a Party Wall Award being in place. Understandably, this is an issue that our client is being pushed to rectify.

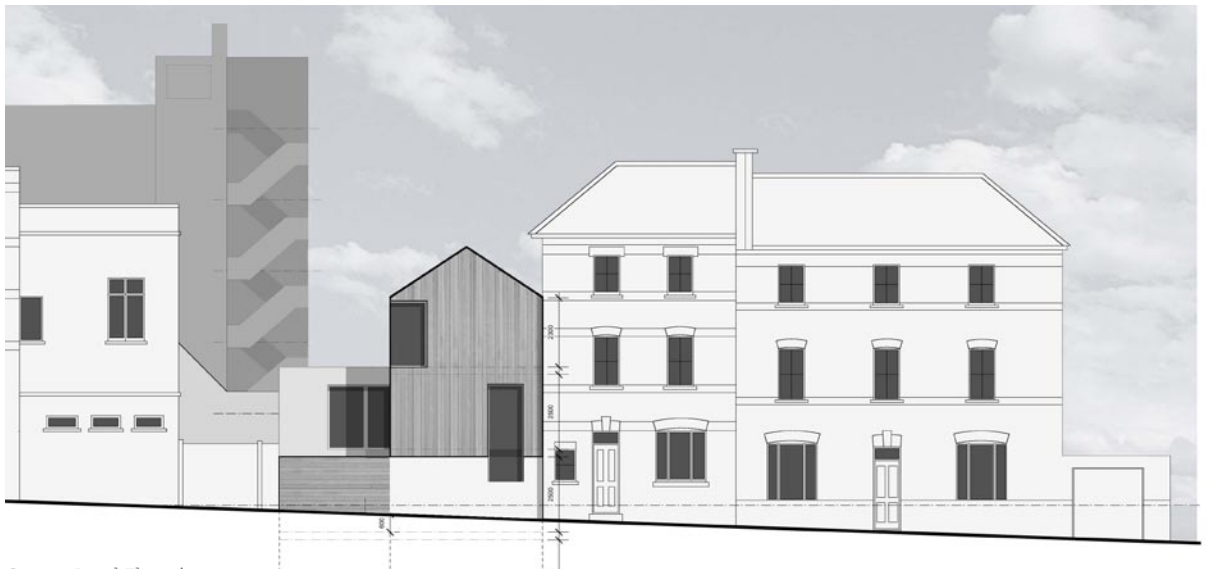
Gayton Road Elevation

The proposal is for a 4 bedroom family dwelling. The building comprises of a 3 storey element to the north of the site in place of the existing cottage, with an adjoining 2 storey construction to the south, set back from the street, forming an L-shaped plan on the same footprint as the existing building shell. In addition it is proposed that the building has a basement level with an open central courtyard, accessed from all low level rooms. It is intended that through the identification of two parts to the body of the building, a hierarchy is established which places emphasis on the pitched element, where an important relationship to the street is formed. (see elevation)

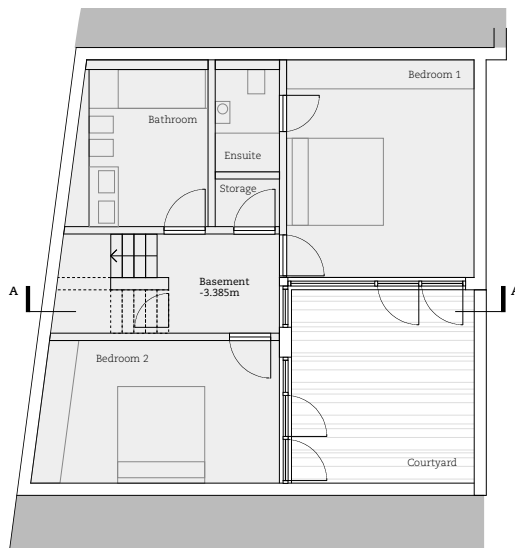
Basement - Bedrooms / Bathrooms

Four Bedrooms are located over the Basement and Ground floor levels. Two bedrooms at Basement level open into the open courtyard allowing direct access to outdoor space, and two bedrooms at ground floor level overlook the courtyard. The entrance to the house is located within the courtyard at a level raised from the street, with access through a door directly from Gayton Road. This opens onto a platform above the courtyard with stairs leading up to the main entrance at 1st floor level. Access in general is further discussed in the access statement.

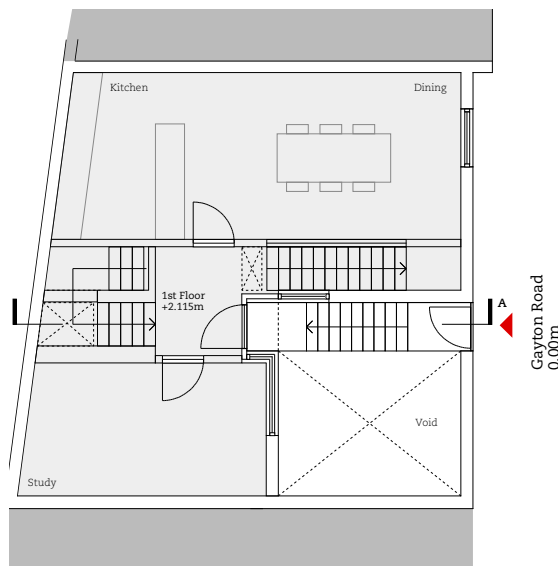
1st Floor - Dining / Kitchen

A large kitchen and dining room are positioned at 1st floor level, (entry level) within the north element of the building with windows facing onto Gayton Road. A study is located within the 2 storey south extension, with a view to the street across the open courtyard. A large living space is located at 2nd floor level where the pitched roof form is internally expressed, creating a high, light and airy space. The living area has access to external space through a recessed south facing 'loggia' on the 2nd floor facade. This loggia sits above a separate access stair to the 2nd floor living room allowing entry to the space along the length of the building.

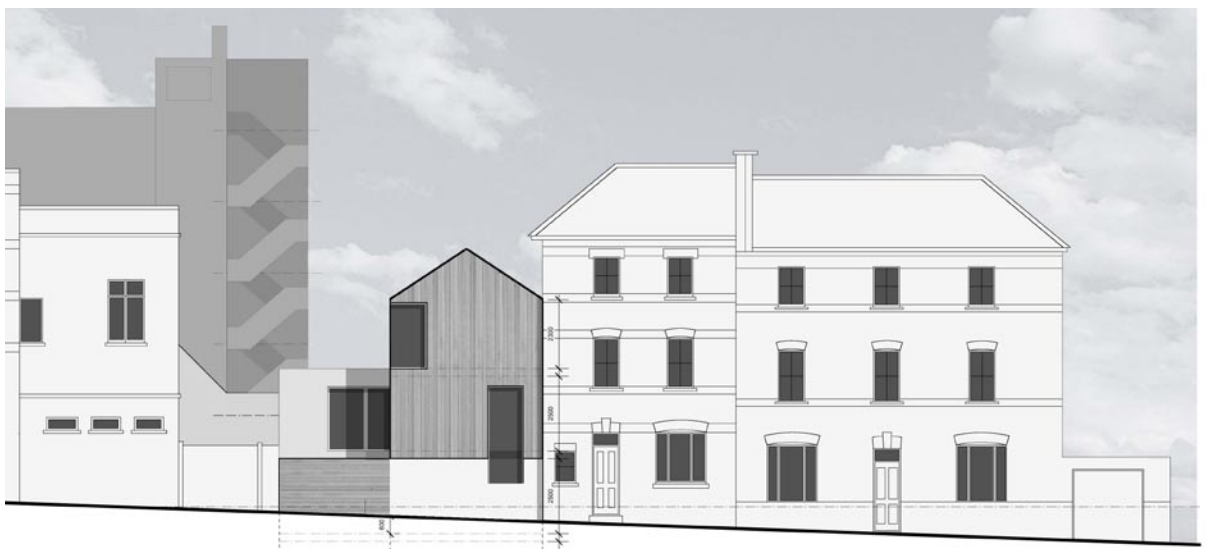
Street Facade drawing showing gap maintained and concrete escape stair

It is understood that the application submitted in 1999 was, in part, refused on the basis of inappropriate scale. We appreciate that the 1999 proposal may have been over-sized in relation to the historical context of the site and neighbouring building to the south. Our proposals have acknowledged this in terms of the overall height of the street façade by lowering the Ground floor below the level of the street in order to retain a 2 storey height at eaves level where the new building adjoins its neighbour to the north.
