ROOF AREAS

Historical Development and Record Information

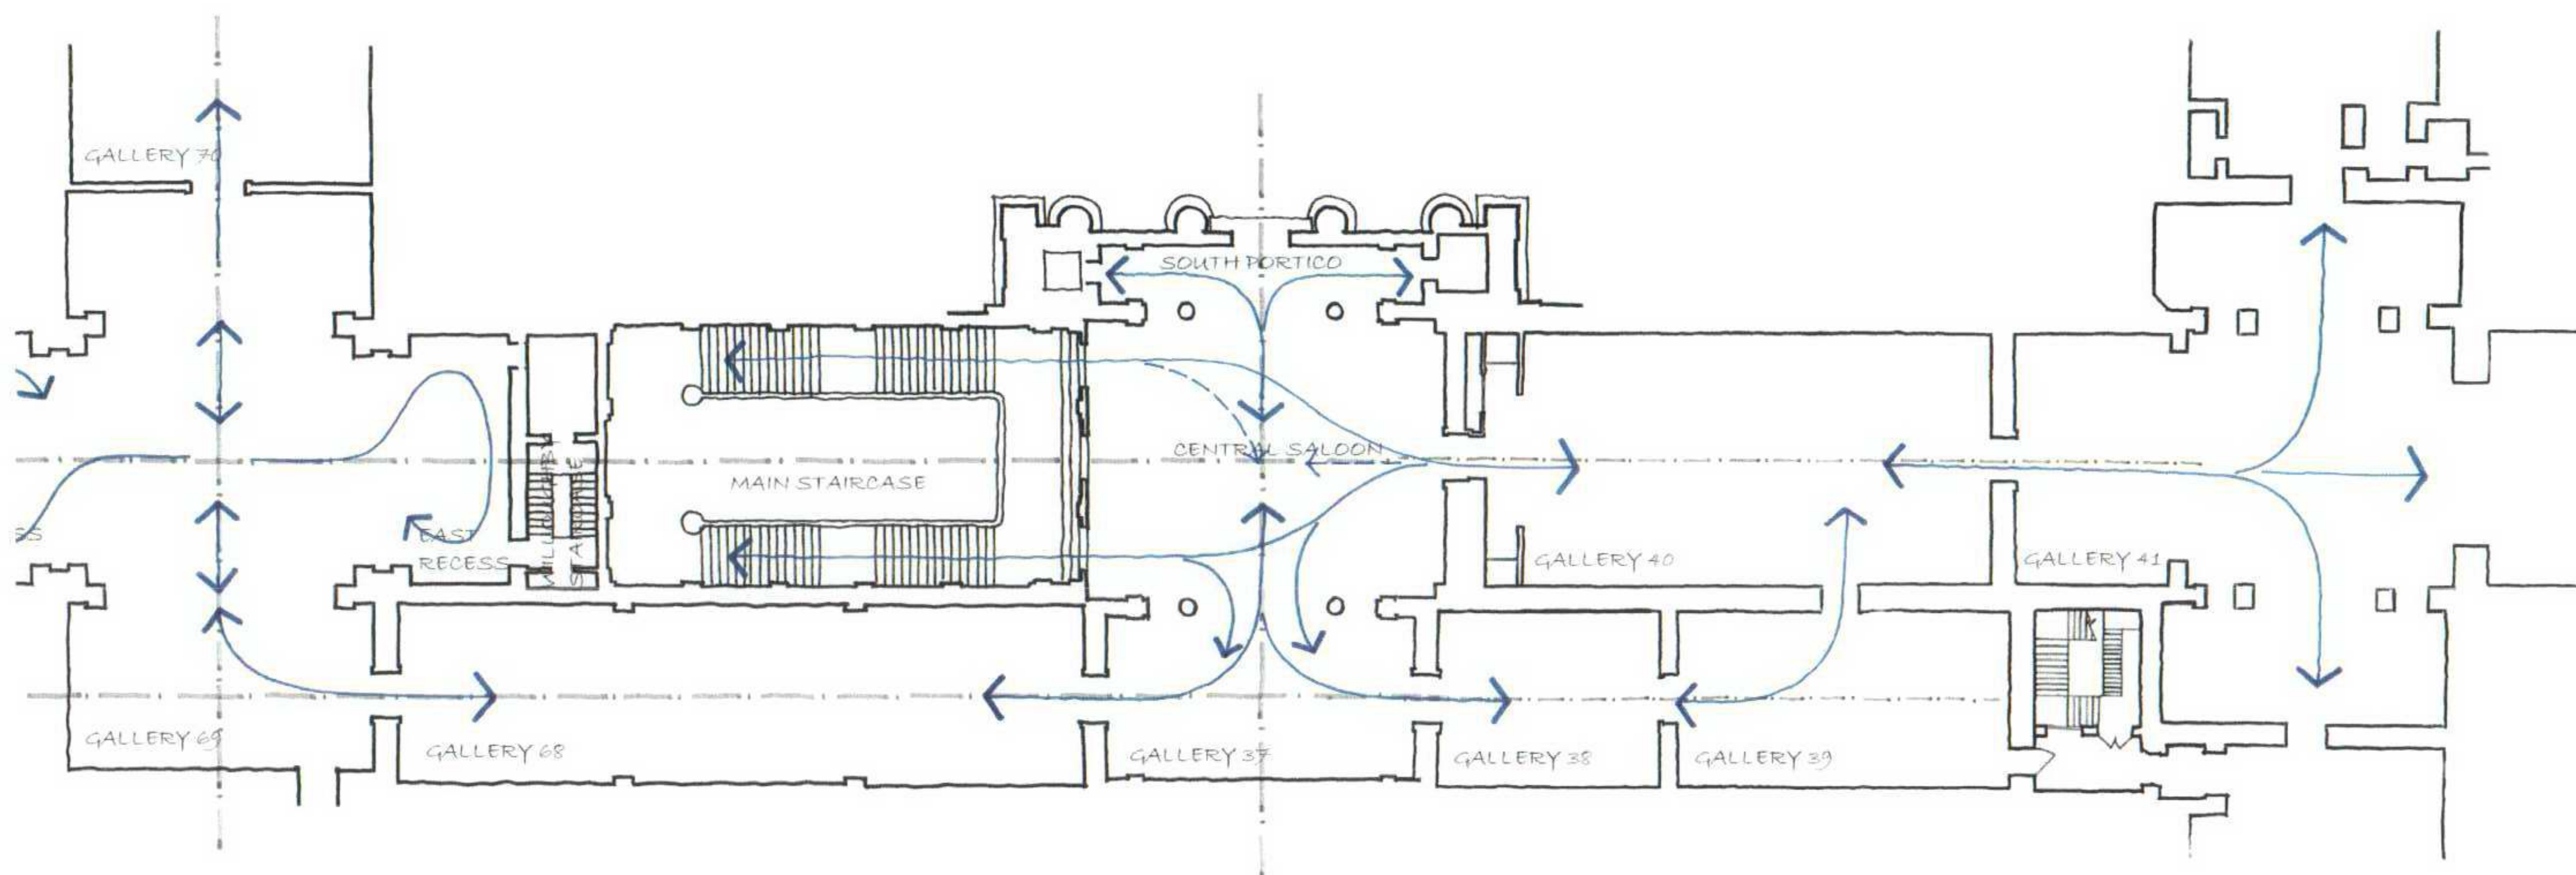
Early study showing circulation desire lines from the South stair through the Central Saloon and adjacent Upper Galleries

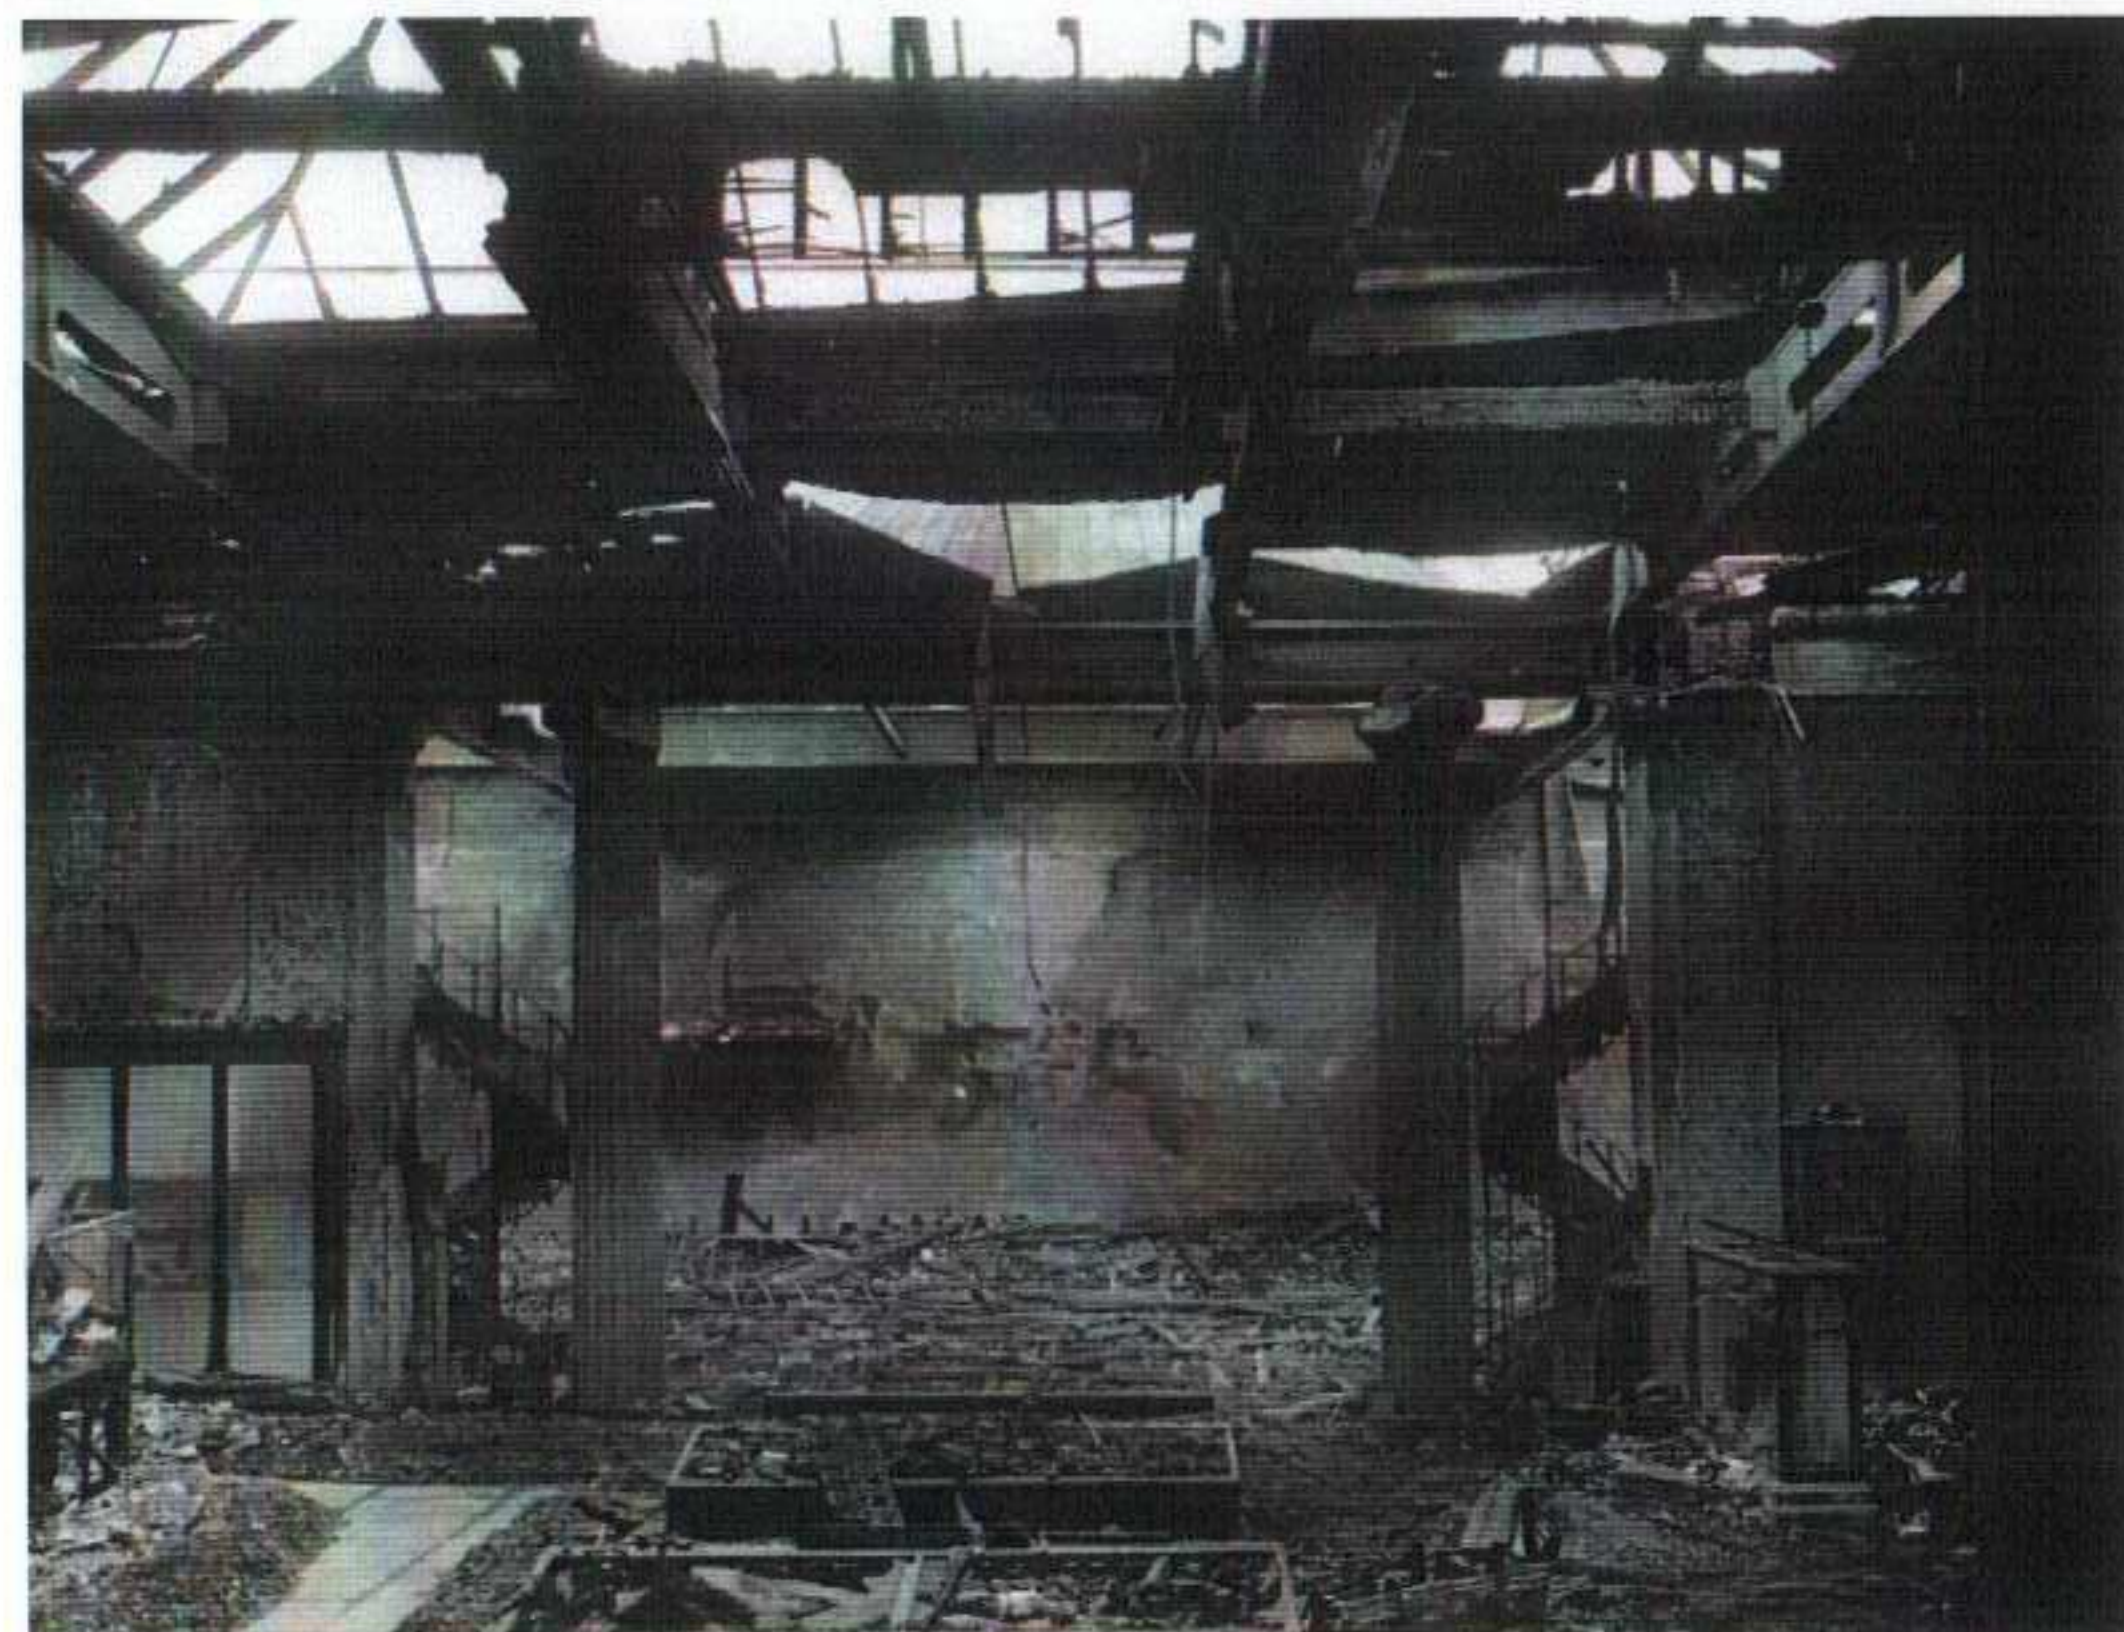
1941 bomb damage to roof areas above South Stair and Central Saloon

It is evident from the archive pre-1941 aerial photograph (pg.4) and bomb damage photographs that the pre-war roof lanterns did not include vertical upstands or glazing. However, these early 20th century roof lights may not have reflected the original rooflights designed by 'Smirke', as evident in archive drawings (pg11) for the lanterns for Gallery 70.

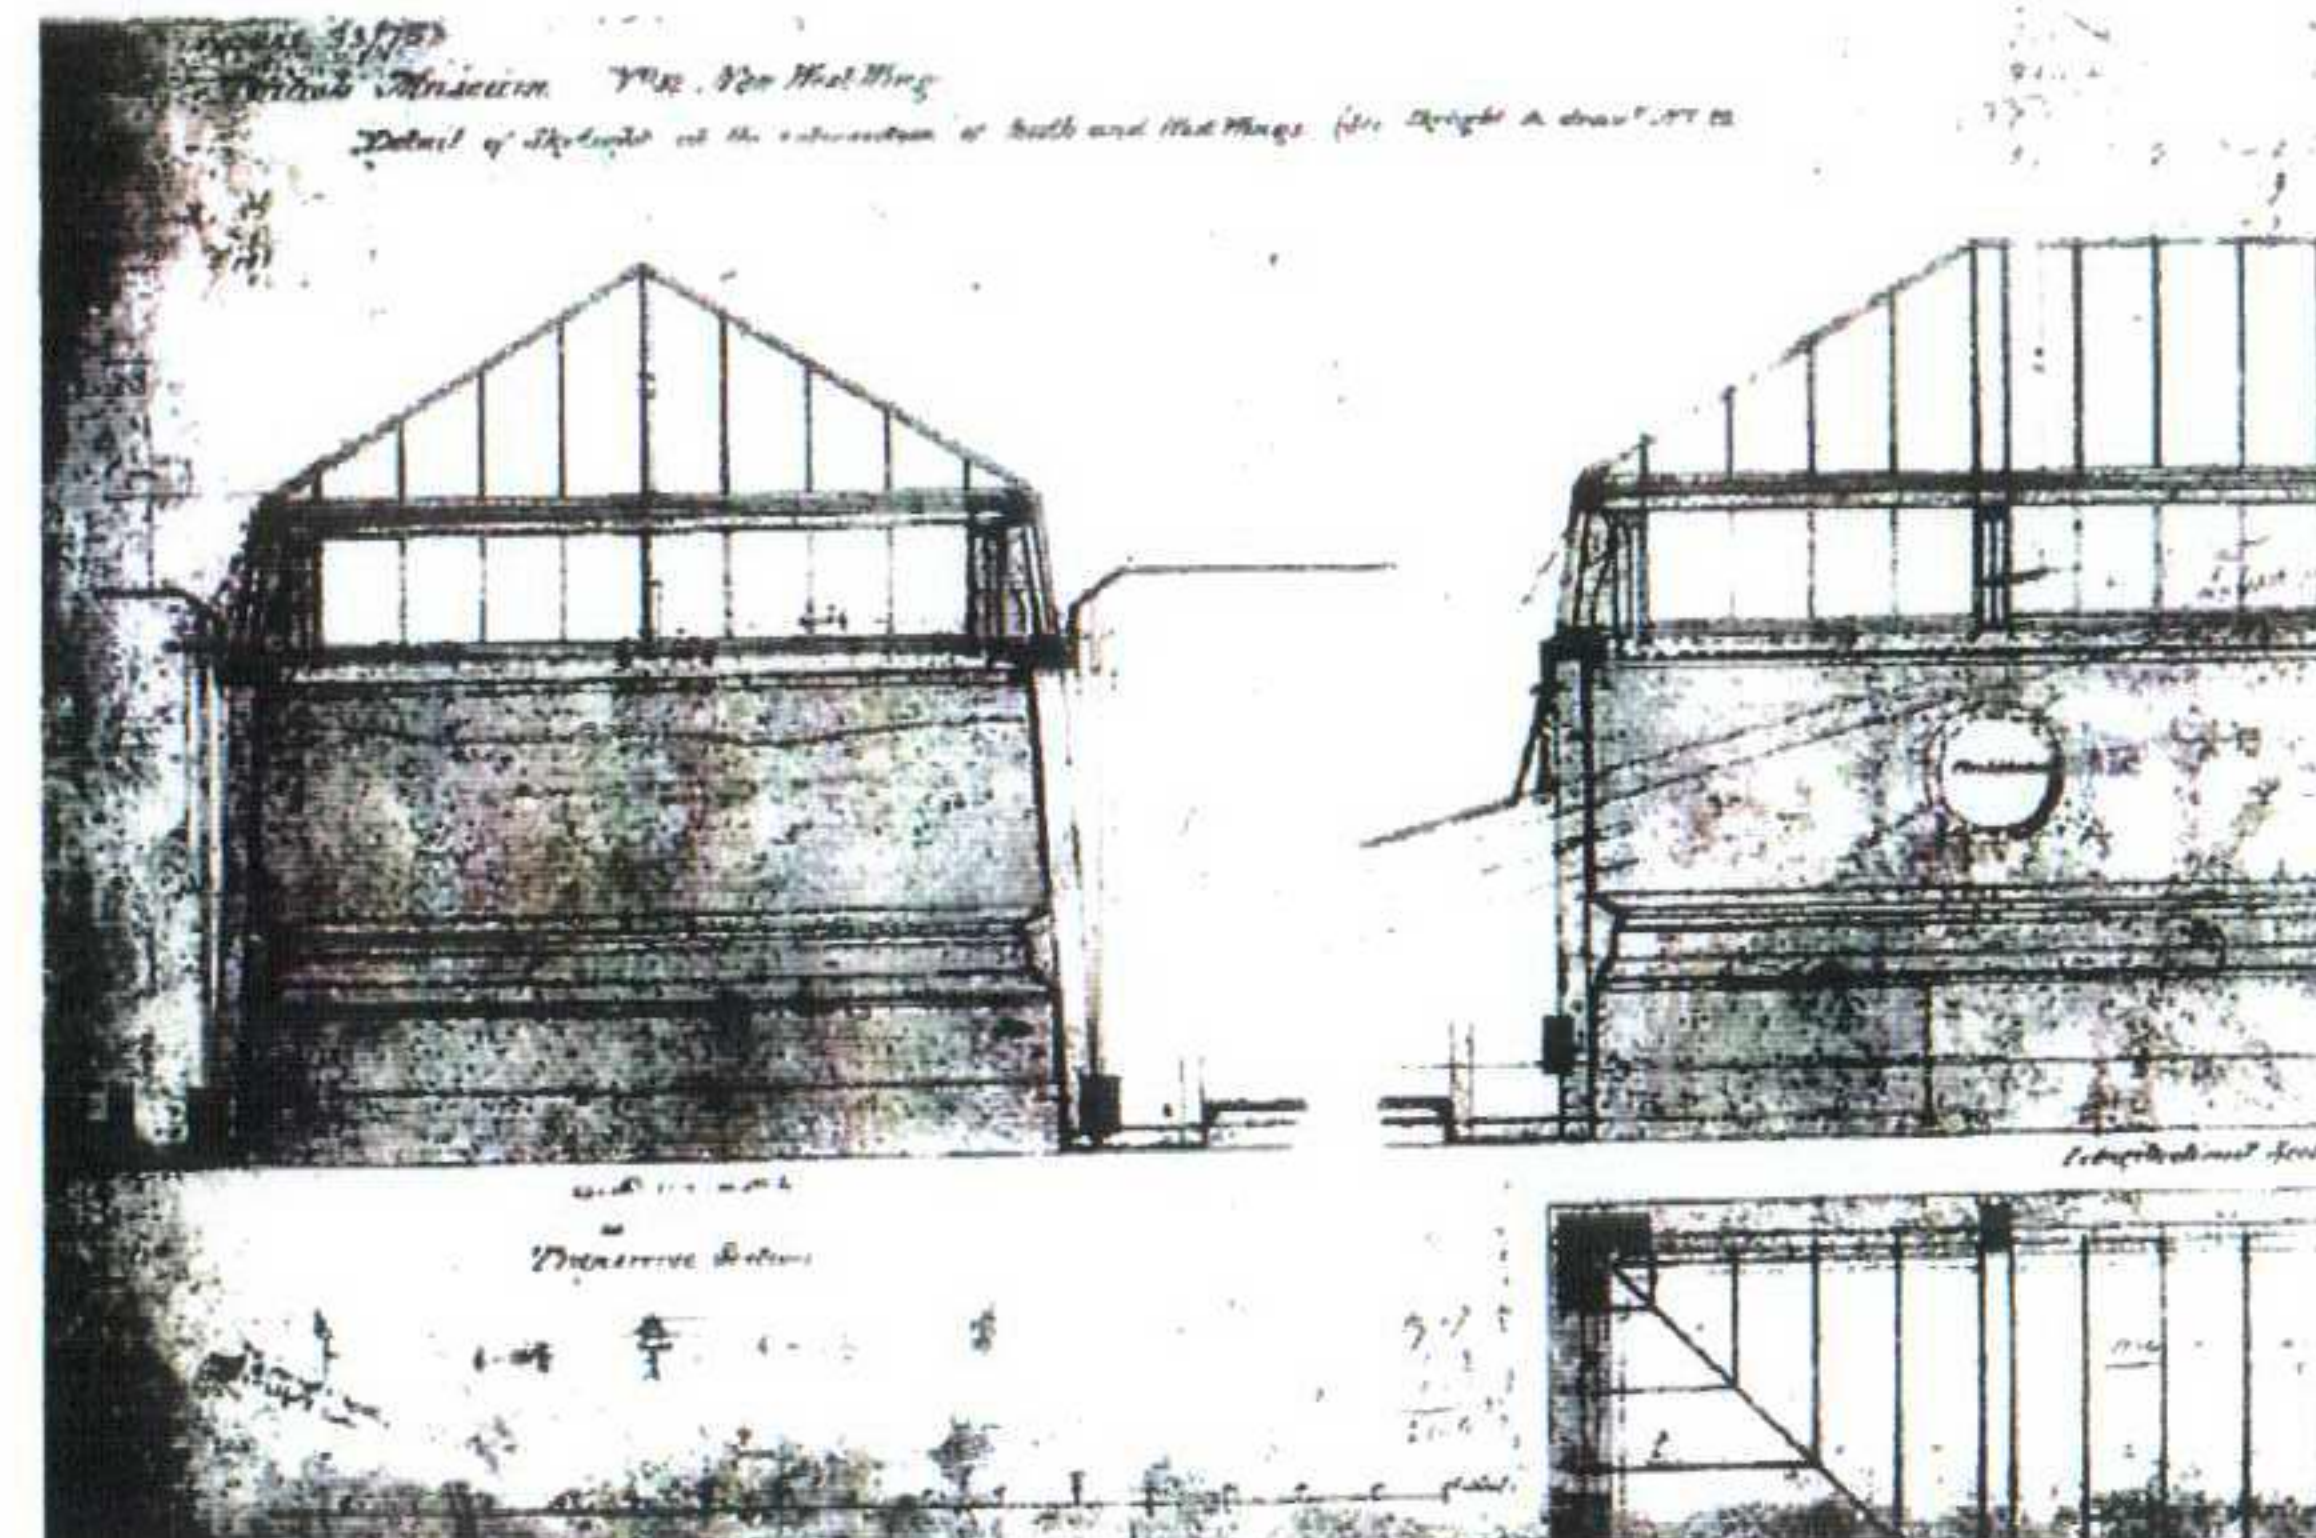
Original design drawing for roof lantern within Gallery 70

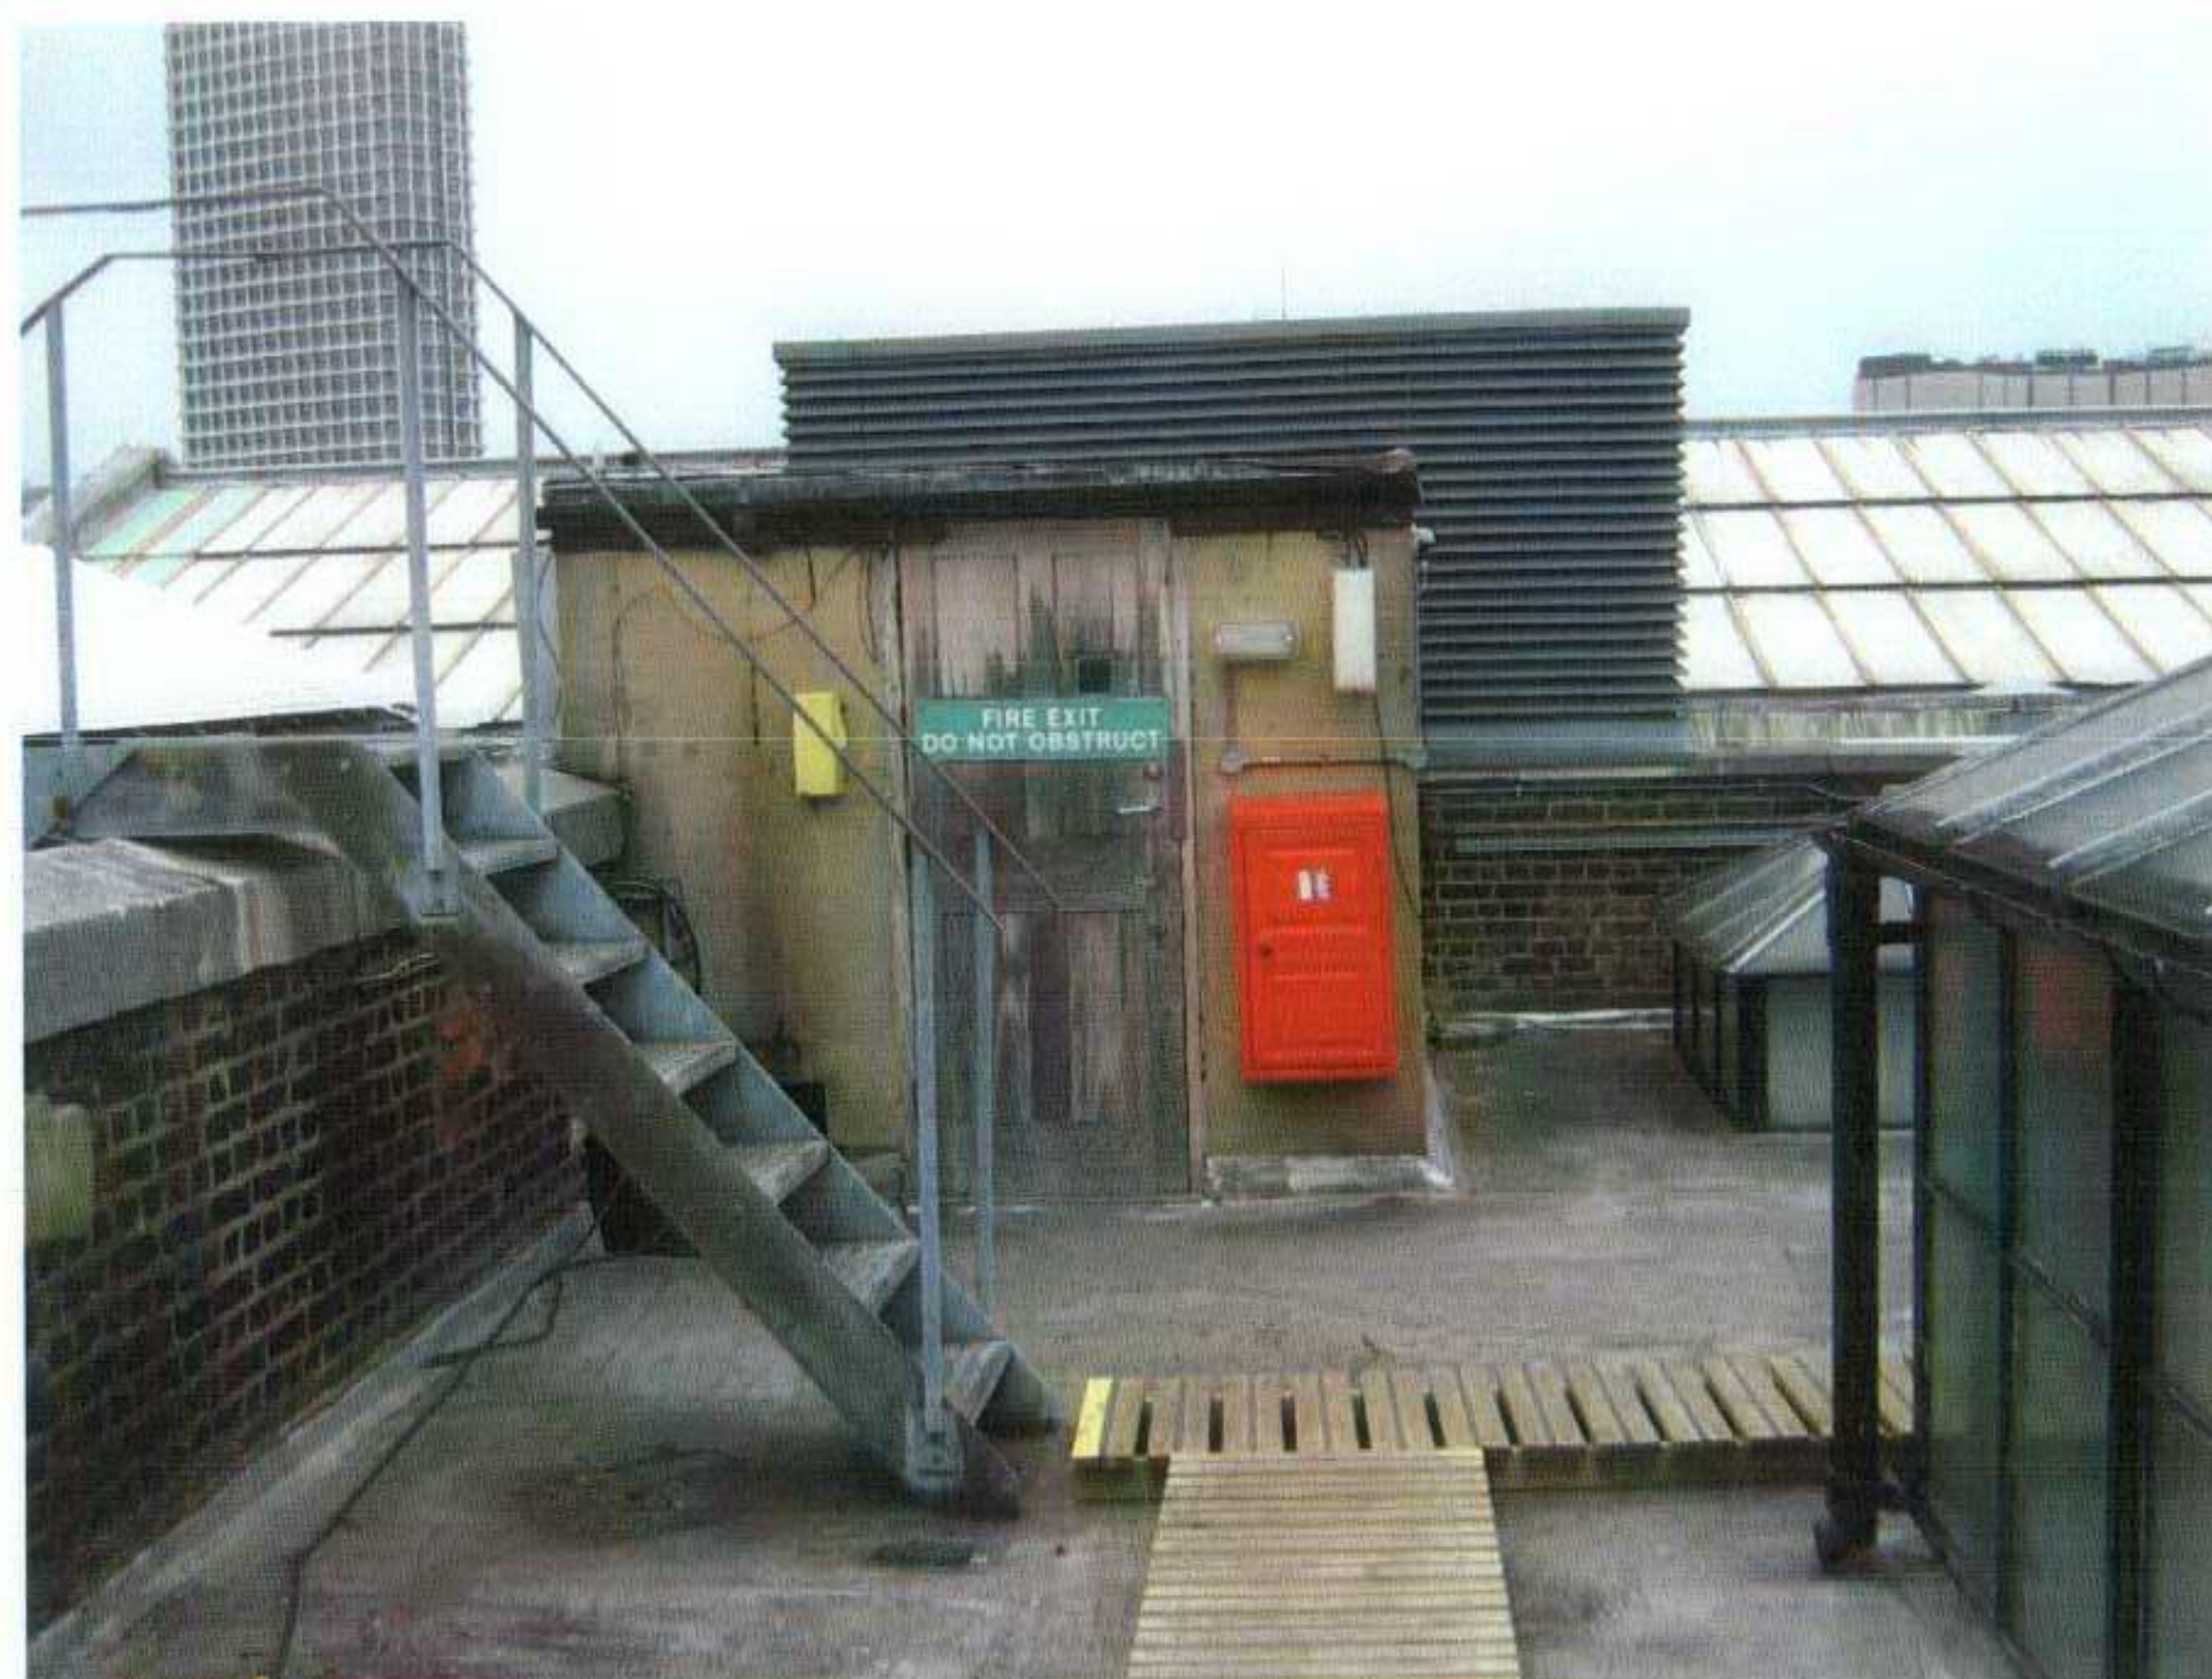
Existing enclosure and small glazed lantern above Willoughby Staircase

- South Stair Roof – Flat roof construction with mastic asphalt finish and single glazed roof lantern above the South Stair. This also includes a roof access stair enclosure and small single glazed roof lantern above the Willoughby Staircase to the west. Although there are no record drawings of this roof, the previous feasibility study by Frank Timothy Associates refers to this being constructed in reinforced concrete.

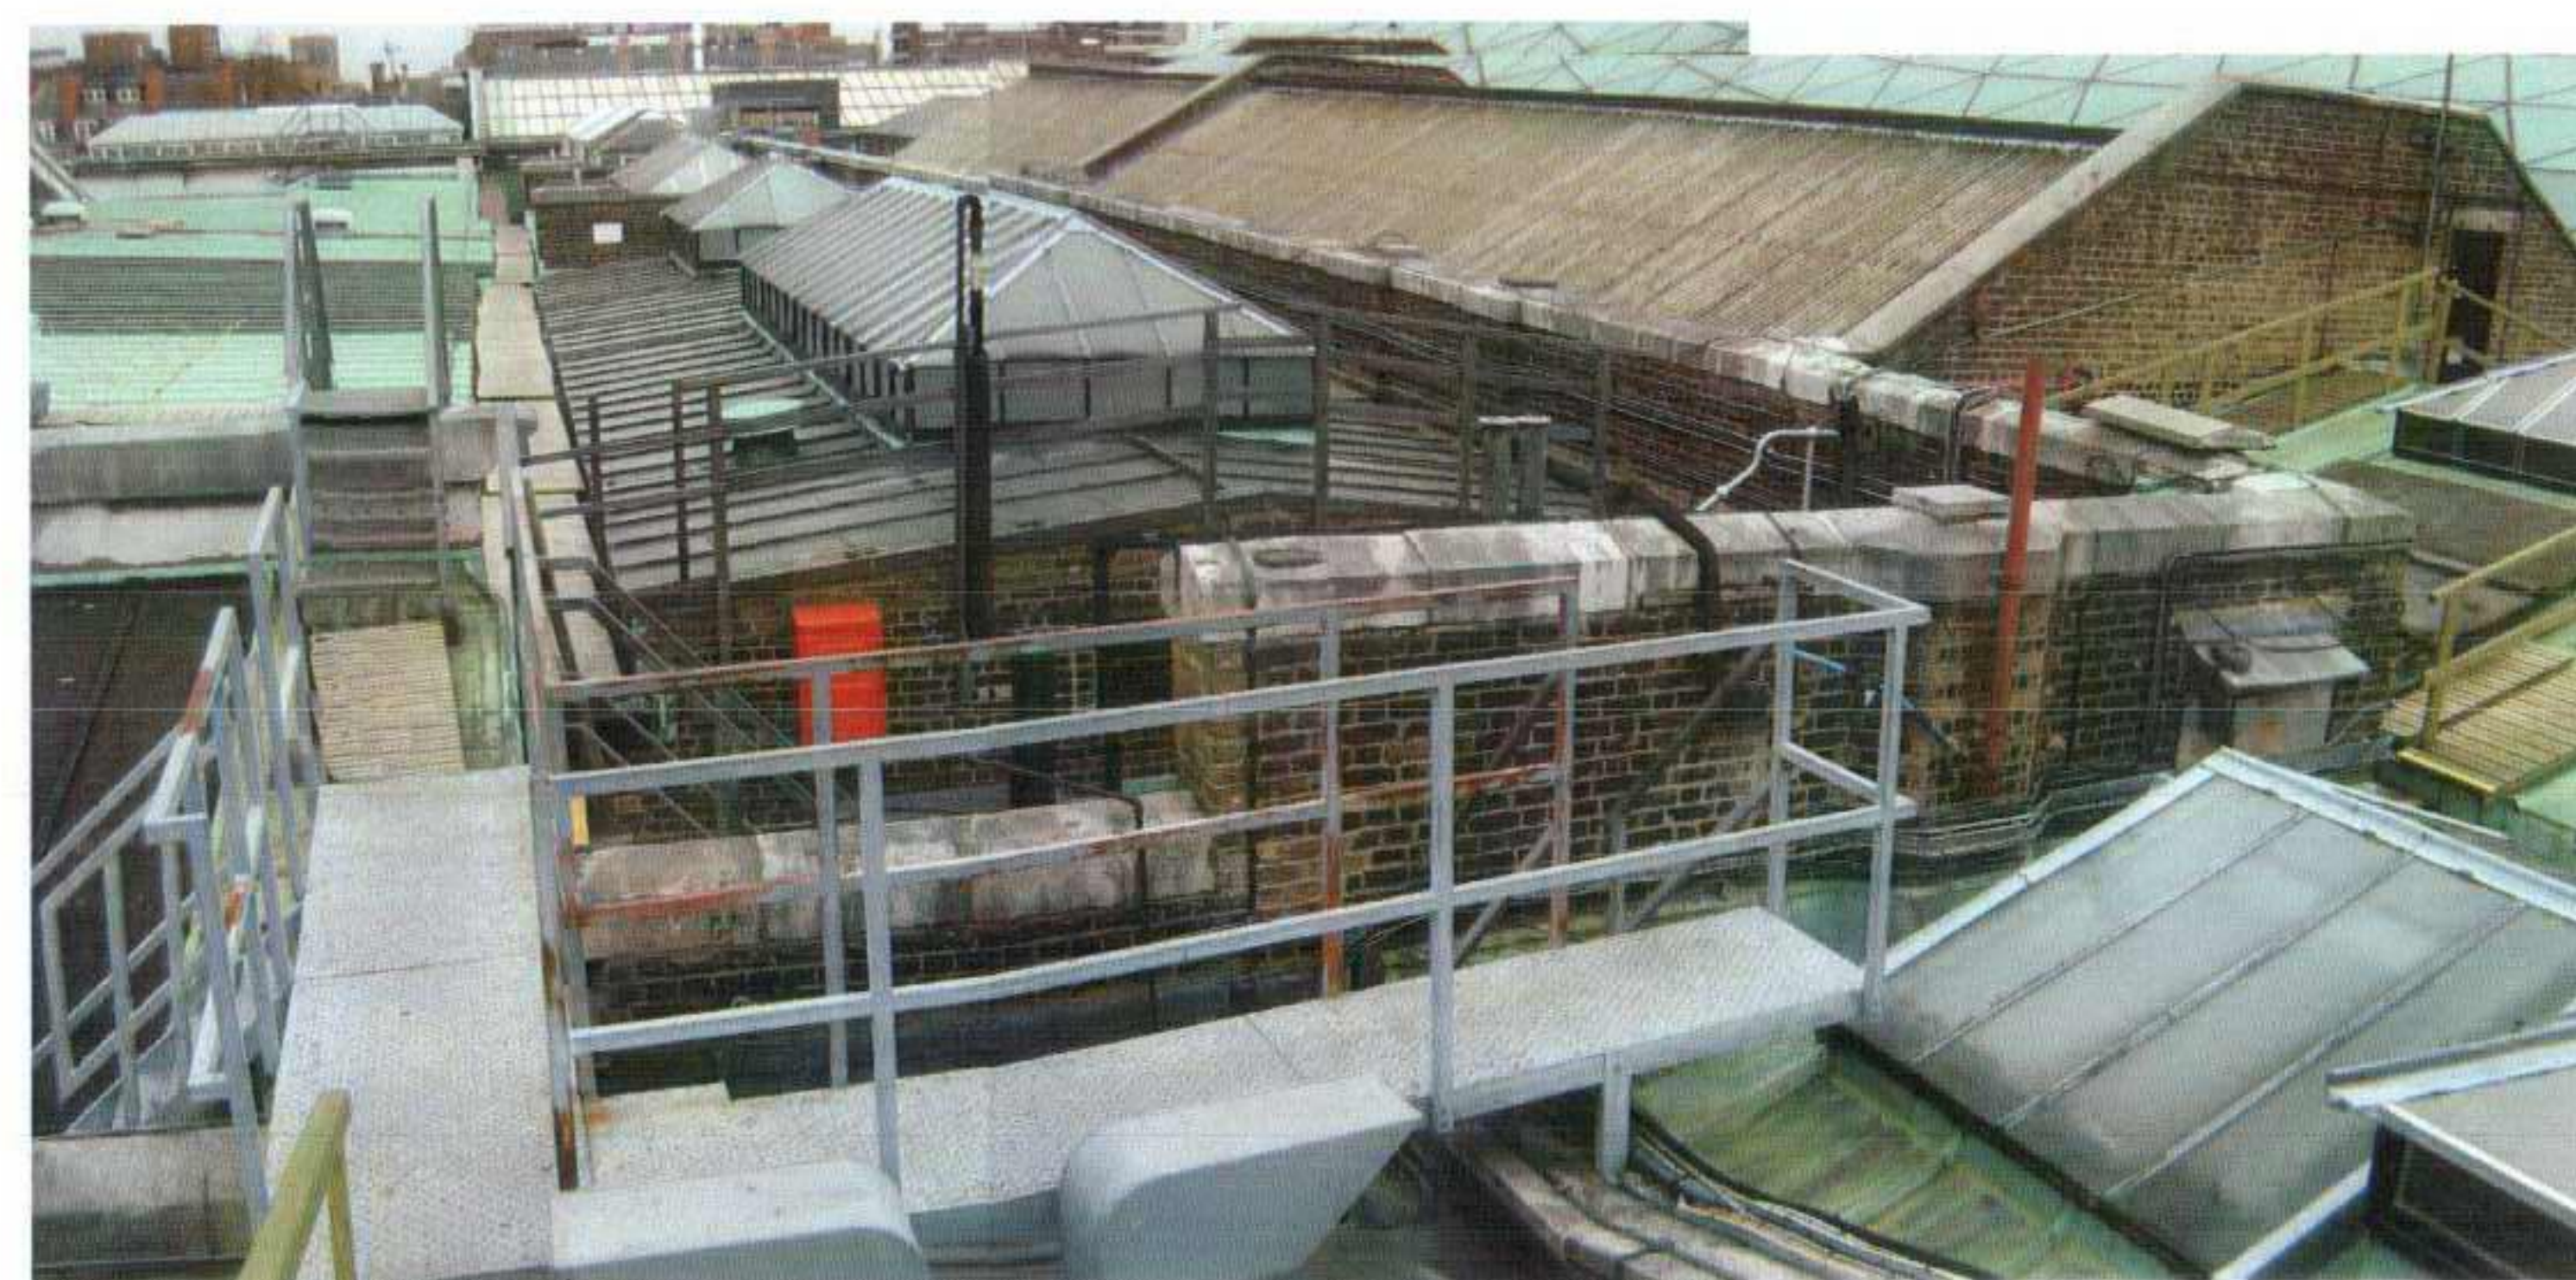
Existing glazed lantern to Gallery 39 in the foreground and the roof over Gallery 40 to the right

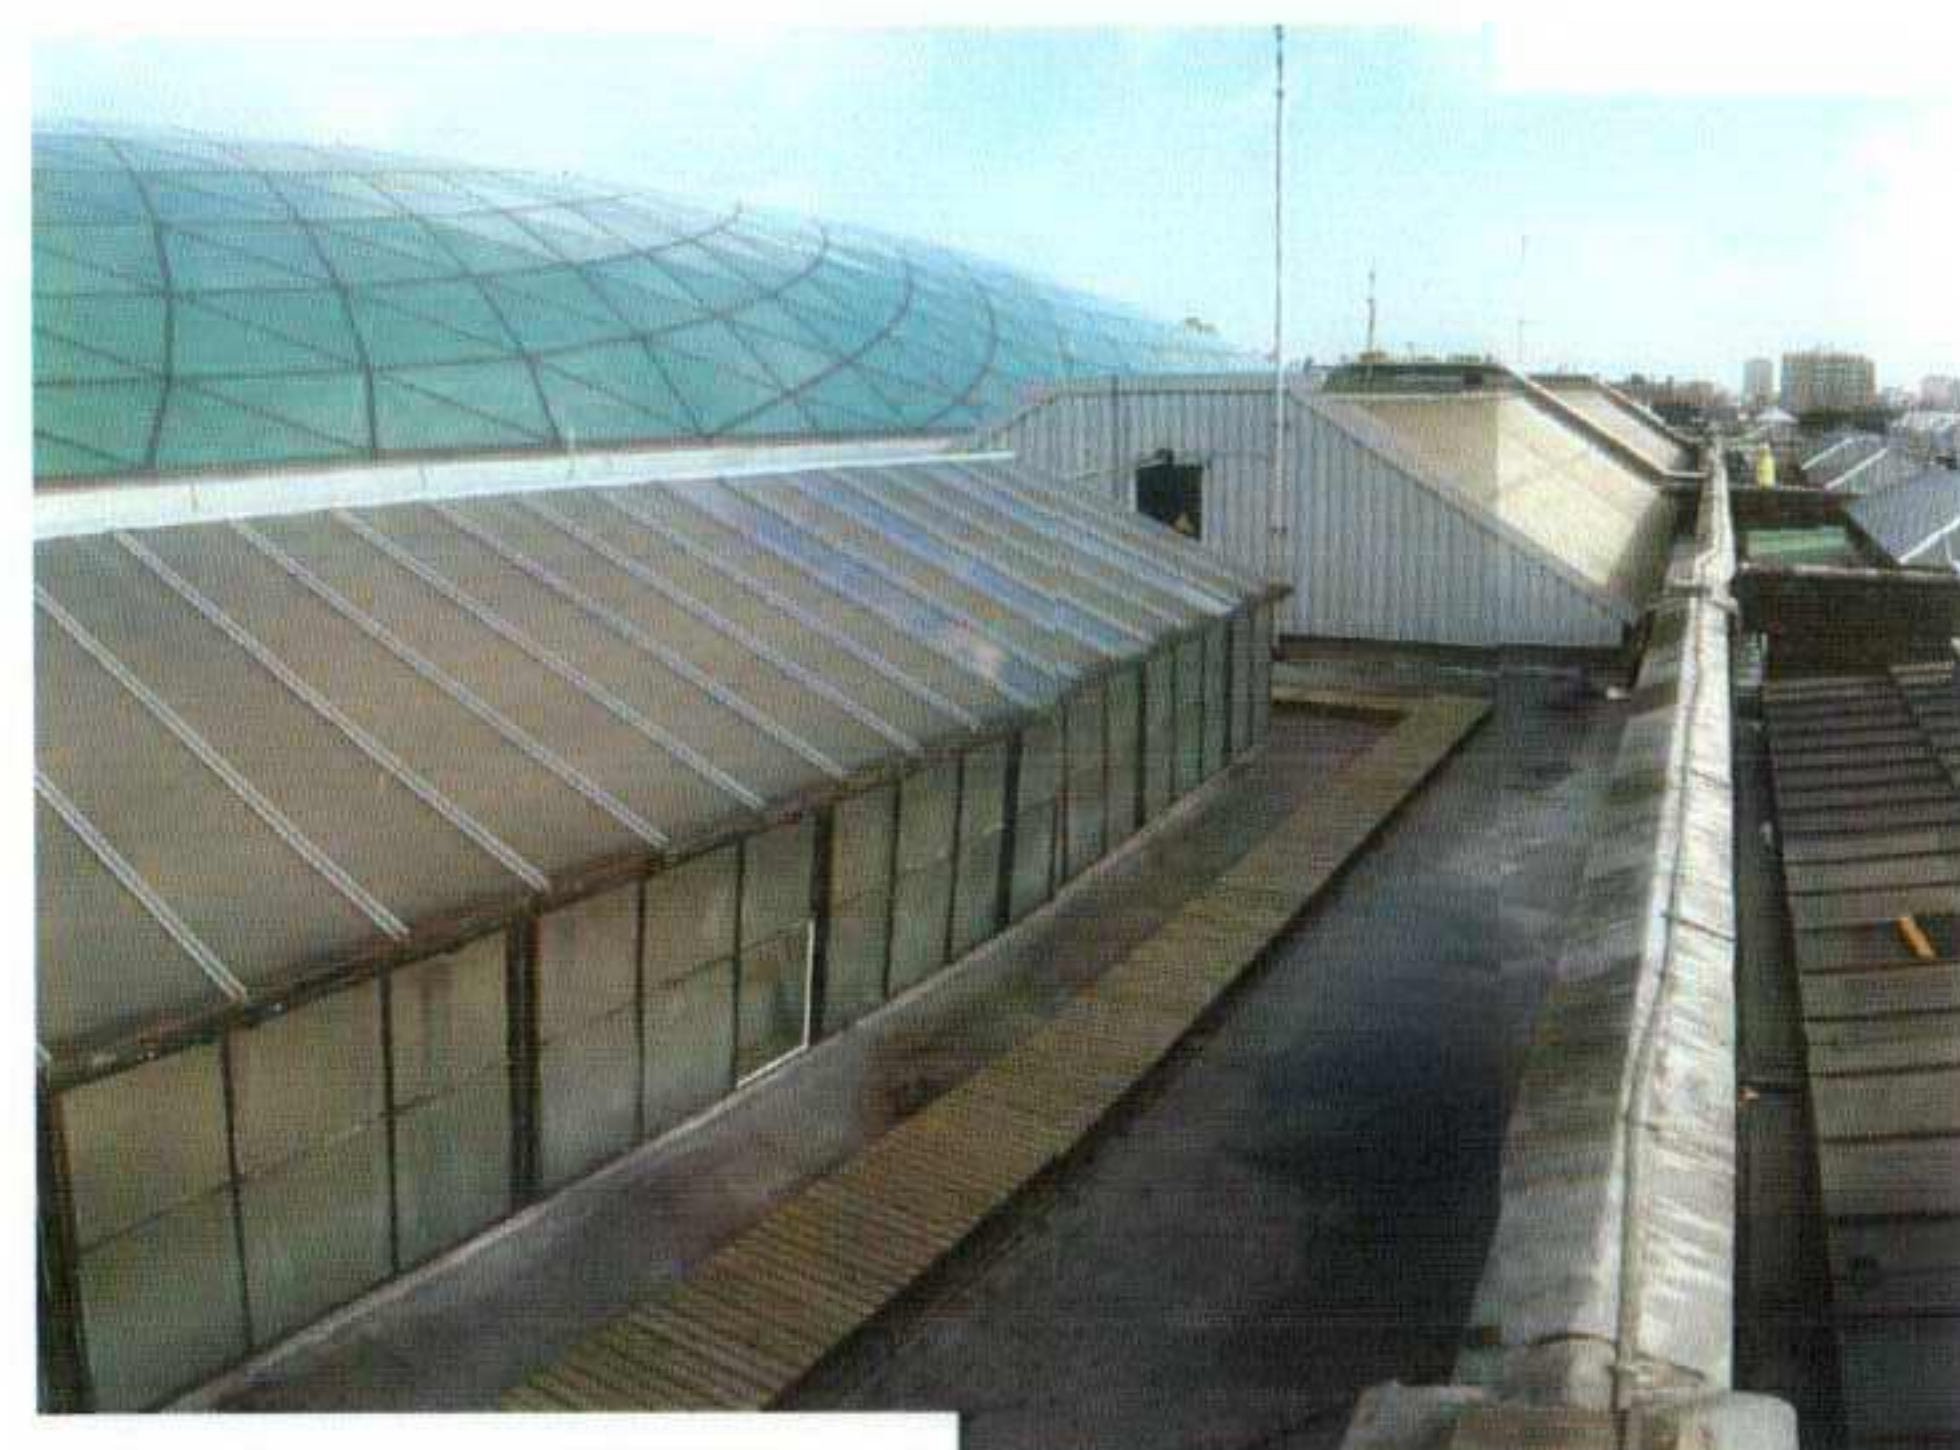
Existing glazed lantern and asphalt roof over the South Stair, and roofs over the Central Saloon and Gallery 40 in the background

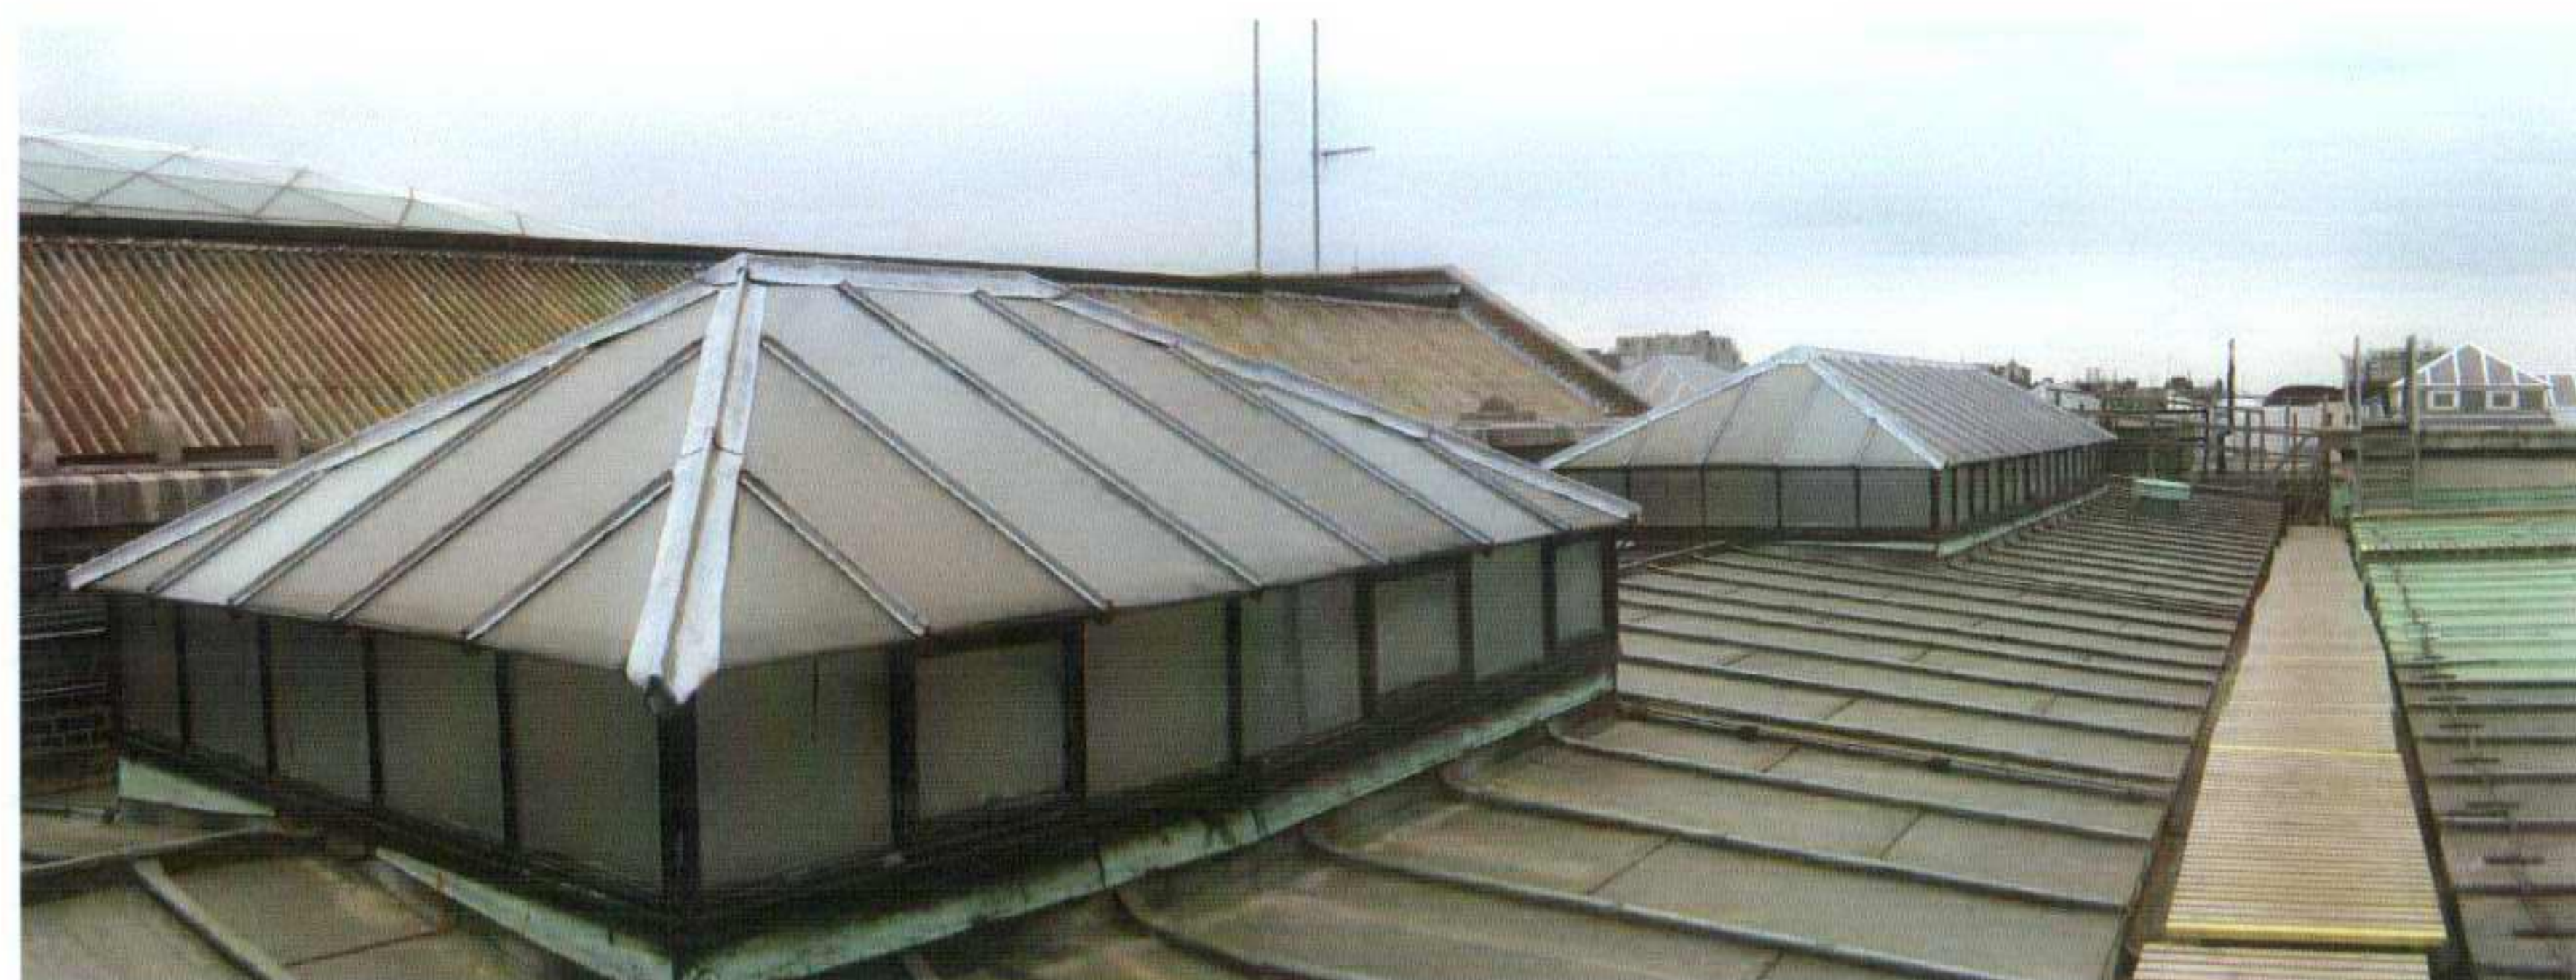
Existing glazed lanterns to Galleries 38 and 39 and roof over Gallery 40 in the background
