ROOF AREAS

Historical Development and Record Information

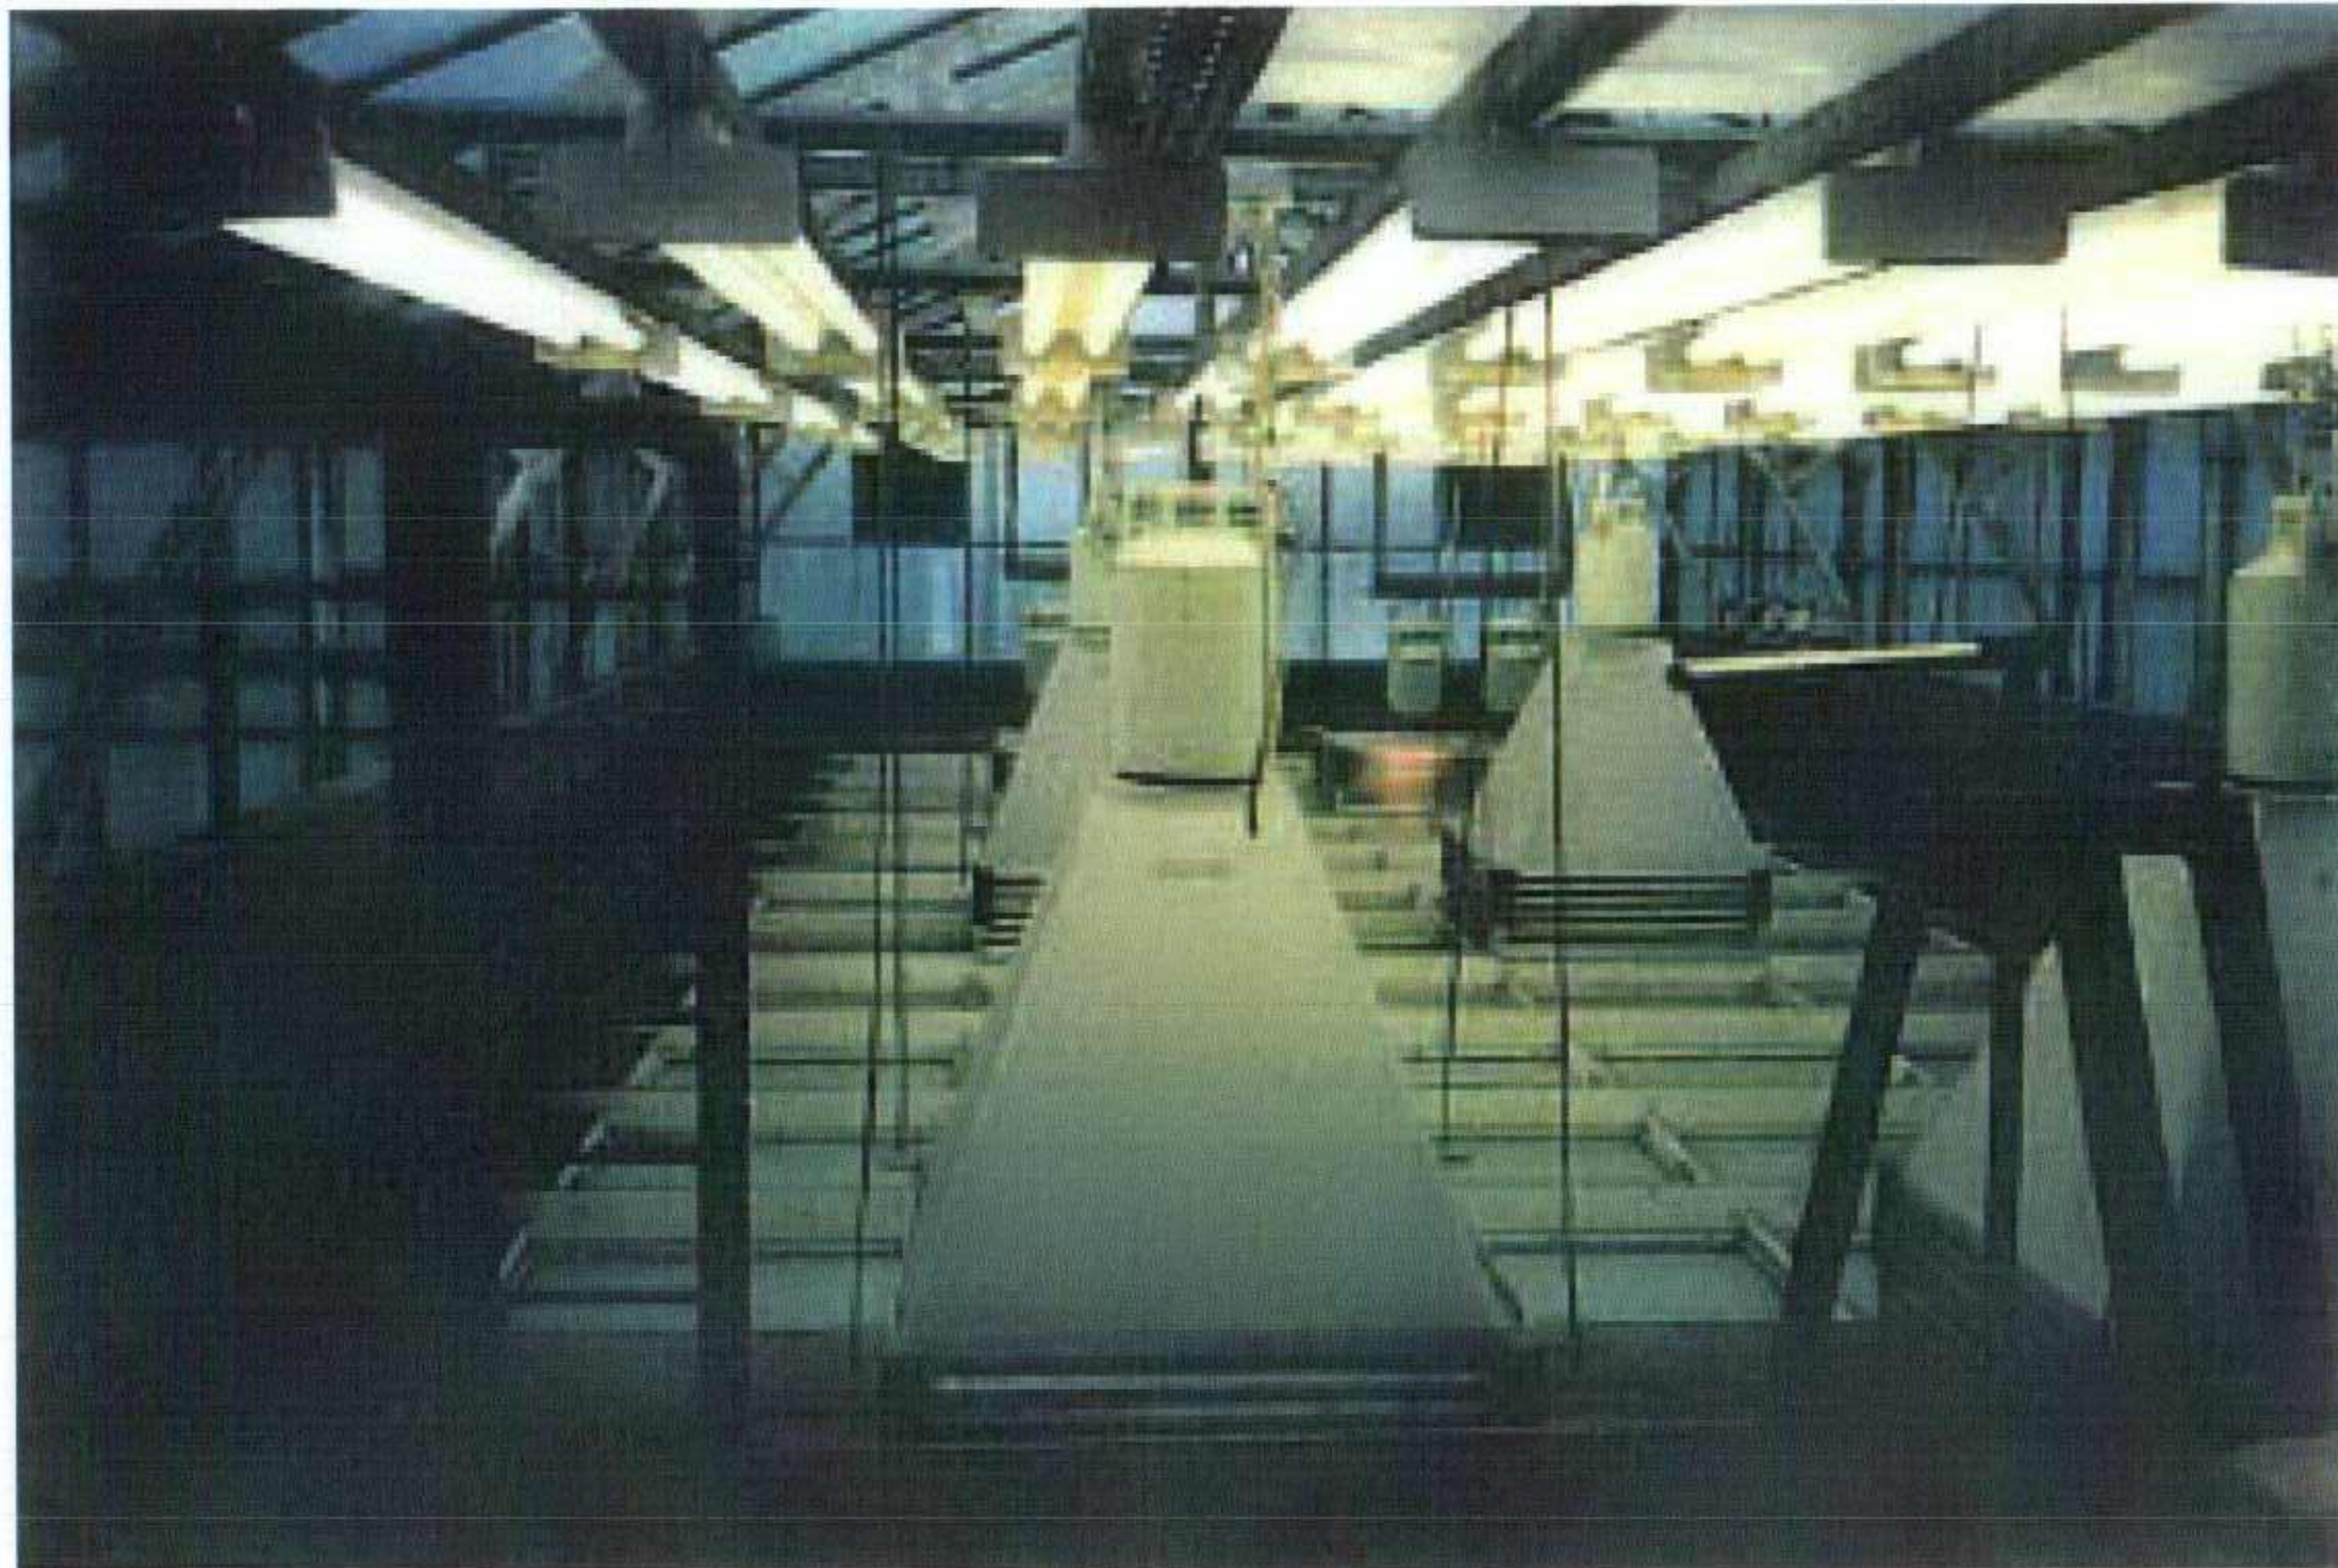
Photograph of the roof void over the glazed lay light to the South Stair from the report by Arnold & Boston, Architects 1994

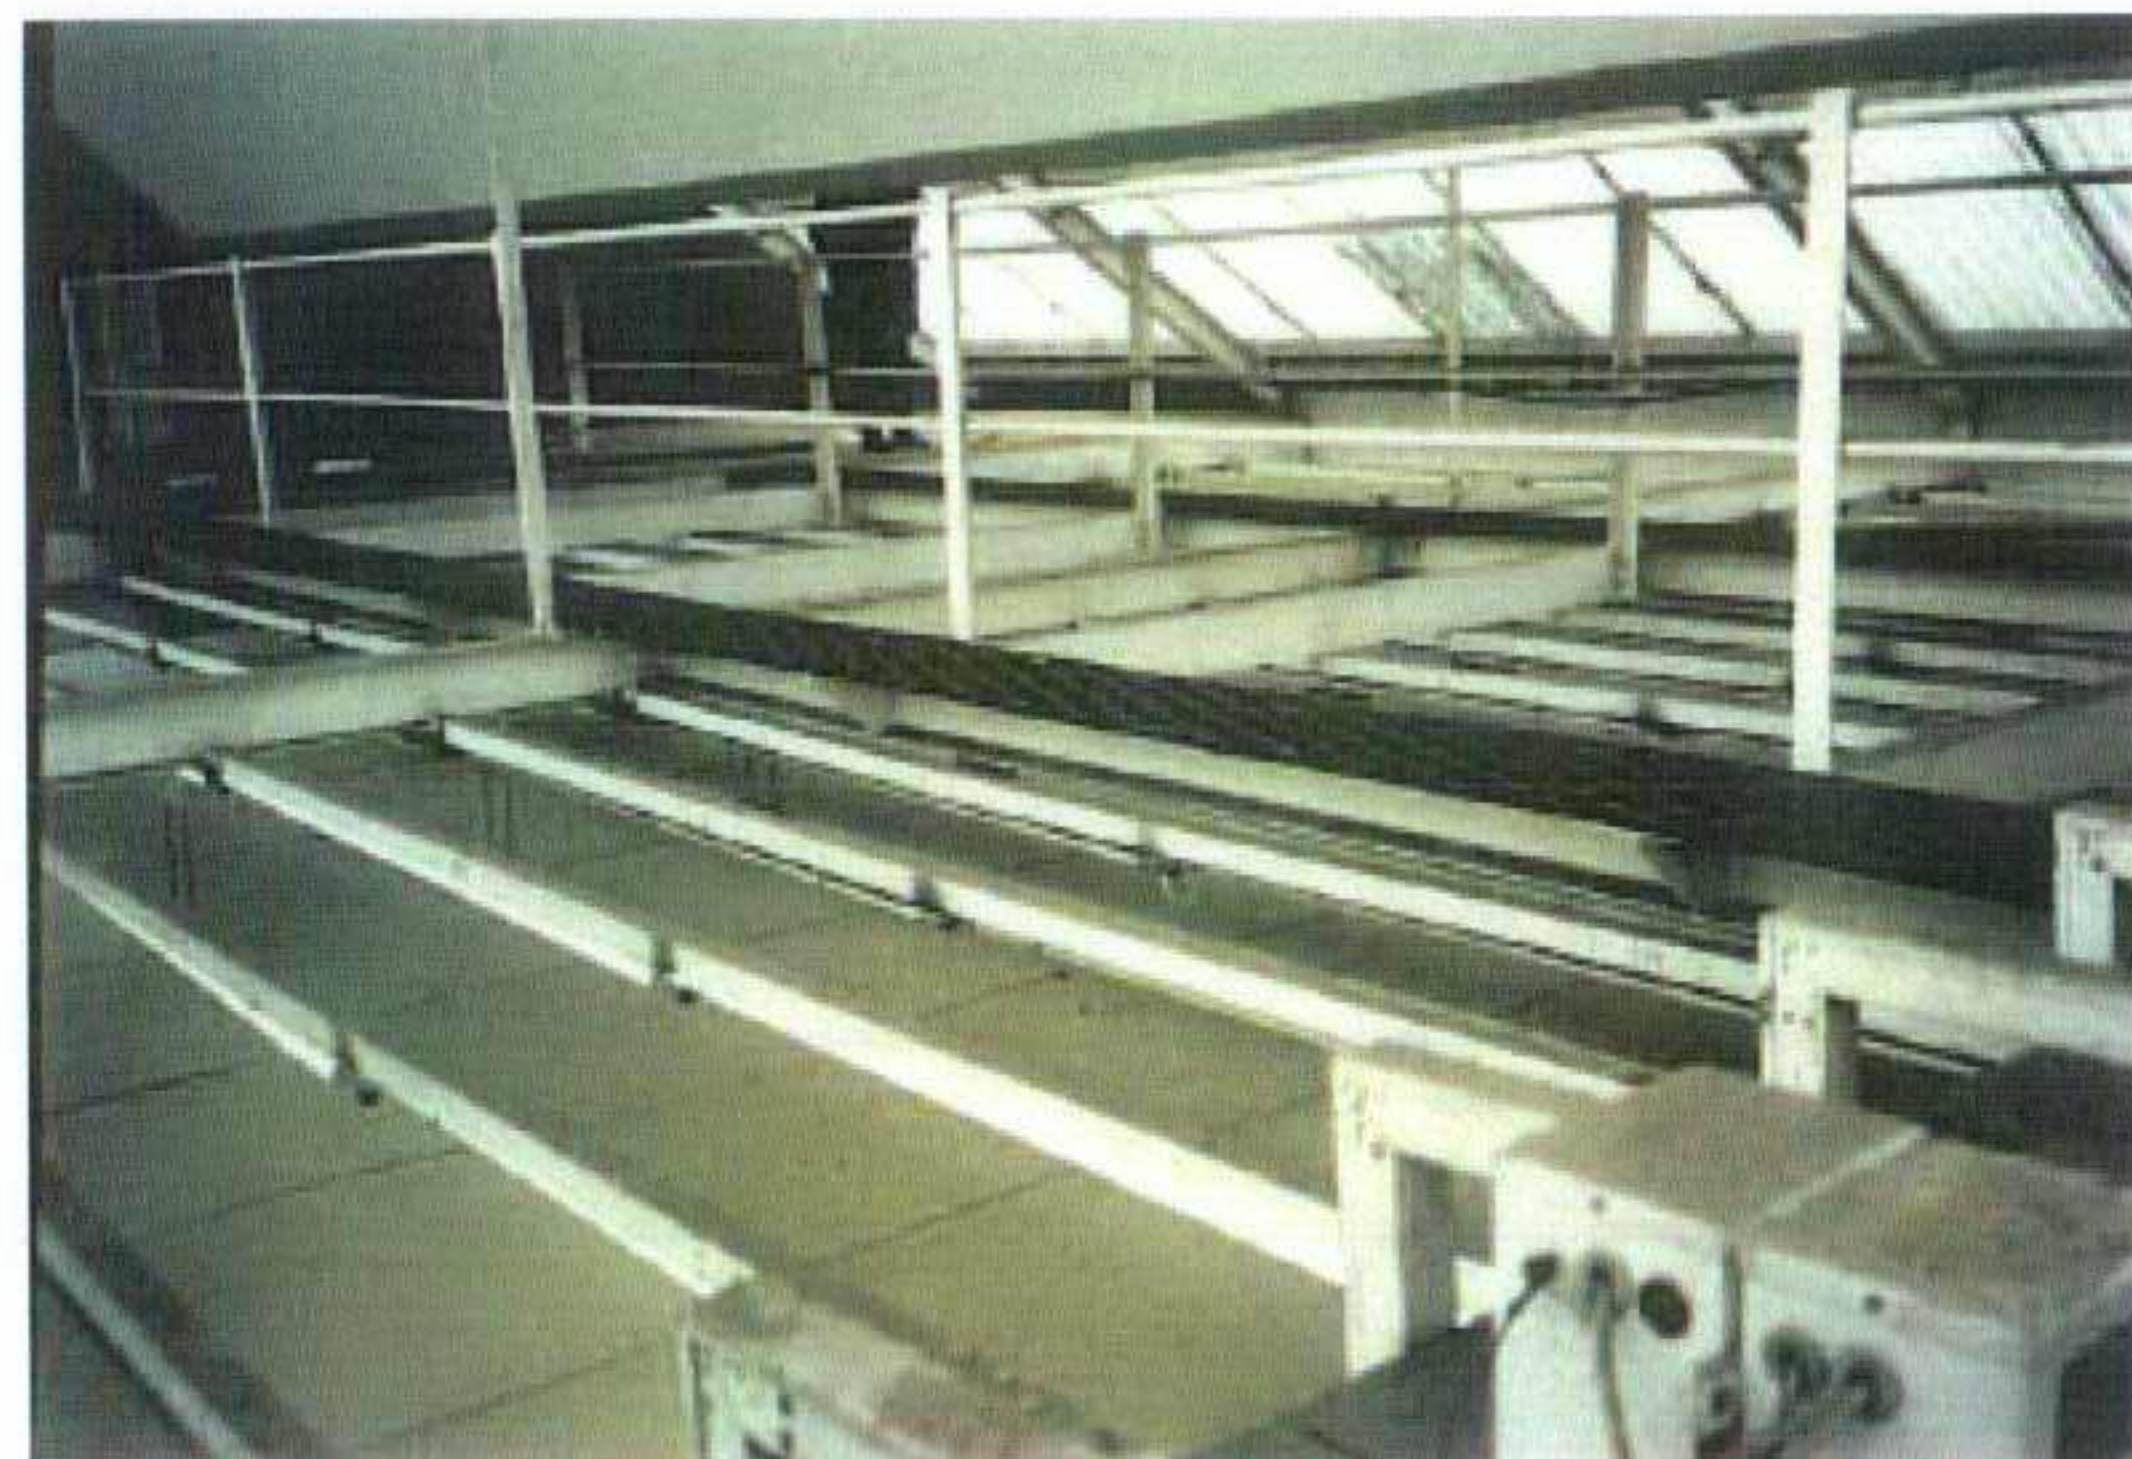
Photograph of the roof void over the glazed lay light to the Central Saloon from the report by Arnold & Boston, Architects 1994

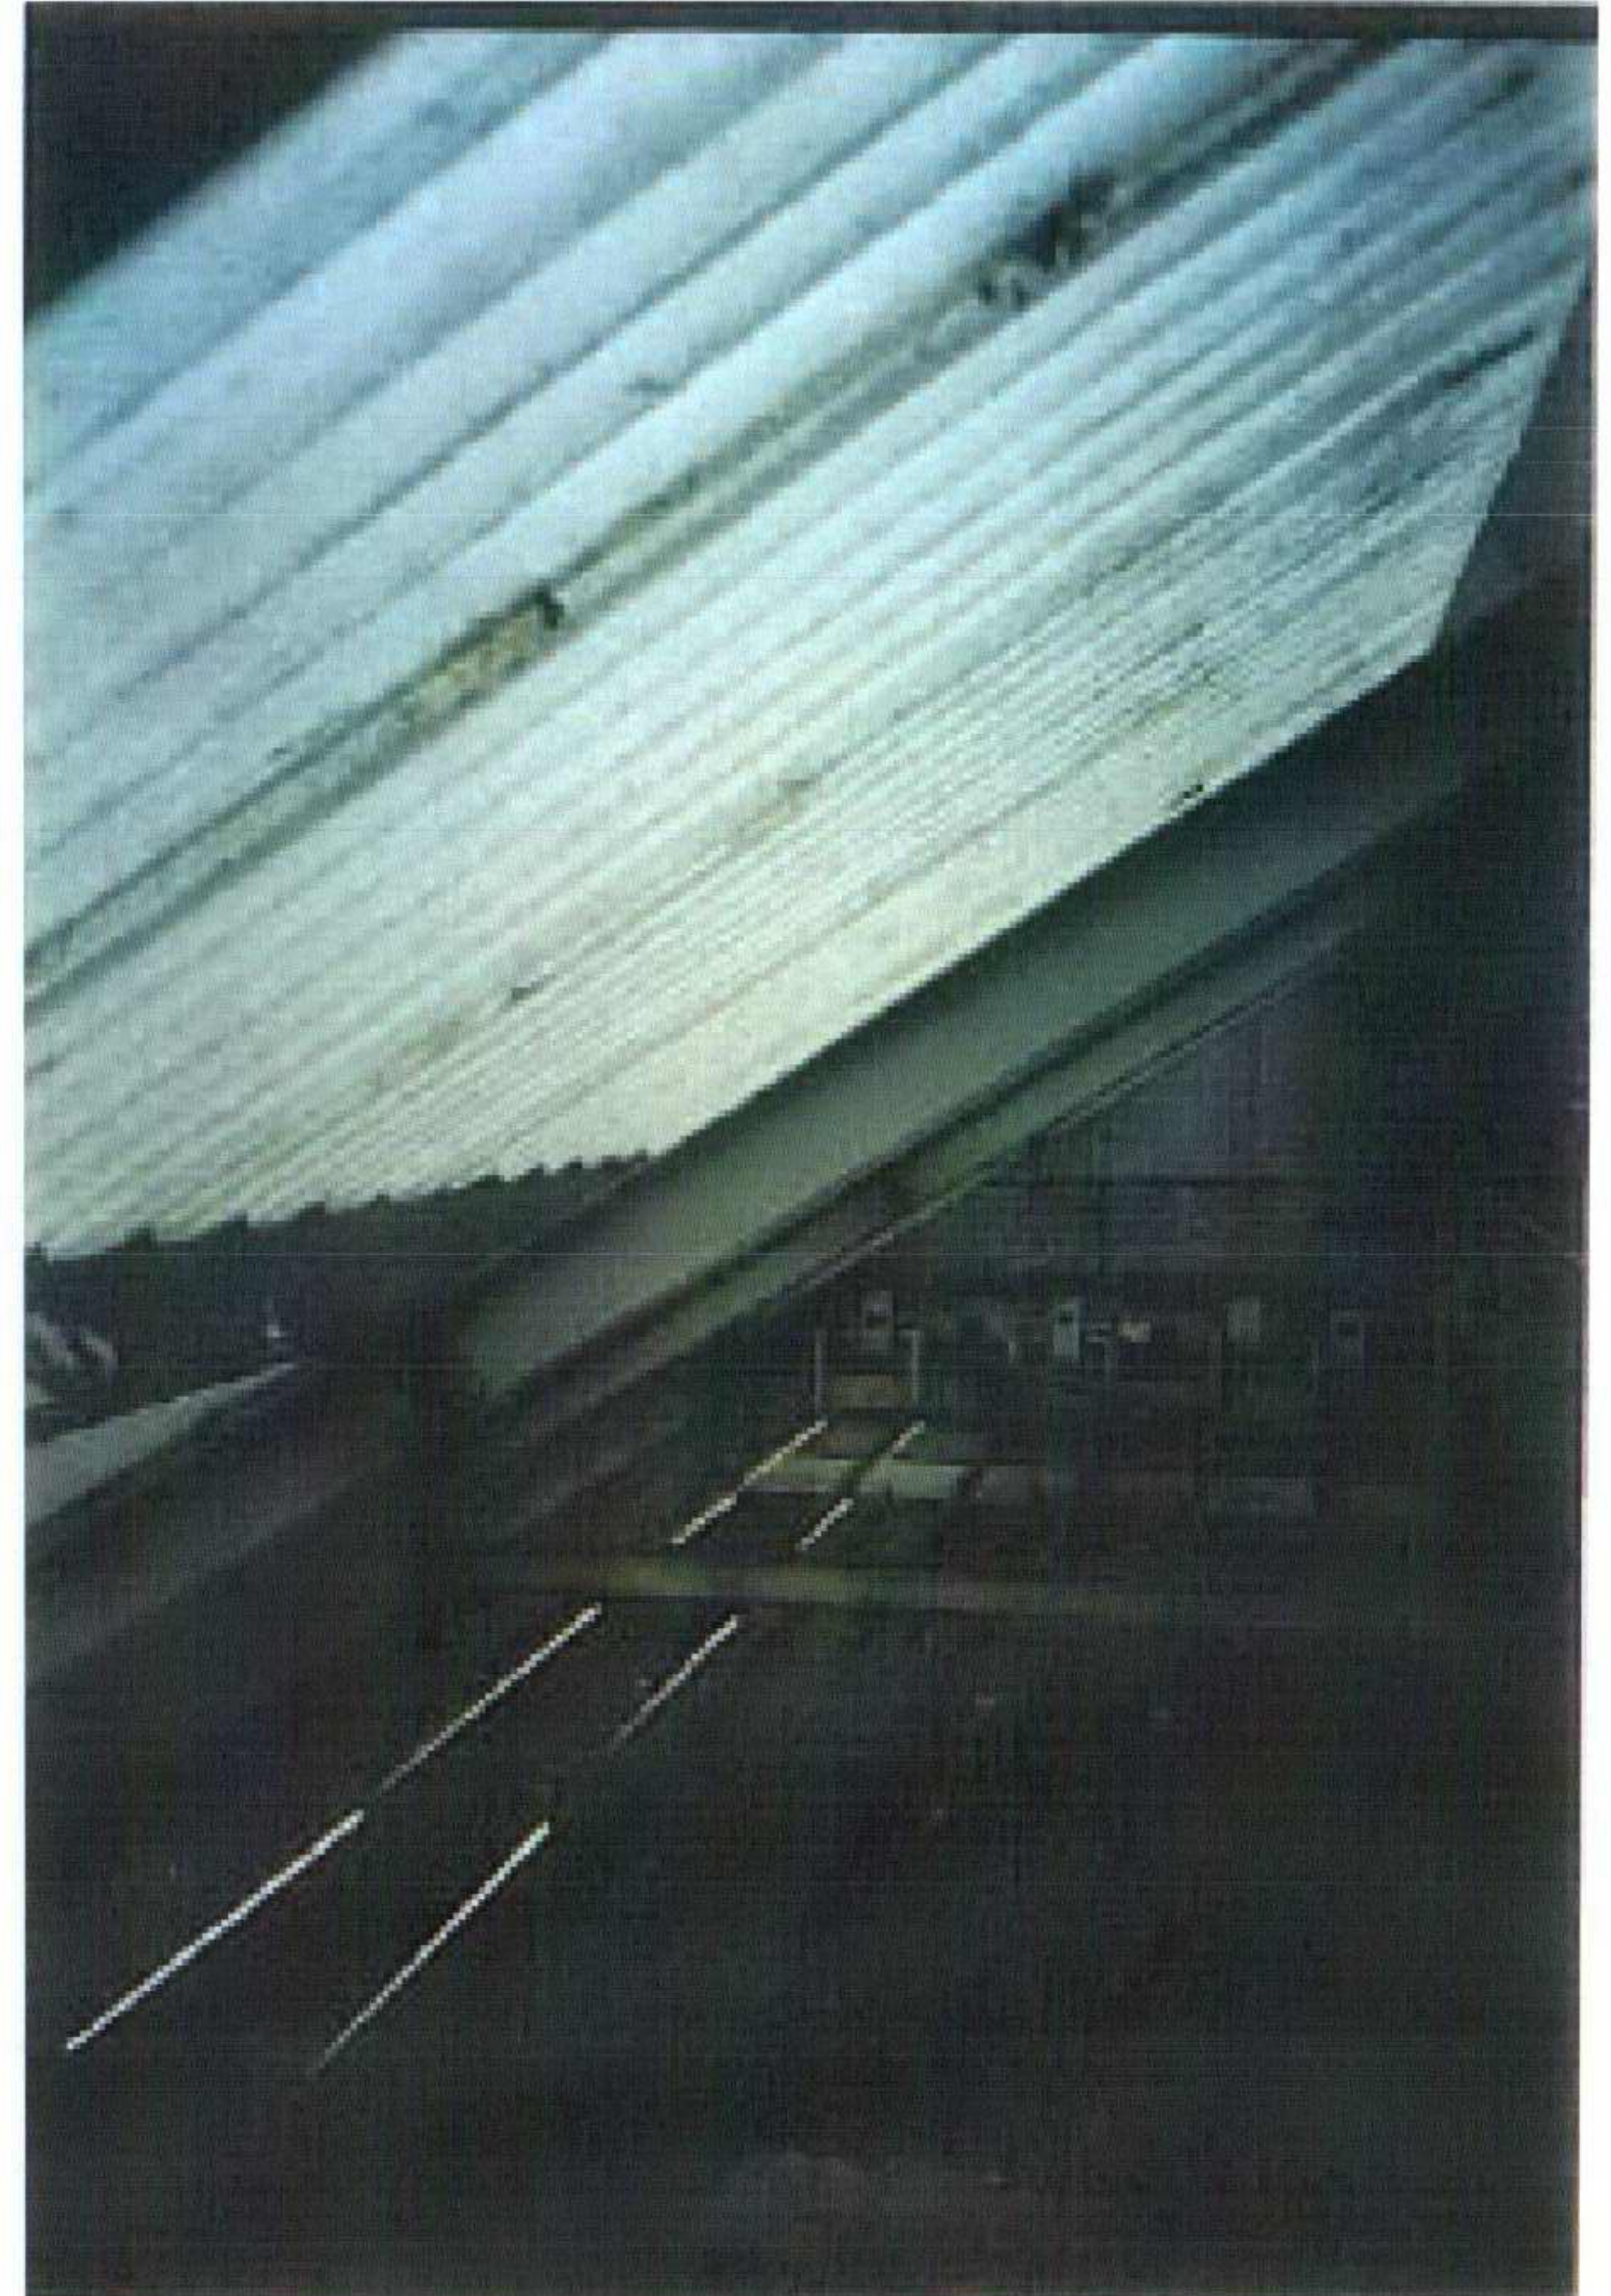
Photograph of the roof void over the glazed lay light to the Central Saloon from the report by Arnold & Boston, Architects 1994
