7.0 Sewer Records

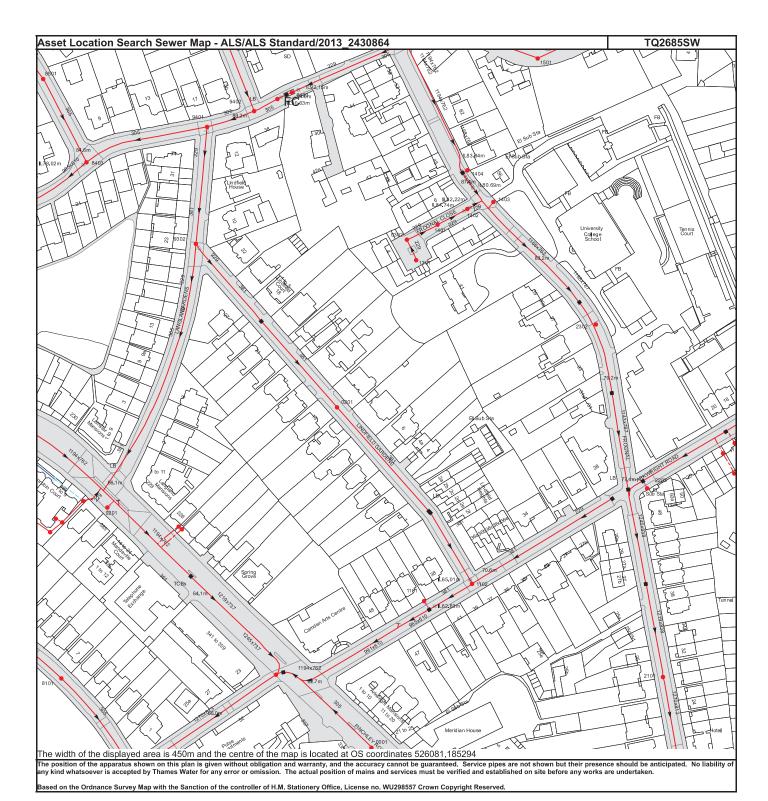
NB. Levels quoted in metres Ordnance Newlyn Datum. The value -9999.00 indicates that no survey information is available

Manhole Reference	Manhole Cover Level	Manhole Invert Level
9302	80.73	74.59
0302	89.8	87.09
1401	88.72	85.96
1402	86.98	n/a
1403	86.35	80.51
1404	88.07	n/a
8403	84.4	n/a
9401	88.18	79.78
9402	91.32	86.21
auto	n/a	n/a
0403	93.85	n/a
8501	88.65	83.83
1501	94.18	88.8
3201	n/a	n/a
3202	n/a	n/a
82BF	n/a	n/a
82CA	n/a	n/a
82BG	n/a	n/a
8101	58.41	54.41
82BH	n/a	n/a
82BI	n/a	n/a
9201	n/a	n/a
9206	n/a	n/a
9207	n/a	n/a
auto	n/a	n/a
0201	79.17	71.93
0001	61.45	58.7
1301	89.91	87.74
1101	n/a	n/a
1102	70.36	64.86
2302	n/a	n/a
2203	n/a	n/a
2101	69.04	62.55
2210	n/a	n/a

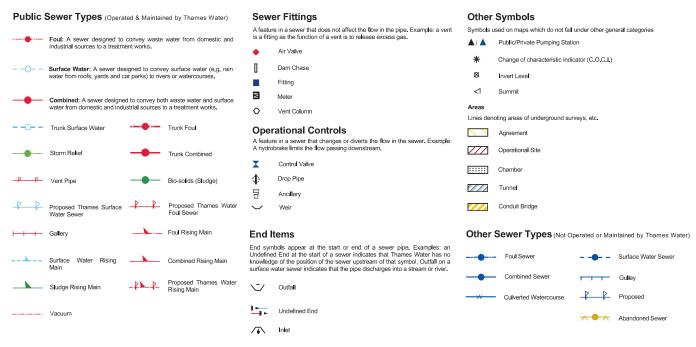
All levels associated with the plans are to Ordnance Datum Newlyn. 2) All measurements on the plans are metric.

3) Arrows (on gravity fed sewers) or flecks (on rising mains) indicate direction of flow.

5) 'na' or '0' on a manhole level indicates that data is unavailable.

6) The text appearing alongside a sewer line indicates the internal diameter of the pipe in millimetres. Text next to a manhole indicates the manhole reference number and should not be taken as a measurement. If you are unsure about any text or symbology present on the plan, please contact a member of Property Insight on 0845 070 9148.
