Alice Gailey, 37 South Hill Park, London NW3 2ST.

Re: Planning Application for 35 South Hill Park, Application Ref. 2014/1938/P

There are THREE reasons for OBJECTING this application and they are as follows;

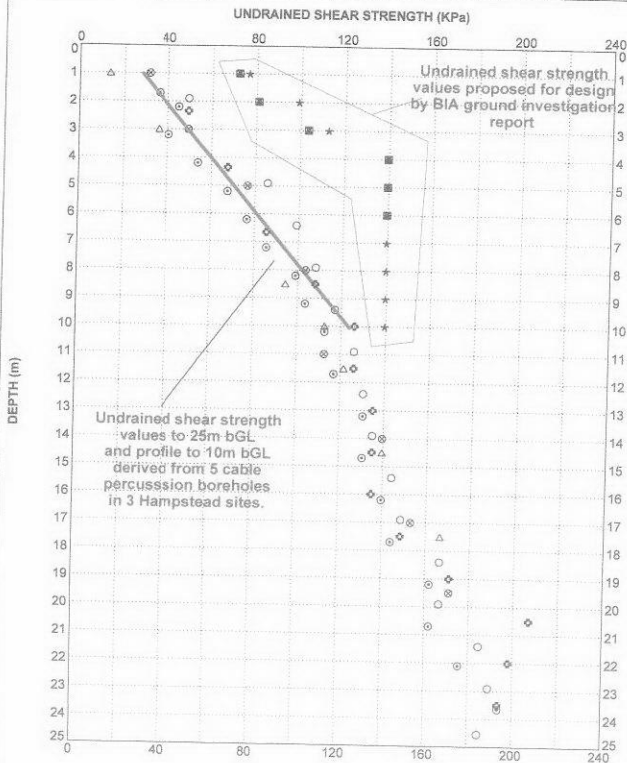
Project Ref. G1406	Project Title. 35 SOUTH HILL PARK NW3	Sheet Ref. FIGURE 1
	UNDRAINED SHEAR STRENGTH vs DEPTH BIA RESULT vs HAMPSTEAD DATA

- BH1-SITE ◆ BH5-SH1
- ▲ BH2-SITE ○ BH6-SH2
- ★ BH3-SITE △ BH7-TA
- ⊙ BH4-DH ⊗ BH8-TA

CABLE PERCUSSION BH LOCATIONS:
 DH - Downshire Hill
 SH - South Hampstead School
 TA - Templewood Avenue

37. These comments are based upon more than 20years experience of conducting ground investigations and operating a soil testing laboratory. They are substantiated by authoritative texts [2]. Figure 1 in Appendix A compares the test results offered by the application with the very consistent results obtained in sites spaced widely over the Hampstead area by different investigators using more reliable methods. The investigation reports concerned are in the public domain. They included investigations of both Unit D of the London Clay and the Claygate Member and demonstrate the well known and expected consistency of the formation.

38. The engineers' method statement relies upon the site tests made and reported by Ecologia. A safe foundation bearing pressure of 150KPa has been assumed for design. In consequence of this comparison on Figure 1 and of experience of other local sites, I believe that the engineers' assumption seriously overestimates the ground strength to a degree that affects the preliminary design adequacy.

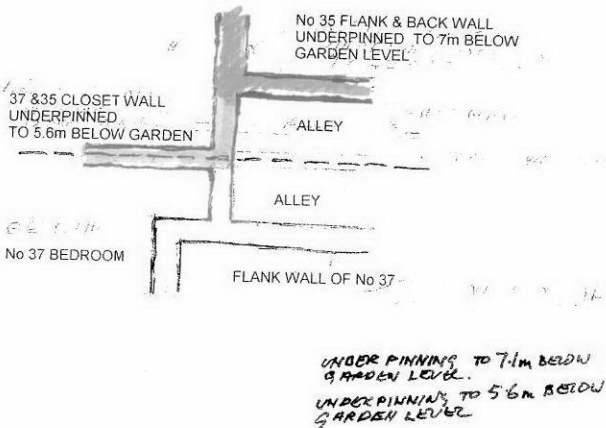
Project Ref. G1406	Project Title 35 SOUTH HILL PARK NW3	Indicative North
Sheet Ref. FIGURE 2	ALLEY WAY JUNCTION OF Nos 35 AND 37

PLAN AT JUNCTION
END OF ALLEY WAY
BETWEEN No 35 AND No 37 S.H.P

SCALE 1:50 APPROX

58. The extremely simplistic model proposed by Burland [3] might suffice for some parts of No 37 but would not be suitable for the much more complex situation shown by Figure 2 of the appendix. There, it is fairly certain that without a change of design, significant local damage at the junction of Nos 35 and 37 could result.

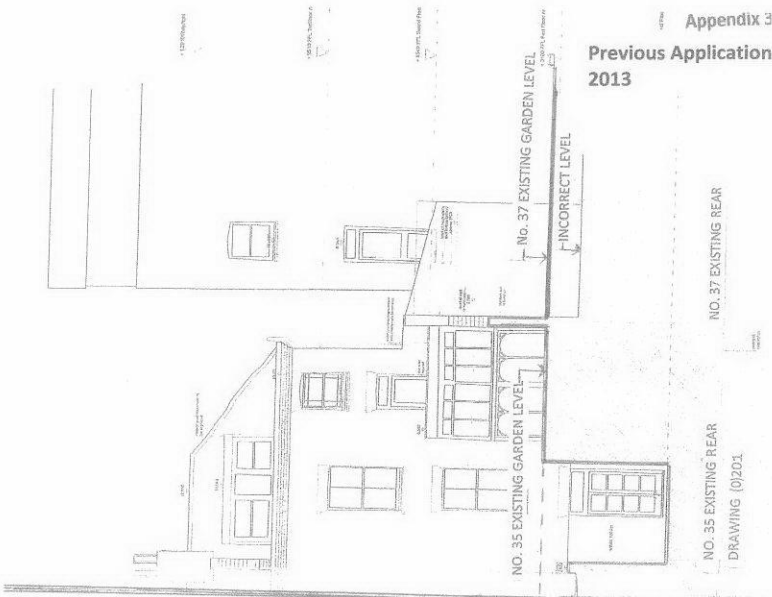
NO. 35 EXISTING REAR
DRAWING (0)201

NO. 37 EXISTING REAR

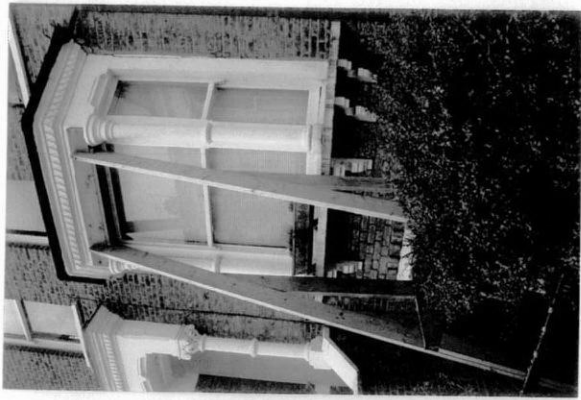
Cracks and damage internally and to the roof
adjoining a property with a new basement in
South Hill Park
MARCH 201

Photo 2 damage caused by basement development in SHP.
