2012/5825/P 8 Pilgrims Lane London NW3 1SL

I wish to submit an objection to this application and its latest changes under 4 headings:

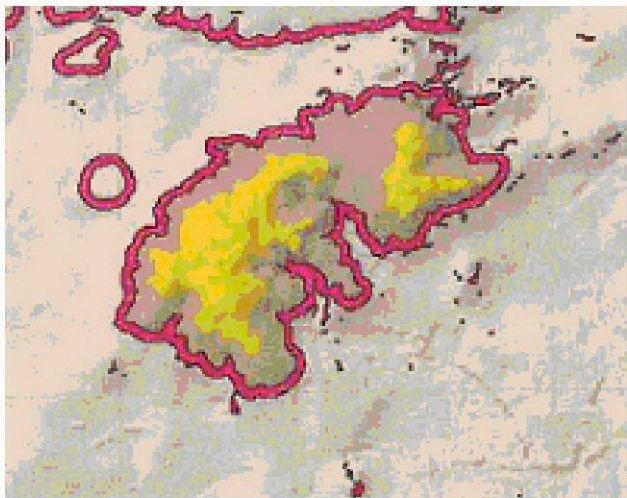
GIS Map of Area of potential landslide vulnerability, Based on causative landslide factors; geology, slope angle, hydrology and know landslide activity

I propose that a position exactly over on a geological boundary line involving Claygate Beds and in a previously (18th century) marshy area with several tributaries of the river Fleet, that drains into an area with contemporary significant and repeat flooding, is not where a basement should be dug unless complete ground mapping of the whole site has been performed to prevent nasty surprises. It should also, with all this risk, only be built if absolutely essential and worth the risk to neighbours and householders 'down-river'. With the flying freehold there is no wiggle room for foundation movement, but the BIA and subsequent ground investigation reports have not taken ground water into account in their calculations - particularly not water under pressure if this is found - only the effect of building stresses during low rainfall periods.
