## SIR JOHN SOANE'S MUSEUM OPENING UP THE SOANE: PH2

ENTRANCE & INNER

HALL (13RmG/7 & 8)

N & S WALLS AS PROP.

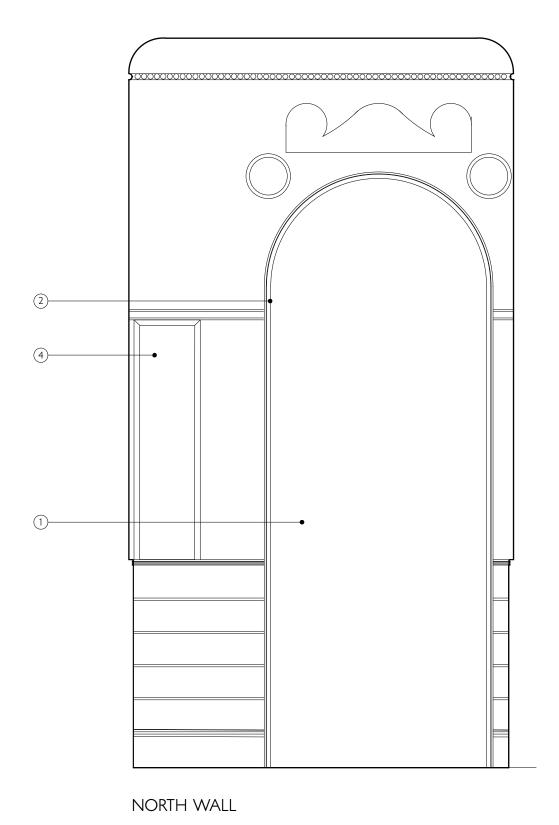
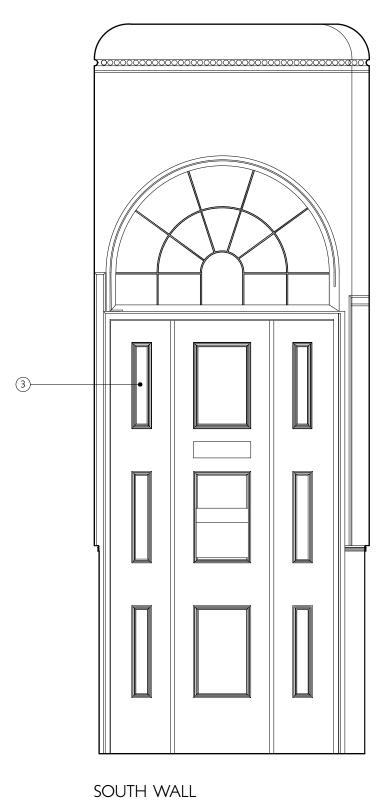
DRWG 506MP3/DD047A

- 1 Existing swing doors to be carefully dismantled and set aside for the removal of the stained glass sections. Fanlight above to be carefully removed, but not de-glazed.

- 2) Allow for piecing in the existing timber frame, where the fanlight has been removed, say  $25 \times 75 \times 45$ mm moulded h/w timber sections to match adjacent.

- (3) Contractor to carefully remove the fluted glass from the upper 3no. panels of the main front door and reinstate 3no. solid hardwood timber panels with moulding details (to match the existing). Inner and outer surface of door to be painted.

- 4) Subject to confirmation from the Architect (post Historic Paint Analysis findings) Contractor to carefully remove the existing internal window, being careful to retain the glass and frame intact, label and hand to the Museum for their Building Archive. Contactor to allow for making good the plastered surfaces. NB the moulding timber cill beneath the window is to be retained as existing.
