DETAILED COMMENTS ON APPLICATION NUMBER: 2012/5825/P part 1

**DETAILED REPORT OF OBJECTIONS TO PLANNING APPLICATION
2012/5825/P**

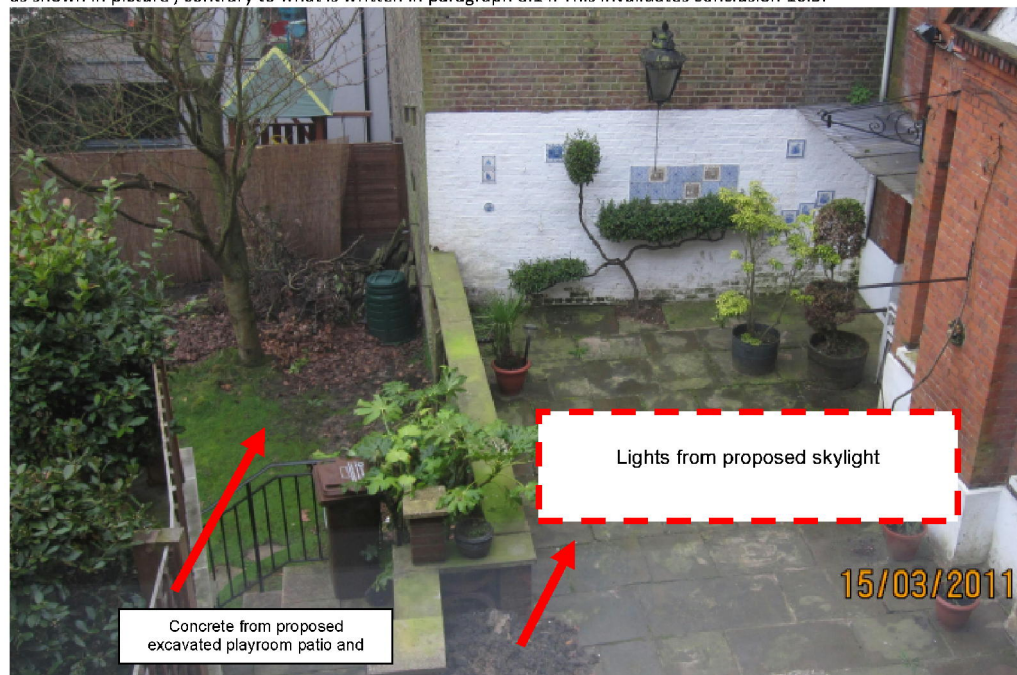
View from 10 Pilgrim's Lane

The light well will be clearly visible from the living room and the main bed room of 10 Pilgrim's Lane, as shown in picture, contrary to what is written in paragraph 8.14. This invalidates conclusion 16.5.

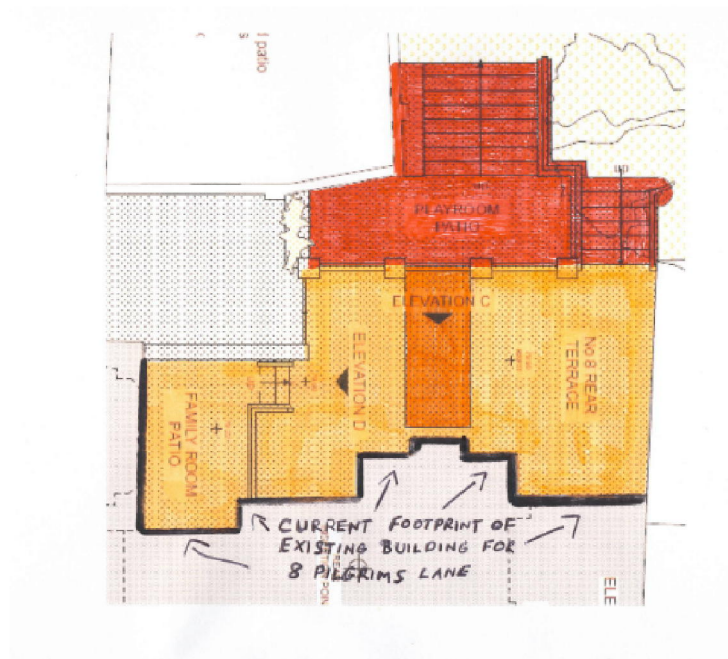
. Point 10.2 (“the proposed basement will not extend beyond the foot print of the house”) of the report is blatantly false. The proposed basement extension will extend substantially beyond the footprint of the existing house on several counts such as:

Basement extension beyond existing footprint (all coloured areas)

It is also inaccurate to write in paragraph 8.1: "the proposed basement construction lies mostly within the existing building". In reality the proposed basement lies substantially outside the existing building footprint.

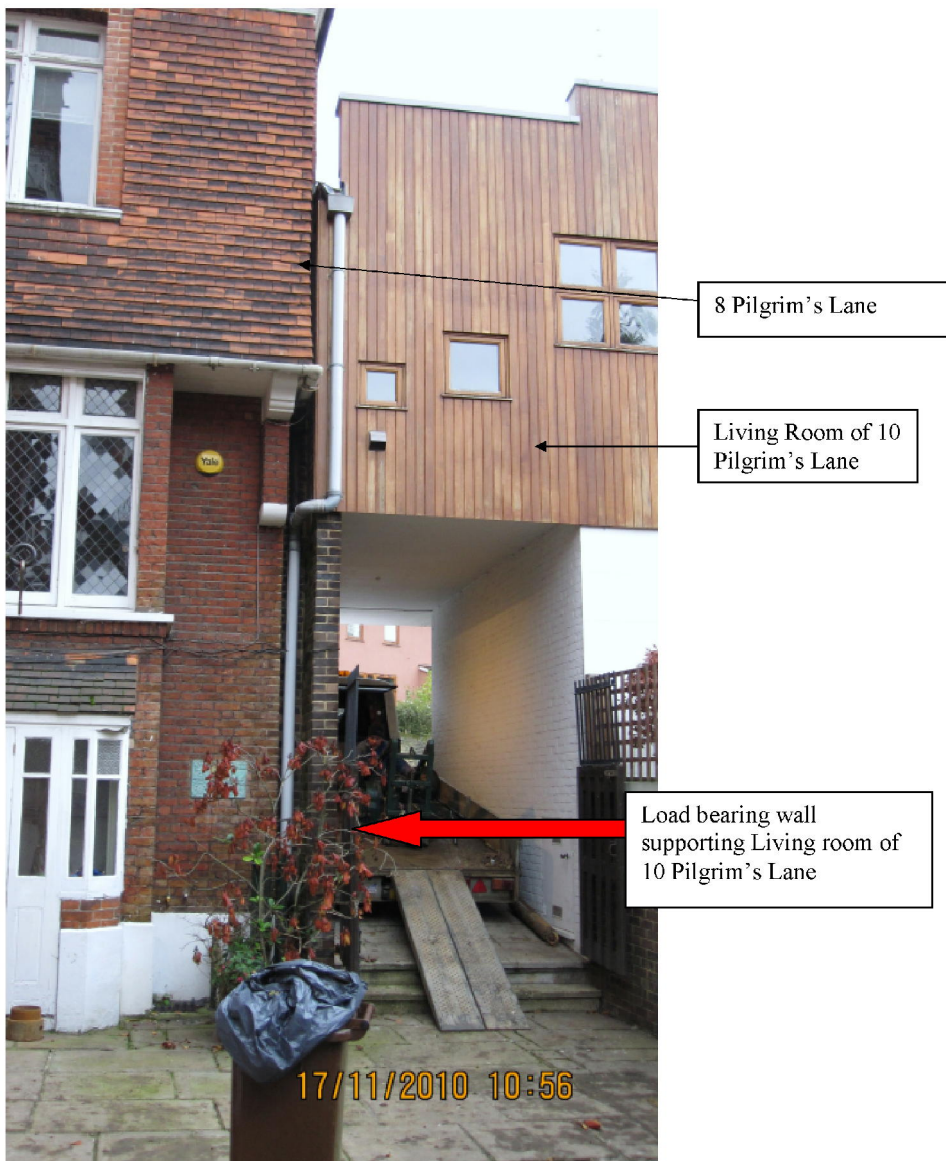
This, cumulated with all the numerous and serious shortcomings that I have highlighted in the above paragraphs as well as in the expert analysis of Michael H de Freitas, is especially of concern considering the vulnerable, challenging and precarious flying freehold structure on which my living room rests. (photo below). The margin of error inherent in this assessment is not proper and given

Flying Freehold of 10 Pilgrims Lane

No such attempts have been suggested or organized by the applicant. Actually, during the borehole testing period that took place in February- March of this year, the column that supports my living room was damaged and despite my complaints, no remedial work has been carried out to date.

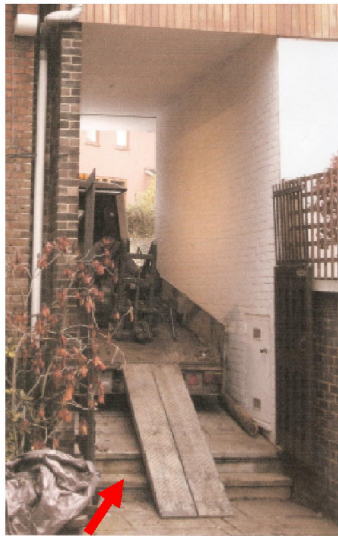
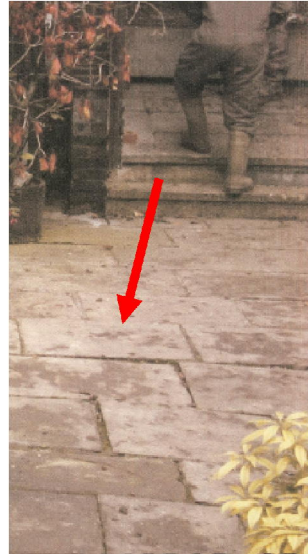
Ref 7 - existing stair case hindering direct access to patio where 2nd car parking space is proposed.
