6.0 Appendices

6.2 Environmental Survey Report [by GEA]

Project title	Phoenix Garden Site, Stacey Street, London, WC2H 8DG	Project ref	J11076
Report prepared by	Matthew Elcock BEng FGS		
Report checked by	Juliet Fuller BSc MSc FGS DIC		
Report checked and approved for issue by	Steve Branch BSc MSc CGeol FGS FRGS MEnvSc		
Issue No	Status	Date	Approved for Issue
1	Final	19 May 2011

This report describes the findings of a desk study carried out by Geotechnical and Environmental Associates Limited (GEA), on the instructions of Sustainable By Design, on behalf of The Phoenix Garden Committee, to determine the history of the site, potential for contamination and to provide preliminary information on foundation options with regard to the construction of a new two-storey building to provide a community space and warden facilities.

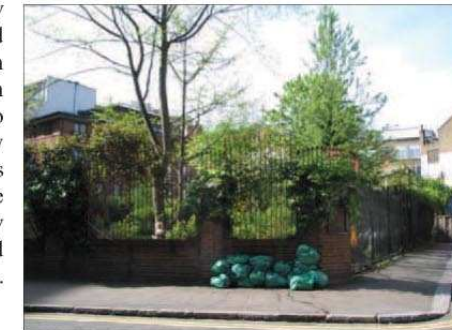
A walkover survey of the site was carried out on 10 April 2011 by a geotechnical engineer from GEA. The site comprises an essentially level, and irregularly shaped area, with approximate dimensions of 70 m north-south by 25 m east-west. Access is gained to the site via a gate along St Giles Passage and the boundaries are mainly formed by a 0.5 m high brick wall with metal railings above.

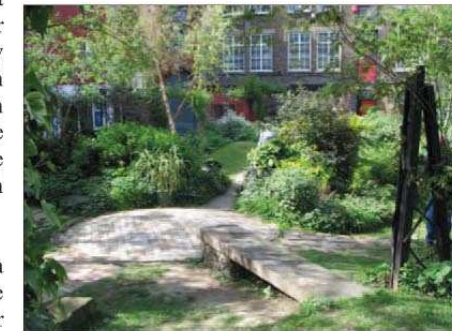
The garden comprises a soft landscaped area with a single-storey building in the southwestern corner which is mainly used for storage. It is very well kept with small isolated grass areas with numerous deciduous and coniferous trees up to 20 m in height separated by numerous paths. There are also a number of ponds in the garden, the largest of which occupies the northeastern corner of the site.
