Our Ref: 371293-L03 (00)

## **Re: Revised Ground Movement Analysis in Response to CGL's Comments of 22<sup>nd</sup> July 2014**

### **1. PROPOSED MODIFICATION TO KING POST WALL**

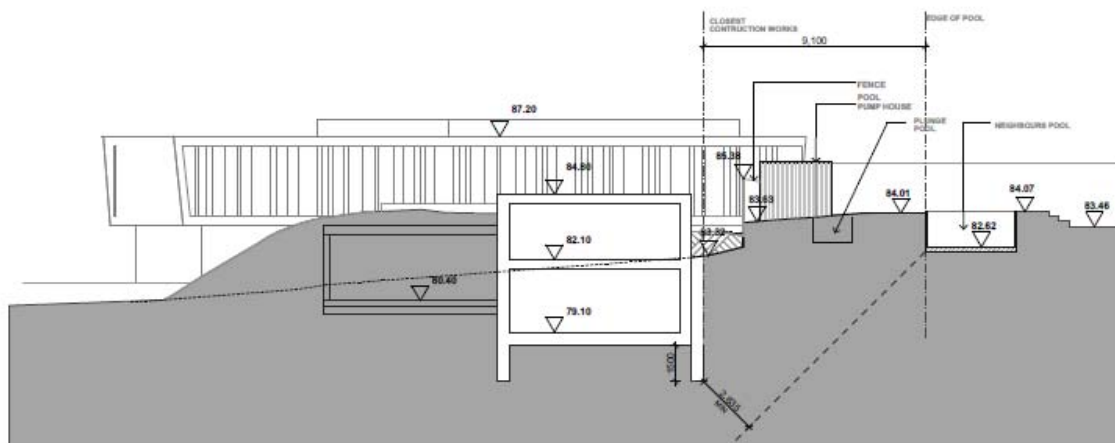
**Figure 1 Modified Cross-Section of the Site Produced by SHH Architects**

These analyses have considered the dimensions presented in Figure 1 recently provided by SHH Architects. These have also been summarised in Table 2.

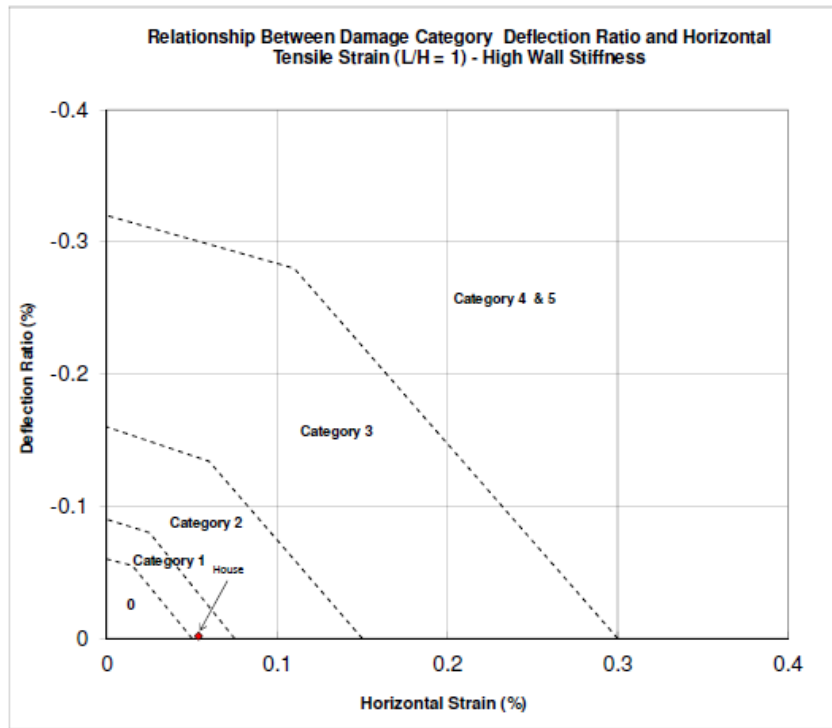
**Figure 2 Strain Rosette Showing Damage Categories for No.49 Fitzroy Park Assuming High Stiffness Retaining Wall**

The associated deflection ratio and horizontal strain for No.49 Fitzroy Park has been plotted on a strain rosette in the way recommended in CIRIA 580 in Figure 2. This show the estimated damage to fall into Category 1 as defined in CIRIA 580 (see Appendix E) assuming a stiff retaining wall system is adopted. It should be stressed however that the damage categories that have been superimposed relate to masonry structures with mortar and as such are only relevant to the house at 49 Fitzroy Park. Such structures are far more susceptible to damage than the other structures considered which appear to be constructed of reinforced concrete and timber.

Based on the High Stiffness wall assessment the damage to the house at No.49 Fitzroy Park falls into Damage Category 1 (very slight) as defined in CIRIA 580. Should the wall stiffness drop to moderate this will move to Damage Category 2 (slight). Both these damage categories are considered acceptable by Camden Planning Guidance document CPG4.

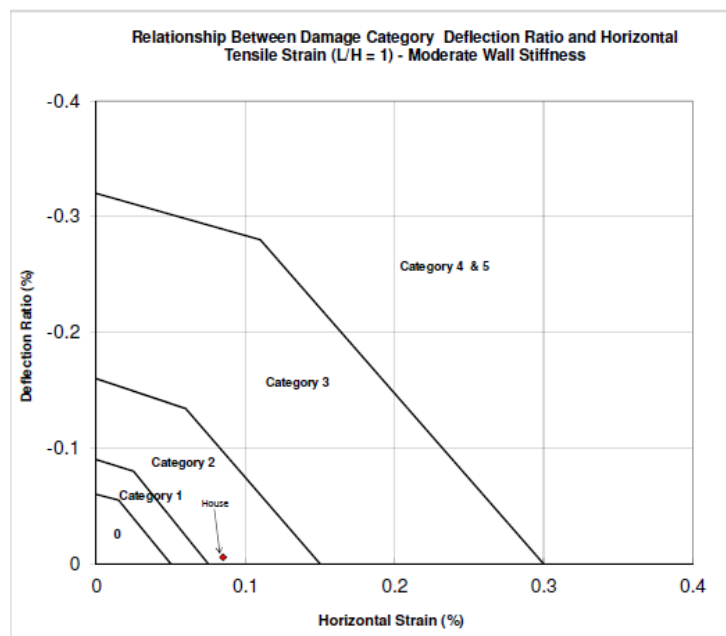
**Figure 3 Strain Rosette Showing Damage Categories for No.49 Fitzroy Park Assuming Moderate Stiffness Retaining Wall**

The associated deflection ratios and horizontal strains for the house at 49 Fitzroy Park have been plotted on a strain rosette in the way recommended in CIRIA 580 in Figure 3. This shows the estimated damage to fall into Category 2 as defined in CIRIA 580 (see Appendix E) assuming a moderately stiff retaining wall system is adopted. It should be stressed however that the damage categories that have been superimposed relate to masonry structures with mortar and as such are only relevant to the house at 49 Fitzroy Park. Such structures are far more susceptible to damage than the other structures considered which appear to be constructed of reinforced concrete and timber.
