Please see below comments in response to earlier comments by First Steps & Michael Eldred relating to a Basement Impact assessment report 13.032.3 prepared by Ecologia. The signatories to the report have responded thus:

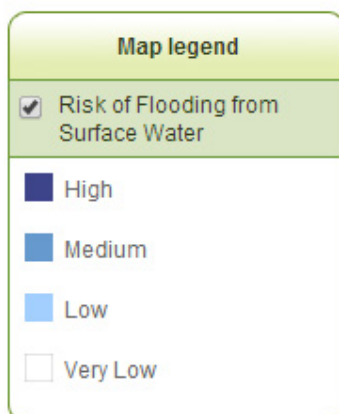
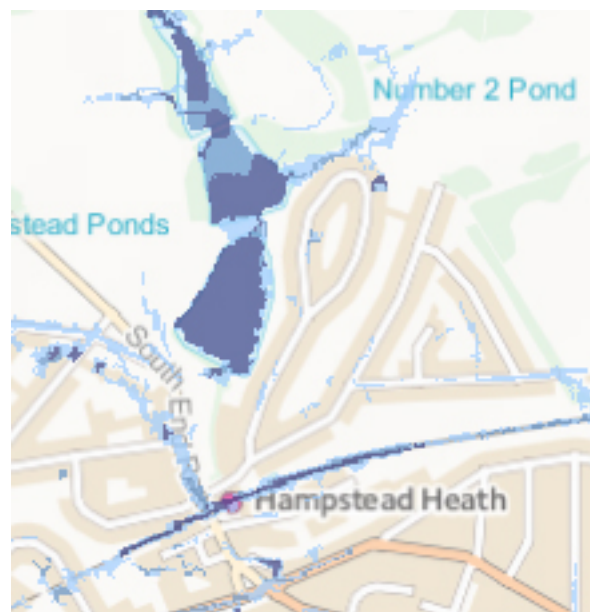
An enlarged extract of the map is presented below for the SHP area which shows no flooding (or to be precise 'Very Low' risk of flooding) in the rear gardens of any of the properties in the part of SHP of current interest.

The Environment Agency published a new map of surface water flood modelling on its website earlier this year, formally called 'Risk of Flooding from Surface Water'. From work on other projects this map has generally been found to be the most detailed and plausible model currently available.
