No. 1 Oak Hill Way. Hampstead . NW3 7LR

Tree Survey and Arboricultural Method Statement. December 2014

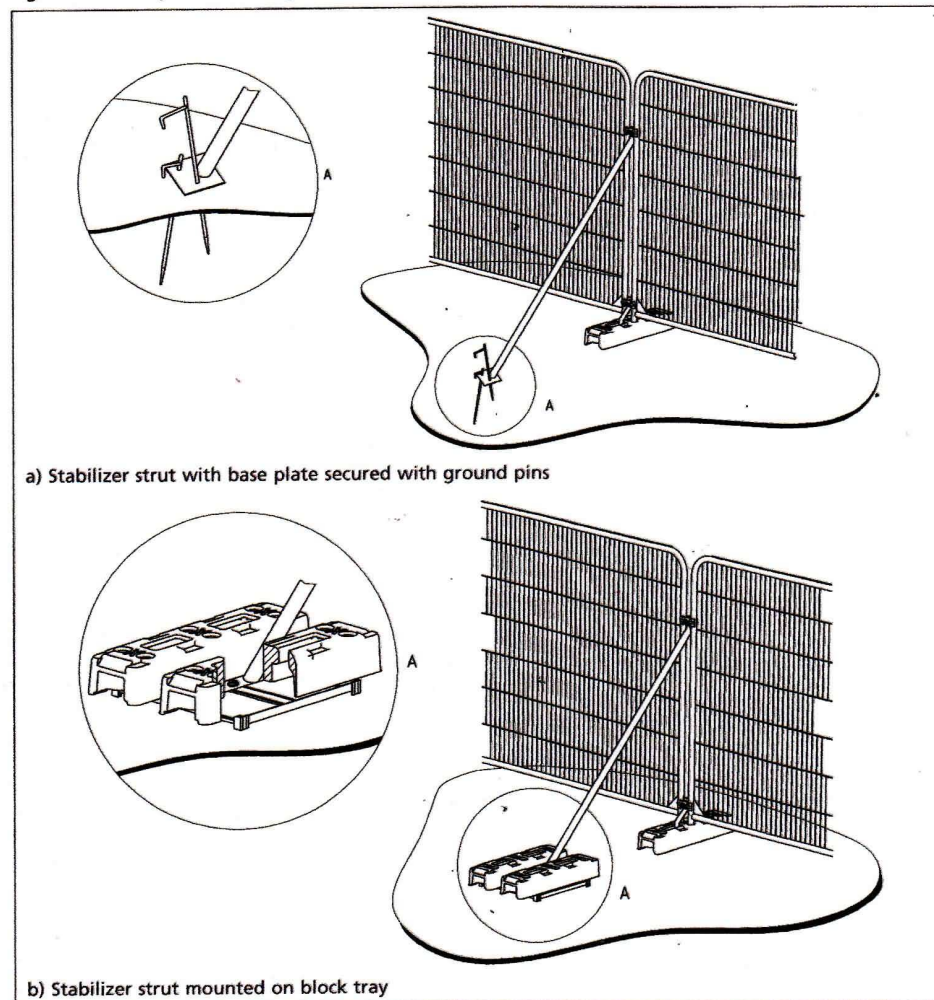
Figure 3 Examples of above-ground stabilizing systems

Tree Protection Fences.

The specification for tree protection fencing is described in fig 3 of British Standard 5837 2012 "Trees in relation to design, demolition and construction-recommendations" (BS)
