GEOTECHNICAL CONSULTING GROUP

BUILDING DESIGN PARTNERSHIP

PEARS BUILDING

NOTE ON MOVEMENTS ASSOCIATED WITH EXCAVATION

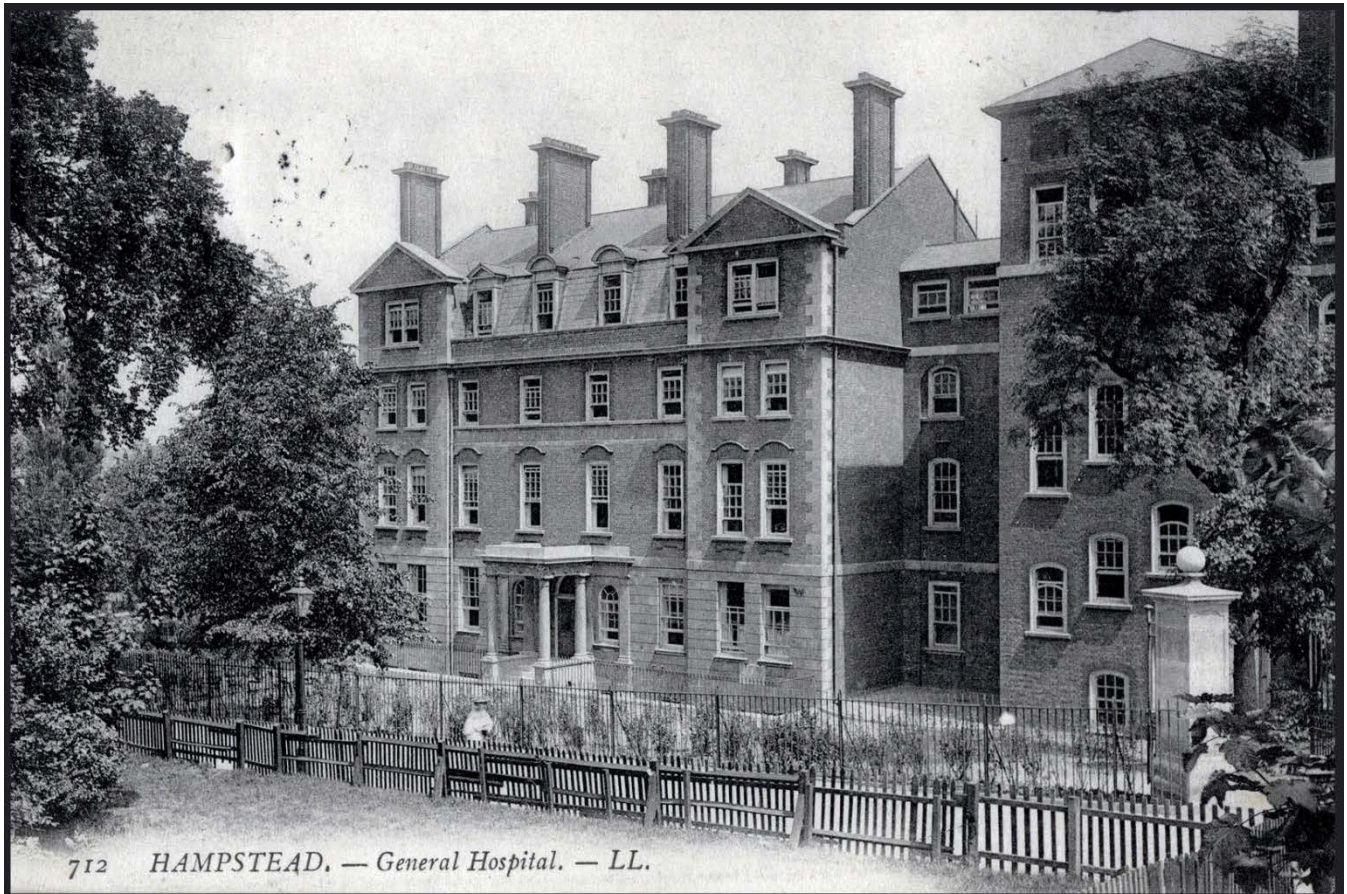
Historical image of Hampstead General Hospital – note the basement windows and expected depth of the foundations.

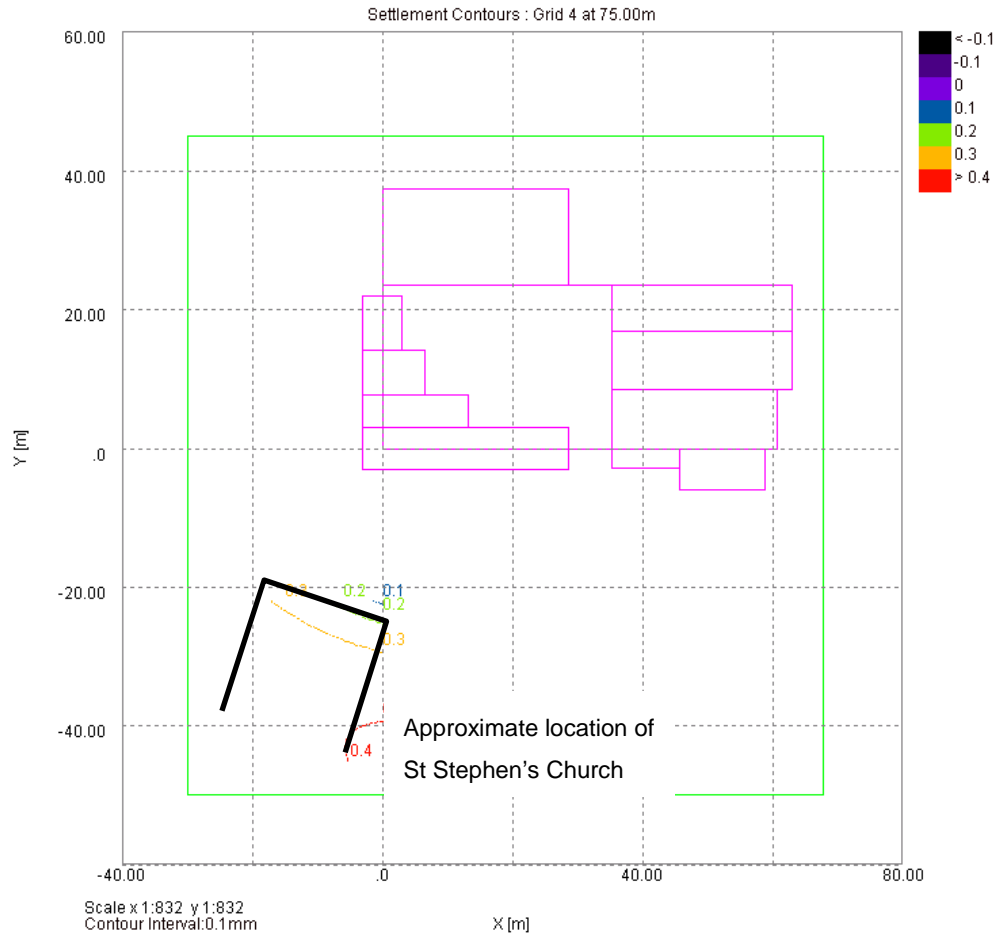
Building Design Partnership

Pears Building

Figures 1 and 2 show contours of short term movement at the end of excavation. These are both for the same analysis, but Figure 1 shows contours of movement in the immediate vicinity of the site, while Figure 2 shows movements in the vicinity of St Stephens Church.

Short term movements as a result of unloading due to excavation as they might apply to St Stephen's Church are shown in Figure 2. These indicate that movements should not exceed ½mm. In addition, it should be noted that elastic analyses such as those carried out here tend to exaggerate the magnitude of movements outside the immediate area of loading or unloading, so the actual movements should be even less than this.
