Date: 06.02.2015
 Your Ref:
 Our Ref: L-STL2926D-SD-002

Re: 95 Hillway, Highgate, London

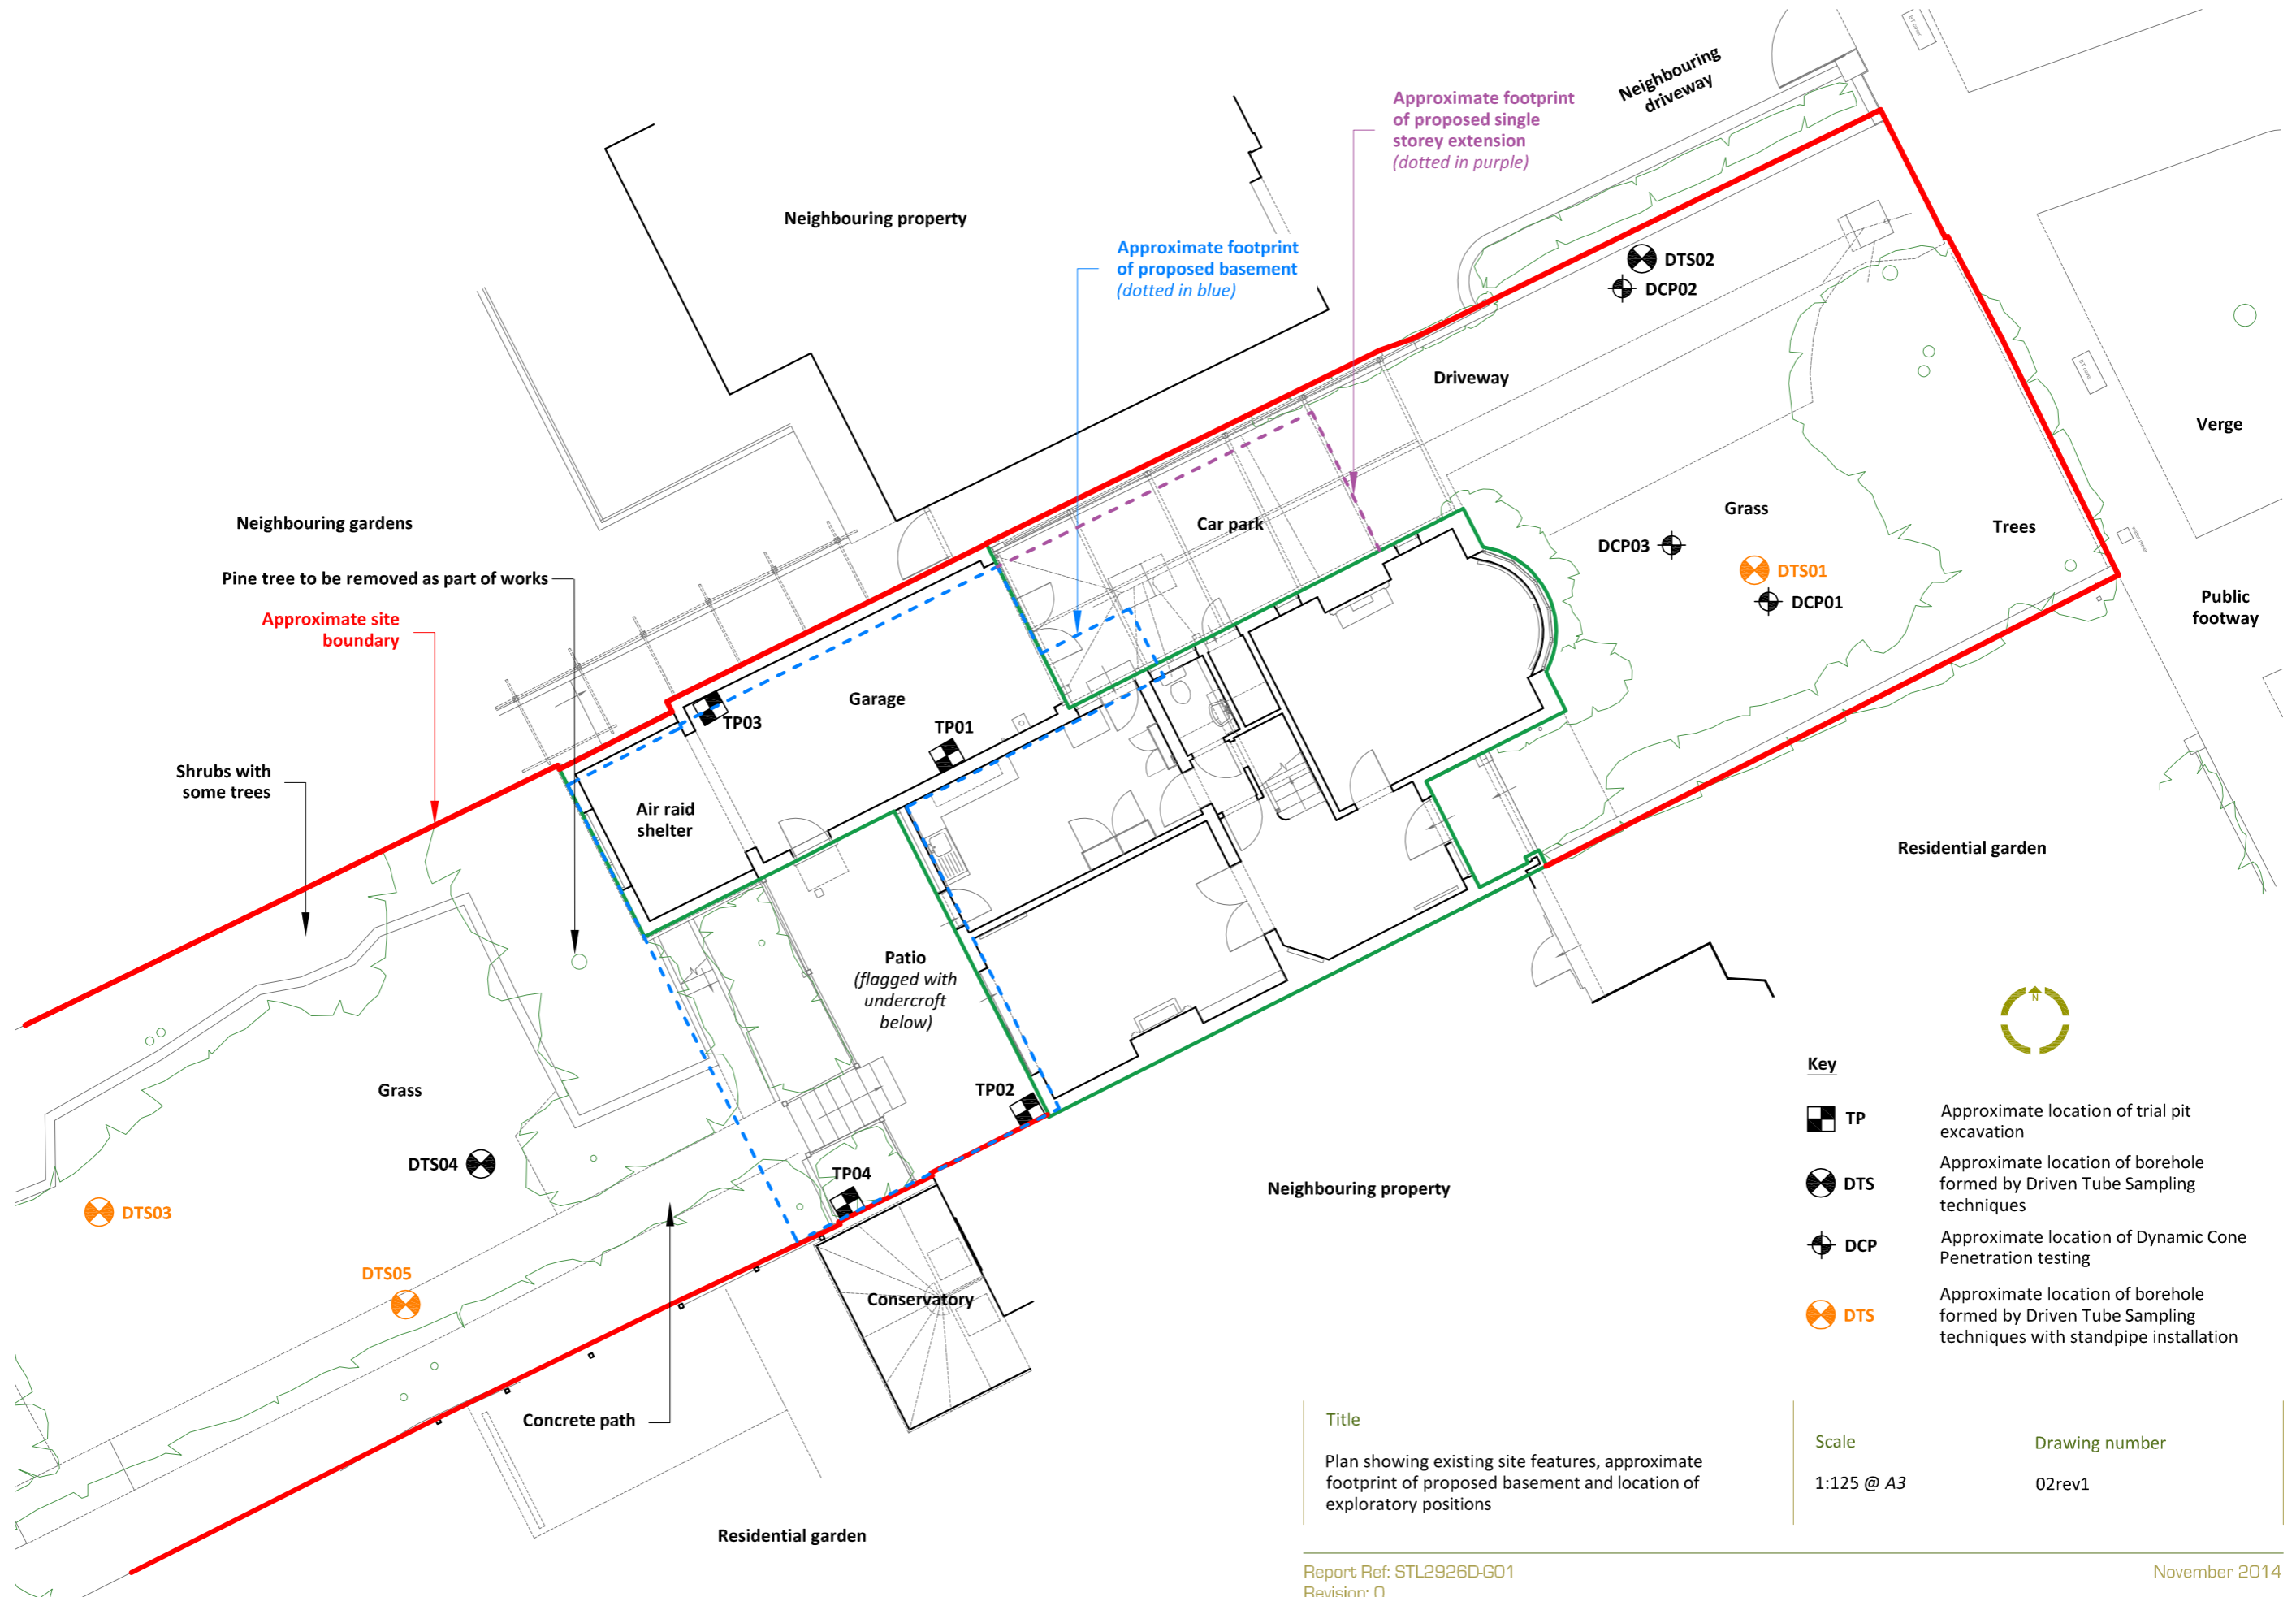
Title	Scale	Drawing number
Plan showing existing site features, approximate footprint of proposed basement and location of exploratory positions	1:125 @ A3	02rev1

Drawing 02 rev 1 - Topographical survey including location of groundwater monitoring positions.

We understand the lane to the rear of 95 Hillway, running from Holly Lodge Gardens to Robin Grove is a former carriageway cutting which is subject to surface water flow with a spring being present within the lane. The lane is approximately 2m below the rear garden level of 95 Hillway. Ground levels across the footprint of 95 Hillway vary by approximately 2.73m from front to back (ref attached topographical survey).

Ground water monitoring has been undertaken at the site and the table below summarises the groundwater levels (to mAOD) in comparison to the proposed formation depth of the new basement.
