Job Name
**The Bedford Estates
24-25 Bloomsbury Square**

Drawing Title
**Proposed
Basement Floor Plan**

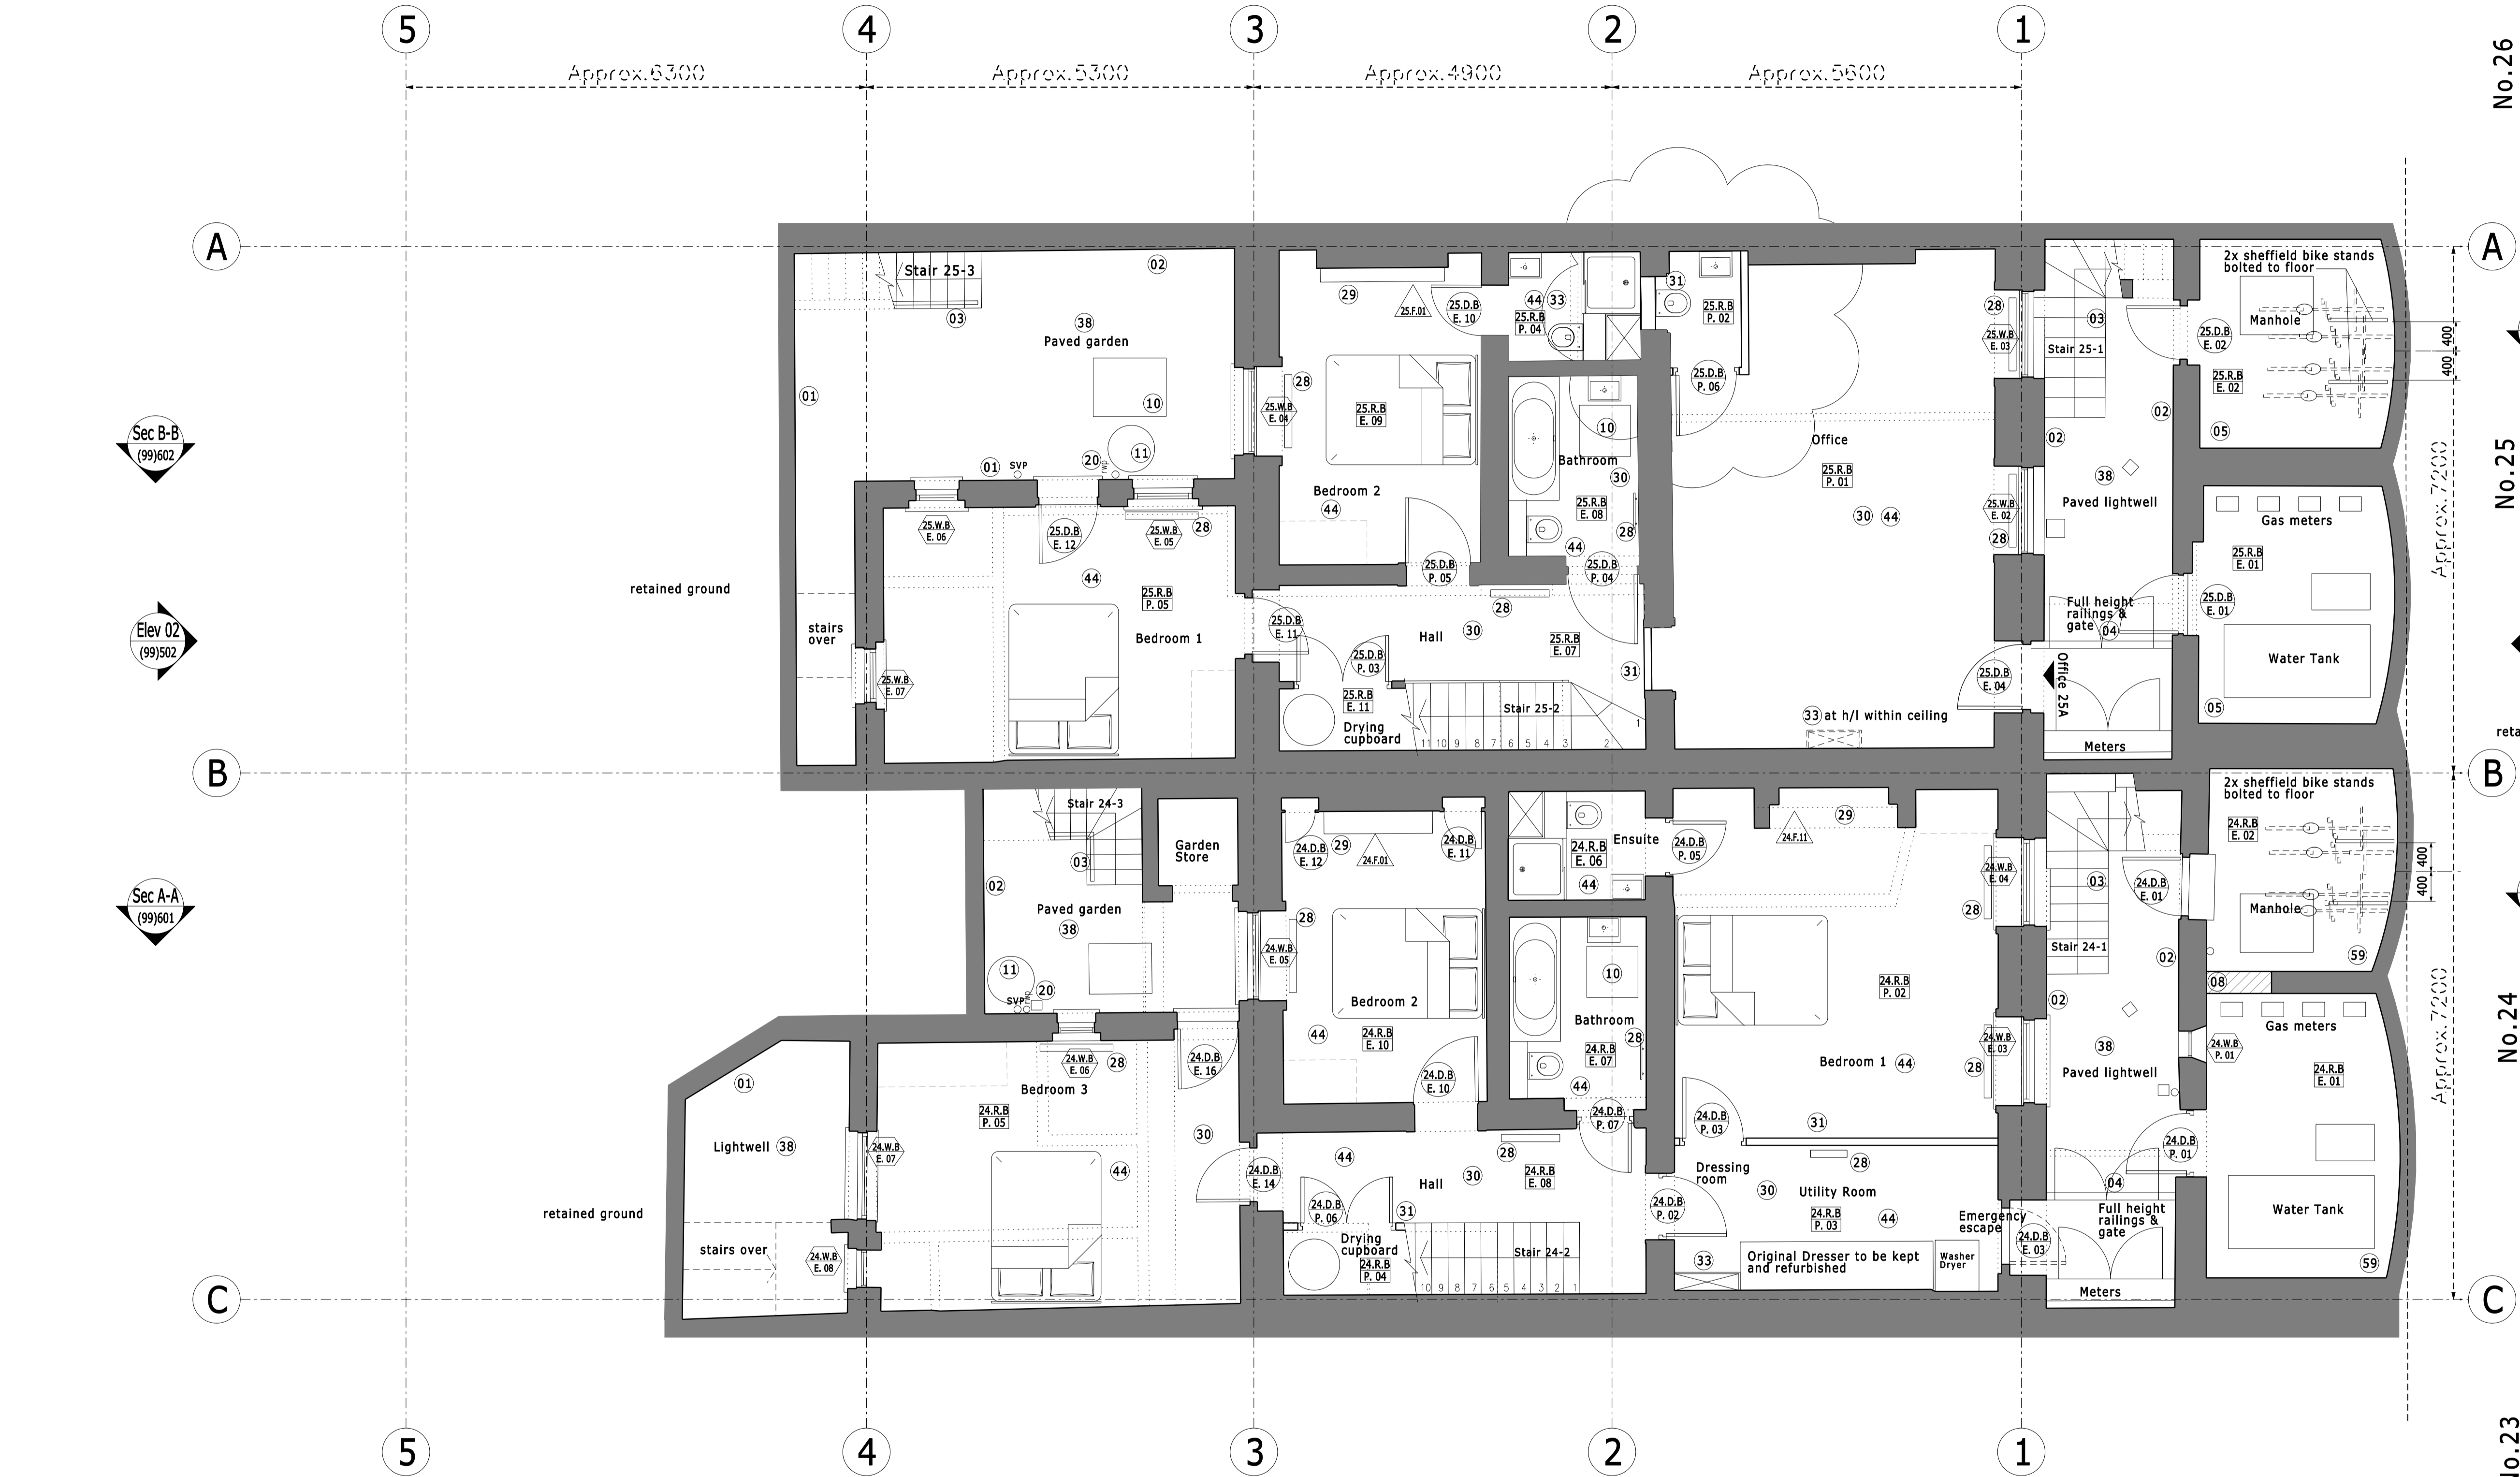
PROPOSED WORKS
REFER TO (19) SERIES DRAWINGS FOR EXTENT OF DEMOLITION WORKS, REFER TO (99)1000 FOR METHOD STATEMENT.
NOTE: All existing rooms to be decorated, any retained existing doors to be refurbished.

01. Repair existing brickwork and pointing as necessary.
02. Repair and clean existing render and decorative stucco (substrate to be repaired as necessary). Repaint as existing.

05. Existing vaults to be repaired as necessary and a cavity drain membrane installed to waterproof internal walls & floor.
06. New Cavity Wall with reclaimed bricks to match as close as possible existing.

07. Selected Cast Stone coping.
08. Existing opening bricked up, bricks to match as close as possible existing.
09. Repair & refurbish existing balcony, repaint.

10. New manhole.
11. Water butt.
12. New Rooflight & Access hatch.
13. Existing lead roof to be repaired and refurbished as necessary.
14. New mansafe access system.

22. Refurbish existing stair and balustrade with new decoration, provide new carpet and of runner and fittings.
23. Refurbish existing hardwood doors and upgrade to fire-rated doors where required, replace or refurbish existing door hardware where required.

24. Install new fire rated paneled door and door set to match existing doors.
25. Take up existing floorboards for new services and leveling works to floor where required. Replace back with existing or new floorboards where required. Provide new selected carpet finish over.

26. Retain & refurbish existing stone floor.
27. Timber panelling to replace obscured Georgian wired glass.
28. New radiators/ towel rails.
29. Make good fireplace.

42. Repair missing railing and paint black to match existing.
43. New coir barrier matting.
44. New basement slab.
45. Replace existing entry phone system with new.

46. New entry phone system.
47. Replace existing letter box with new.
48. New letter box.
49. New remotely operated window.
50. Apply selected obscure film.

51. Gravel.
52. Area to reuse stone slabs from basement level.
53. New brick wall and foundation to support vault above, bricks to match as close as possible existing.

59. Sprayed concrete structural repair to vault.
