**Penny Davis
29 Briardale Gardens
London NW3 7PN**

PLANNING APPLICATION REF 2014/5117/P

Project Ref. G1422	Project Title. 31 BRIARDALE GARDENS NW3 7PN	Indicative North N ↑
Sheet Ref. Figure 1	GROUND SURFACE CONTOURS RELATIVE TO O.S. DATUM

**Geology and ground conditions in the vicinity of
31 Briardale Gardens, London, NW3 7PN**

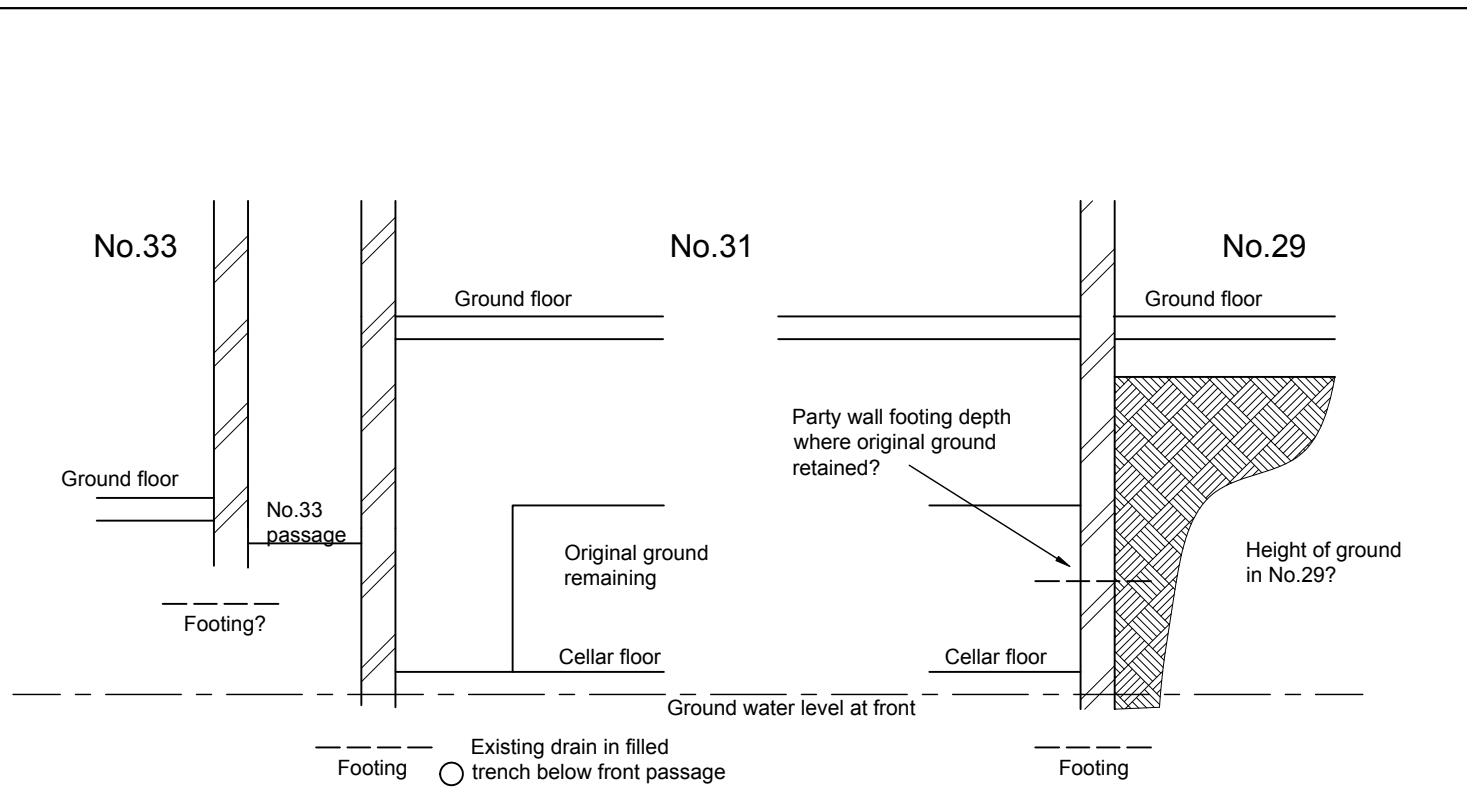
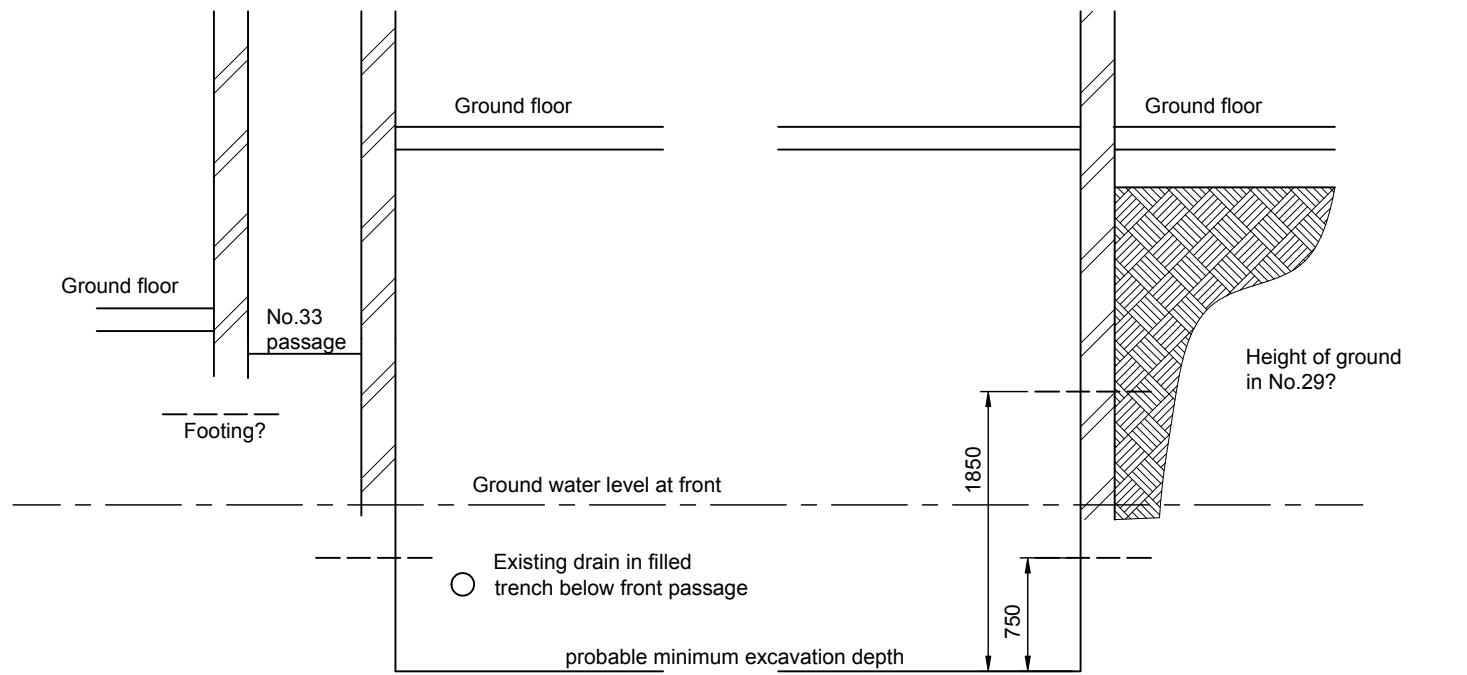
EXISTING
Approx on line of Architect Section B - B

PROPOSED
Approx on line of Architect Section B - B

Information for sketch measured from application drawings using Adobe software and otherwise from application reports.

18. Figure 2 gives an approximate sketch section of the existing and proposed situations at the 29/31 and 31/33 boundaries.

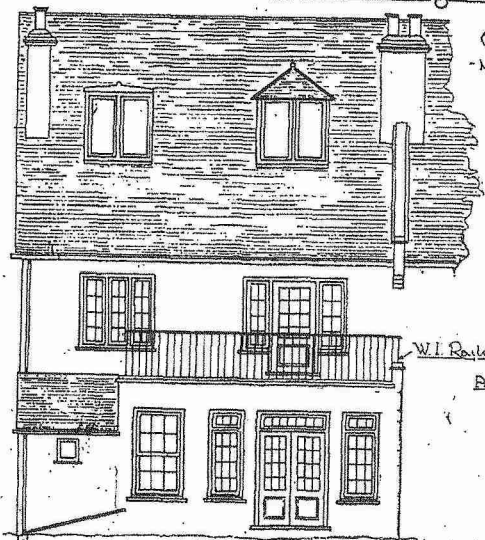
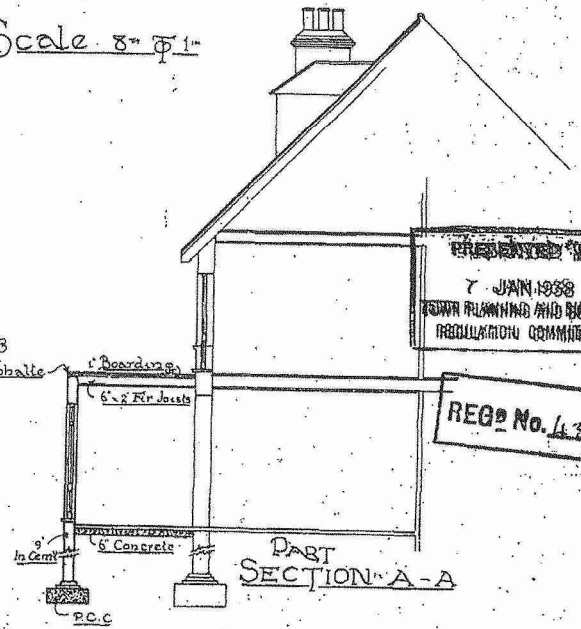
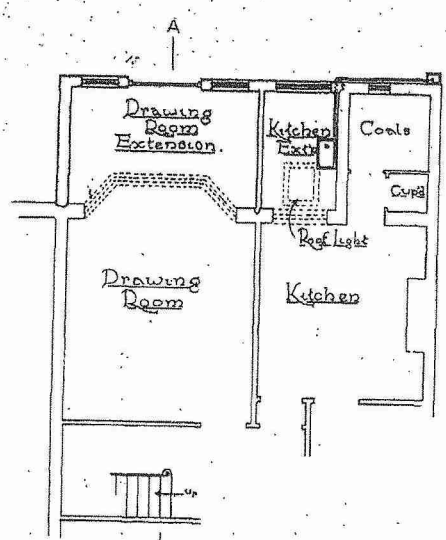
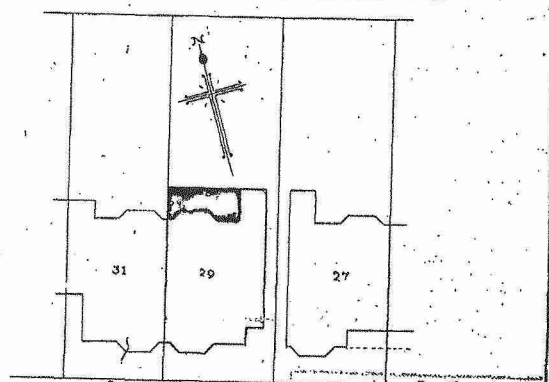
Project Ref. G1422	Project Title. 31 BRIARDALE GARDENS NW3 7PN	Indicative North
Sheet Ref. Figure 5	29 BRIARDALE GARDENS 1937 REAR EXTENSION

29, BRIARDALE GARDENS NW3
PROPOSED ADDITION AT REAR OF PROPERTY

Extension of Drawing Room & Kitchen approx. 9ft into garden to line with existing Cool House excrecence

NORTH ELEVATION

PART SECTION A-A

GROUND FL. PLAN

- (xviii). A planning drawing (Figure5) prepared in 1937 for the rear extension of No 29 by builders based in Finchley Road suggests that they might have expected the foundation to be deeper than normal shallow strip footings.

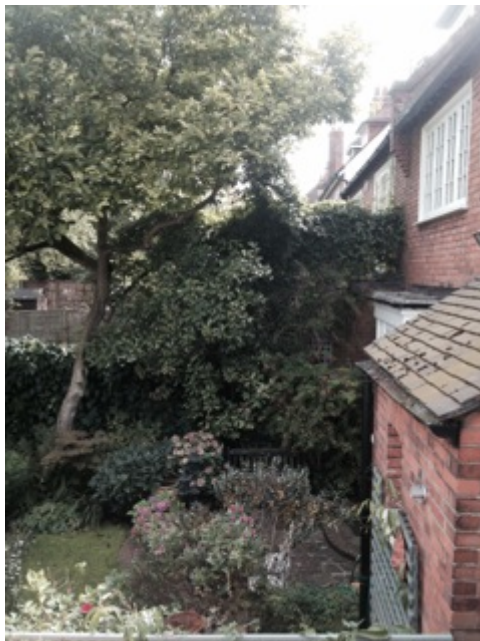
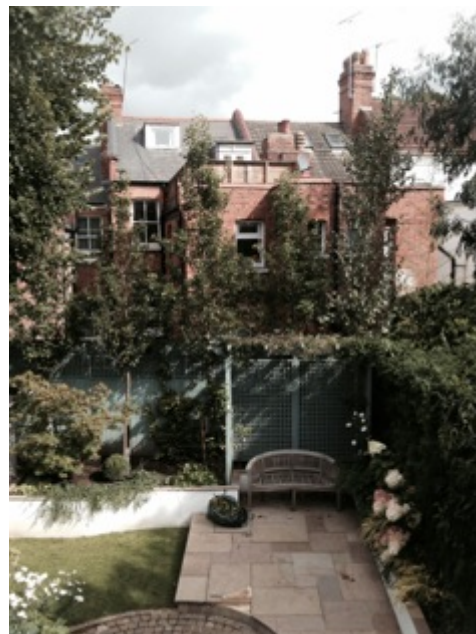
Photographs 2 & 3: T1 within the rear garden of 31 & Newly Planted trees to the Rear of 33.

3.2.1 There is 1 category B (Moderate Quality) mature magnolia on site (T1), with a category C early mature plum within the neighbouring garden (No. 29) situated to the north of T1. There is also a relatively young Monterey cypress within the rear garden of No.29, and recently planted birch trees within that of No.33.

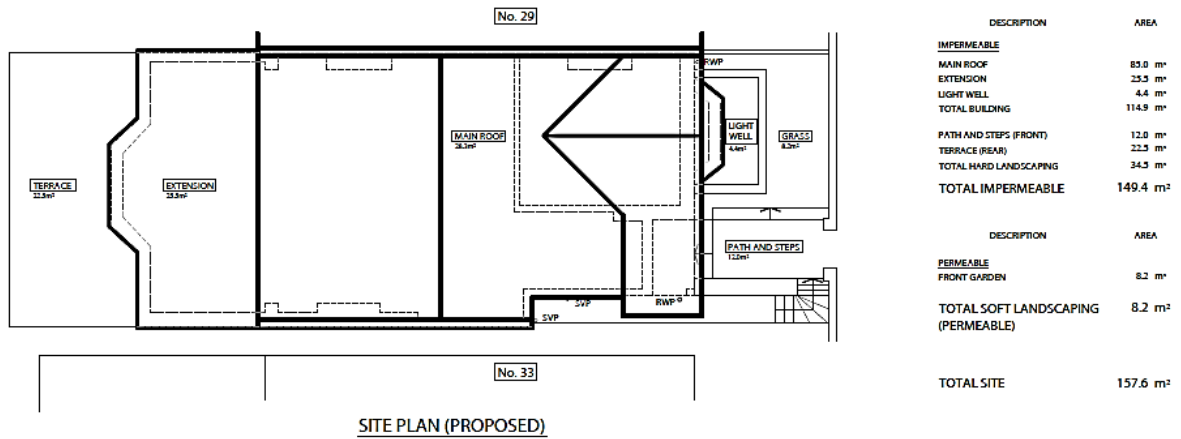
Extract 3: Proposed Impermeable Terrace (Source: Mann Williams Consulting Civil and Structural Engineers subsequent amended assessment)

- 5.1.2 This inextricably links the basement to the extension proposals, along with the proposed breaking out and filling in of the existing steps down to the basement.
- 5.1.3 The additional information provided by ATS does not address the concerns raised over the protection of this tree. In summary, the main omissions are as follows:
- The impact of the foundations noted for the proposed extension, which highlighted as being stepped down to basement level; this excavation would occur within 1m of the stem of the Magnolia Tree T1 (see Extracts 1 & 2 above).
 - The impact of the proposed underpinning of the party wall within the RPA of T1, which has not been addressed in the revised arboricultural impact assessment.
 - The omission of mitigation for the proposed terracing within the RPA of T1, which should be no-dig and permeable (see Extract 3 below).

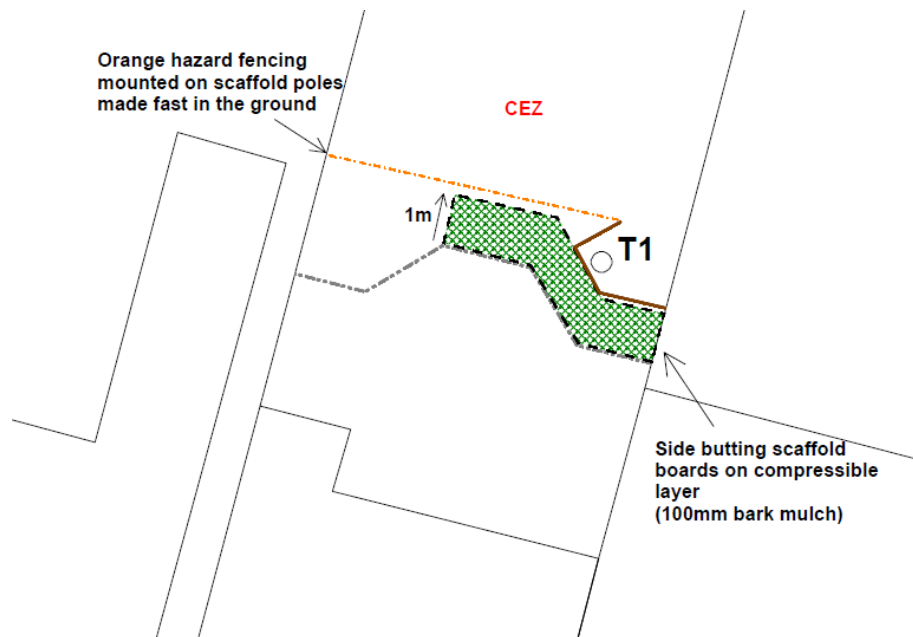
Extract 6: Tree Protection Plan from Revised ATS Assessment (RPA and Canopy required)

- The minimal information within the AMS regarding construction techniques to be used for the extension and relevant tree protection measures.
- The absence of information regarding the location of on-site storage, which will be required in accordance with the Construction Management Plan.
- The omission of clear identification of the RPA and canopy on the Tree Protection Plan (see Extract 6 below). The revised AMS has provided slightly better tree protection; however, it is still insufficient in that it does not show the canopy overhang or the RPA. These must be shown in order to get a full understanding of the protection necessary. If the tree is not rooting under the patio as suggested by the current trial pits, a modified RPA is required and must be fully protected.

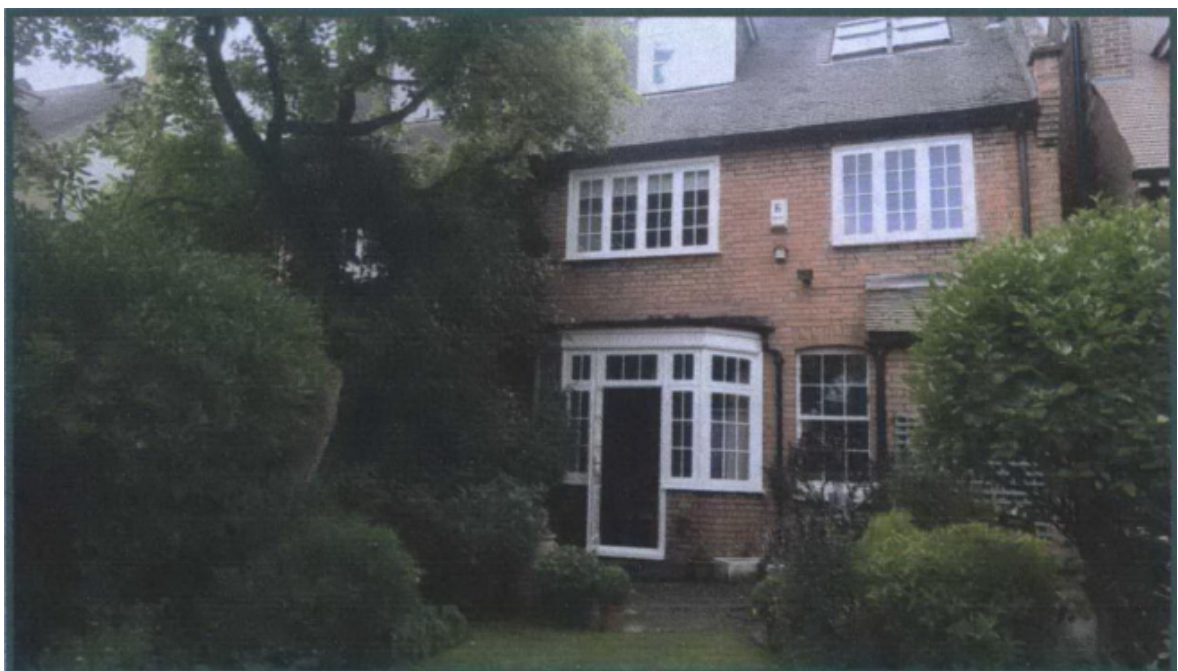
Photograph 4: Existing canopy encroachment from T1 (Source: ATS Report)

- The absence of information and mitigation required to address the likely secondary impacts of leaf litter and organic deposition on the sky-lights/glass roof and guttering, likely to result from the over-hanging canopy. This is a significant omission that may lead to pressure to crown reduce/fell this tree in the future. There is no mitigation for leaf litter/organic deposition either, which could prove problematic with the proposed design. Photograph 4 below illustrates this point.
