Ref: 15406/R1

March 2015

Basement Impact Assessment

55 Ornan Road, London, NW3 4QD

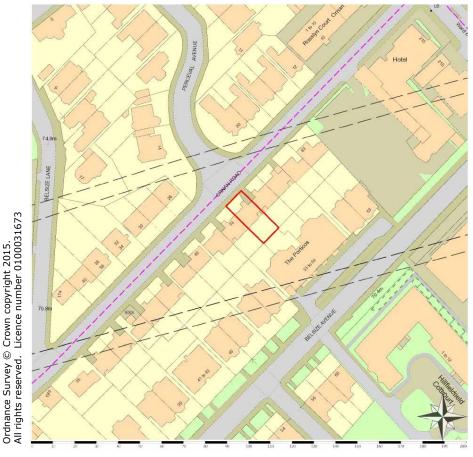
Figure 1: Extract from 1:1,250 OS map (not to scale) with the site outlined in red.

2.1 No.55 Ornan Road is a two-storey terraced house (see cover photo) in the London Borough of Camden (LBC). Ornan Road is located between Belsize Lane to the northwest, and Belsize Avenue to the south-east, and can be accessed at its north-eastern end where it joins Haverstock Hill (A502), at its south-western end where it joins Belsize Lane, and opposite the property where it joins Perceval Avenue. No.55 is situated on the south-eastern side of Ornan Road, between No's 53 & 57, and the plot is bounded to the south-east by the rear garden to the Porticos, as shown in Figure 1 below and Photo 1 in Appendix A.

- 2.3 As shown in Figure 1, two tunnels which form part of Network Rail's Midland Main Line pass just to the north and south of the site. The historic OS map dated 1871 shows that the tunnel which passes just south of the site had already been constructed prior to this date, whereas the northern tunnel does not appear until the 1953 OS map. It should be noted however that many of the maps between 1871 and 1953 do not show either of the tunnels. Also shown on the 1871 OS map is a well, located just to the west of the plot of No.55.

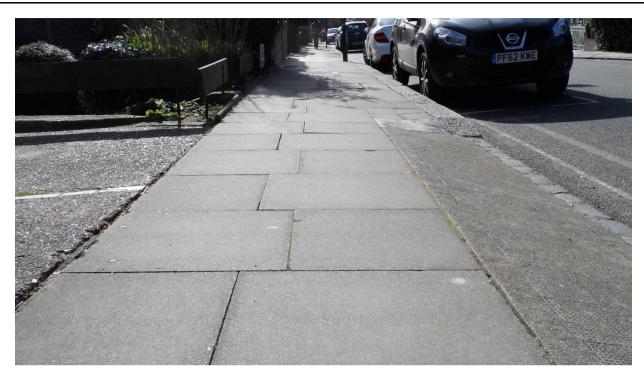
Photo 3: The footway falls gently towards the carriageway in front of the property, and falls more steeply towards the carriageway in front of the driveway.

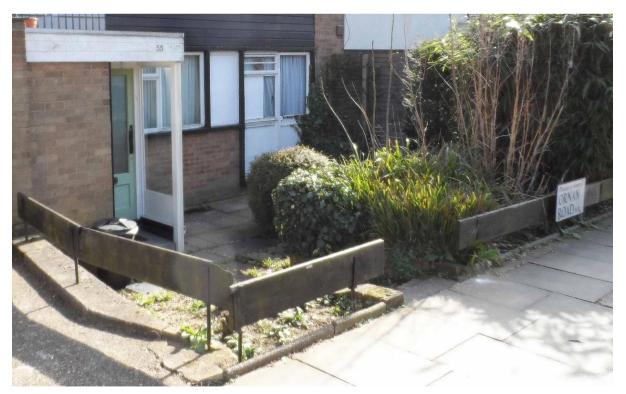
Photo 4: The front garden to No.55 sits below the height of the footway and adjacent driveway. It is bounded by a low curb where it meets the footway, except at its access point.

- 2.4 Externally, there is a front garden which is mostly paved, with the exception of perimeter and inset flower beds, and is set below the height of both the driveway, which leads to the integral garage, and the public footway. The drive is supported by a low brick retaining wall and is open to No.57's adjoining driveway. The raised flower bed alongside the footway is also supported by a brick retaining wall and is separated from the footway by upstanding low edgings except at the access steps (Photos 4 & 5). The front garden is bounded to the south-west by a wooden fence. The rear garden is mostly laid to lawn, with perimeter flower beds and a small patio area (Photo 6).

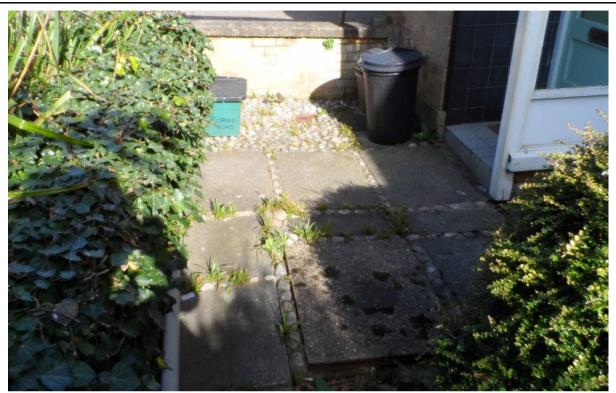
Photo 5: Concrete manhole cover within the front garden, indicating the possible position of a lateral sewer. Note gully in pebbled area near boundary.

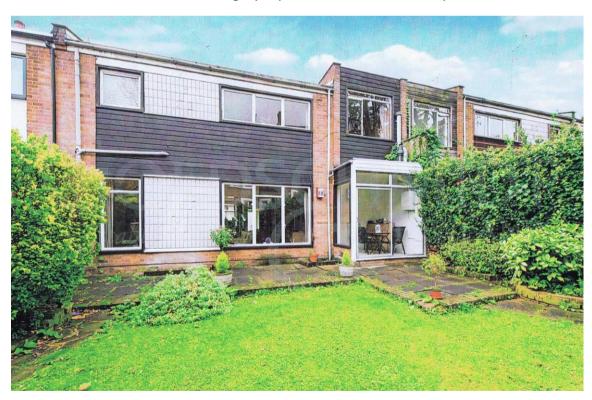
Photo 6: The rear garden to No.55 is mostly laid to lawn with a small patio area adjacent to the house. Like the first floor extension above the garage, the rear conservatory is a latter addition.
