Heal's Phase 2B Refurbishment

WINDOW TYPE SCHEDULE

jmarchitects

January 2015

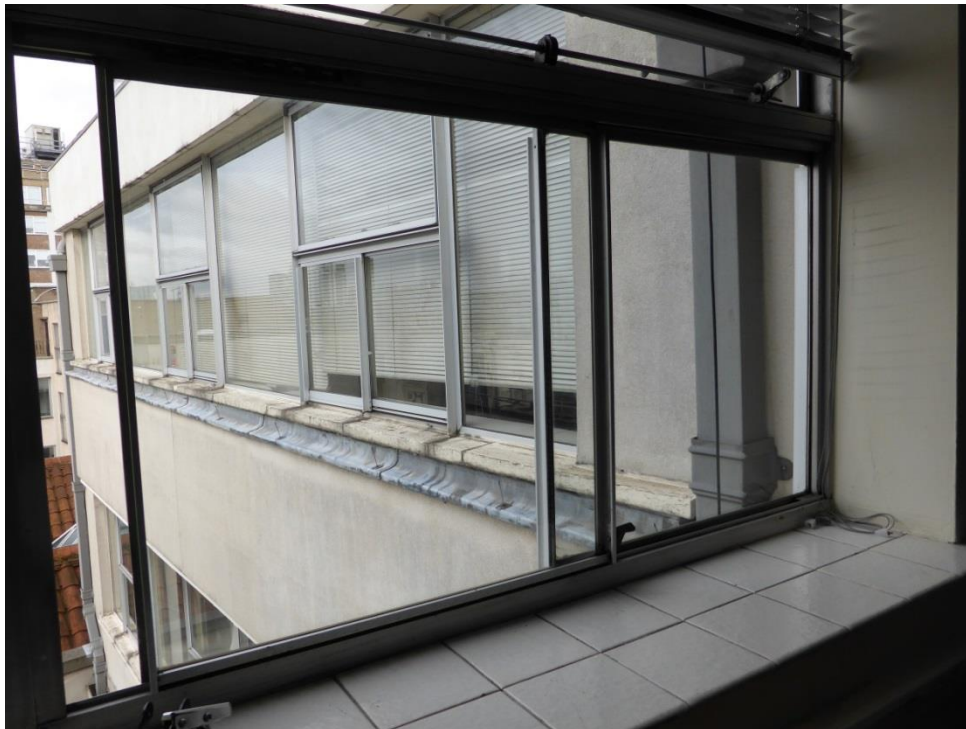
Replacement Window Types 8, 9, 10, 13, 14, 15, 16 & 17

Location: 5th & 6th floor offices

Material: Aluminium

Opening type: Horizontal sliding sashes with fixed lights

Scope: New double glazed white painted steel window.

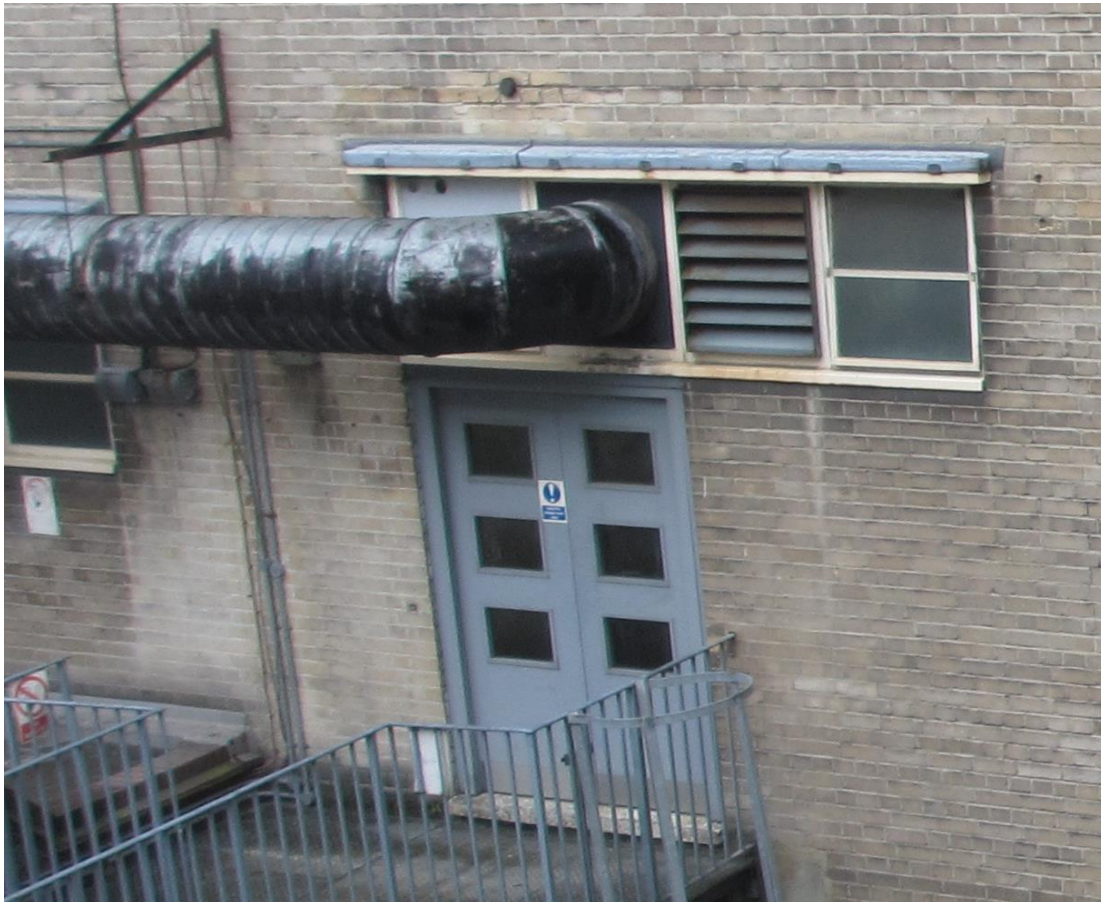
Replacement Window Types 2 & 5

Location: 3rd & 4th floor circulation

Material: Steel

Opening type: Pivot with fixed lights

Scope: New double glazed white painted steel window. Pattern to match existing and incorporating new air outlet louvre grille.

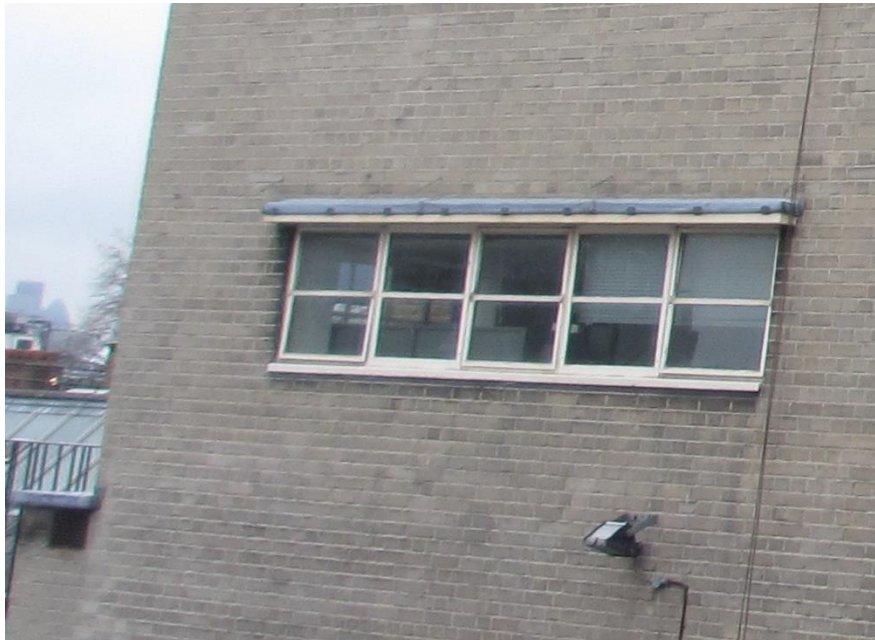
Replacement Window Types 1, 3 & 4

Location: 3rd & 4th floor offices and circulation

Material: Steel

Opening type: Pivot with fixed lights and louvres.

Scope: New double glazed white painted steel window. Pattern to match existing, but incorporating new air outlet louvre grille.
(Note – consents were obtained to refurbish these windows in 2014, but this application is for replacement as this is needed to incorporate the necessary service grilles as outlined in the Design and Access Statement).

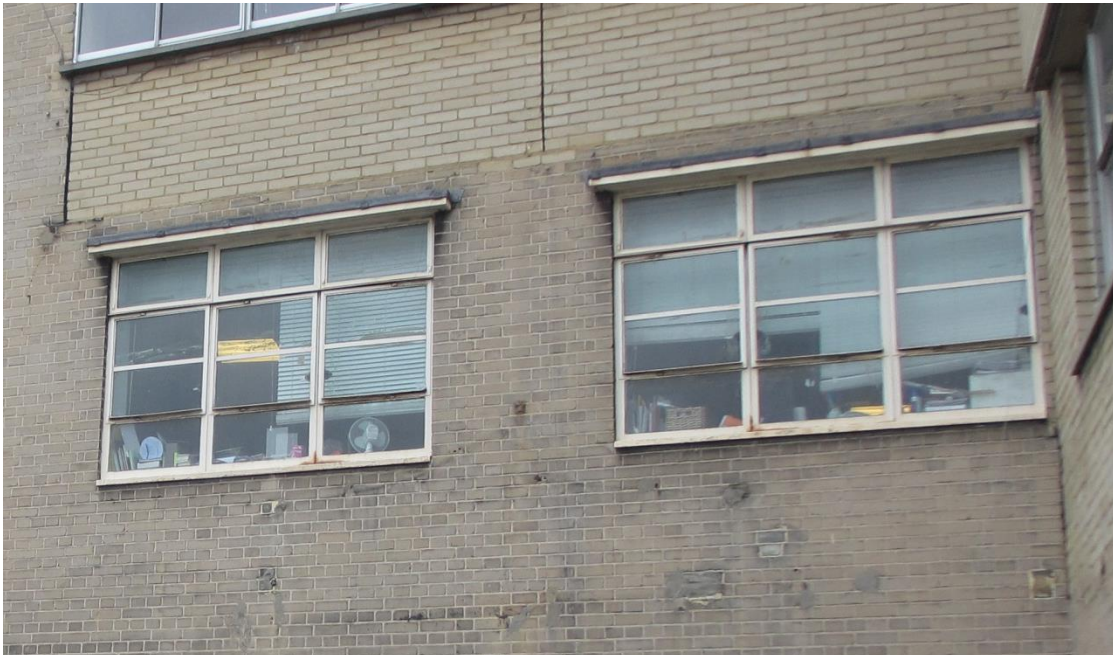
Replacement Window Type 7

Location: 5th floor offices

Material: Steel

Opening type: Pivot with fixed lights and louvres

Scope: New double glazed white painted steel window. Pattern to match existing, but incorporating new air outlet louvre grille.

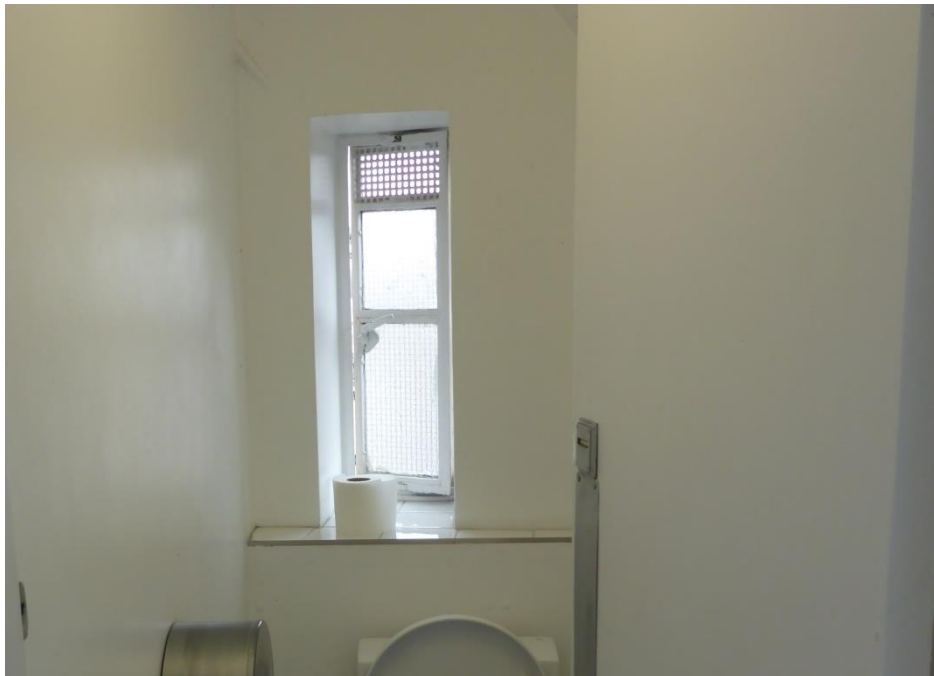
Replacement Window Type 18

Location: 5th floor WC (to become office)

Material: Steel

Opening type: Pivot

Scope: New double glazed white painted steel window. Pattern to match original (as existing has been altered to incorporate permanent ventilation) .

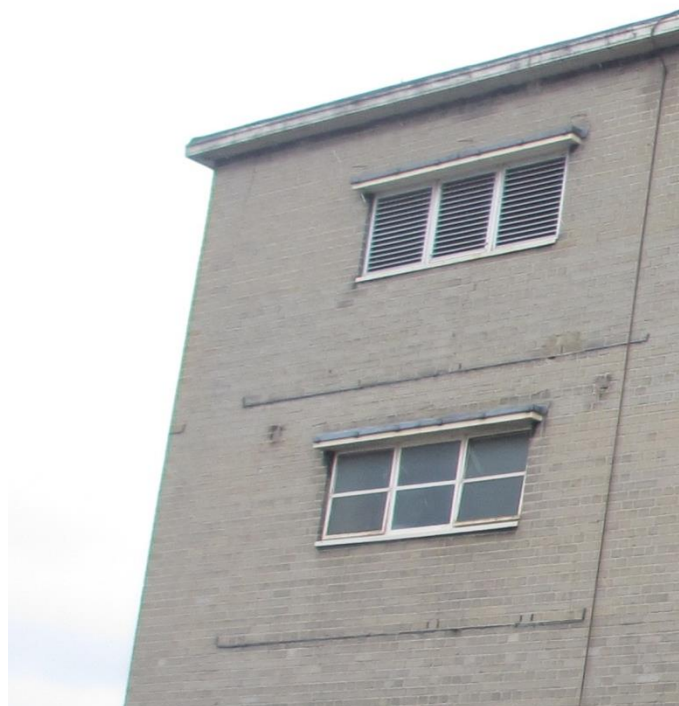
Replacement Window Types 6 & 11

Location: 5th & 6th floor WC/Plant area

Material: Steel

Opening type: Pivot

Scope: New double glazed white painted steel window. Pattern to match existing to W.5.4.7 but with louvre grilles for air extract to WC's.

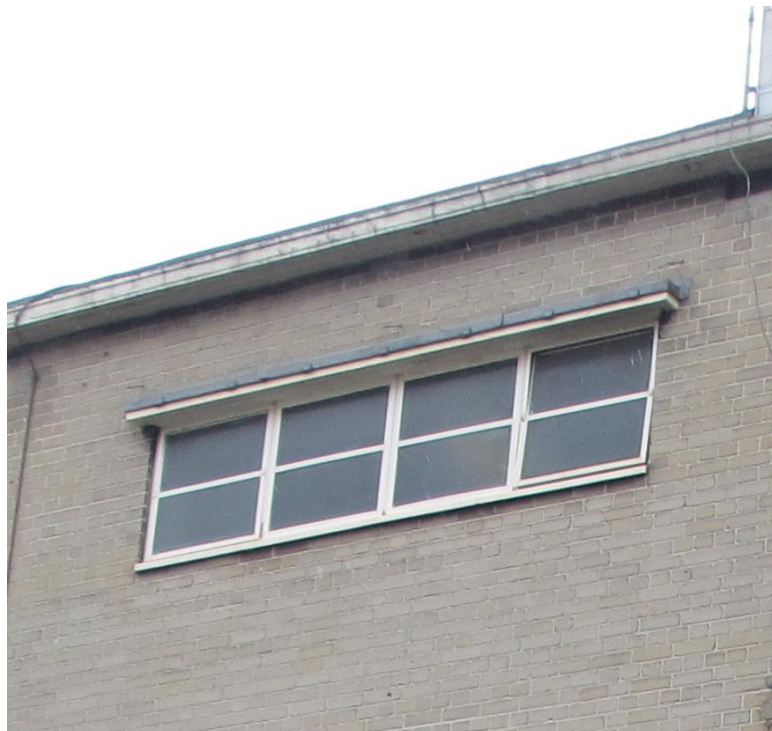
Replacement Window Type 12

Location: 6th floor stairwell

Material: Steel

Opening type: Bottom hung opening out

Scope: New double glazed white painted steel window. Pattern to match existing but with opening lights opening out rather than pivoting to provide smoke extract as required by fire brigade.

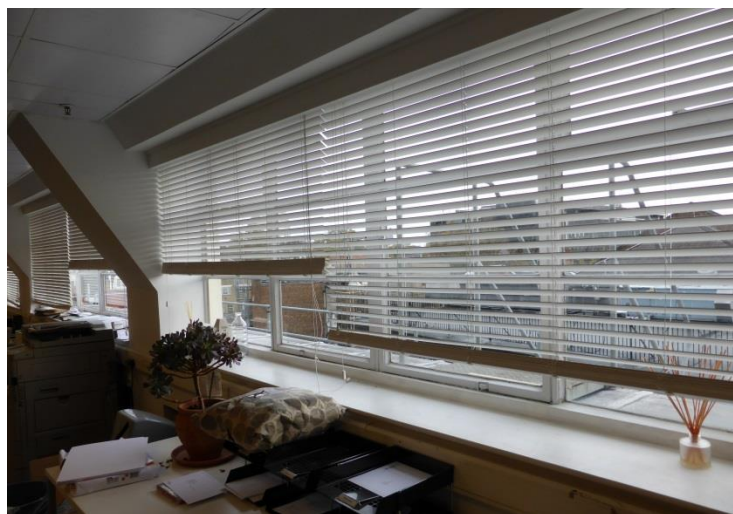
Refurbished windows Types 1 & 2

Location: 5th floor offices

Material: Steel

Opening type: Vertical pivot casement with fixed lights

Secondary Glazing: Yes

Scope: Obtain specialist condition survey of all windows and repair or replace items as required as per the list below.

- 1.) To any distorted windows, straighten and reglaze.
- 2.) Replace defective or ill matching ironmongery.
- 3.) Replace broken or cracked glazing. Replace using putty or beads to match.
- 4.) Replace all mastic seals to intermediate couplings, between window and wall, etc.
- 5.) Replace individual glazing beads where damaged.
- 6.) Replace putty throughout. Rake off old glazing putties. Clean out all old mastics from the glazing rebate. Re-putty glazing with new glazing sprigs (where required) and non-setting metal casement putty.
- 7.) Replace damaged glazing beads.
- 8.) Rust: Investigate and treat as follows:
Sections of window requiring replacement due to rust. Cut out defective corroded bars and replace them with new bars.
Local deep set corroded areas: rake out and fill with bulk metal filler, treat with rust neutralising solution and prime with suitable rust inhibiting primer.

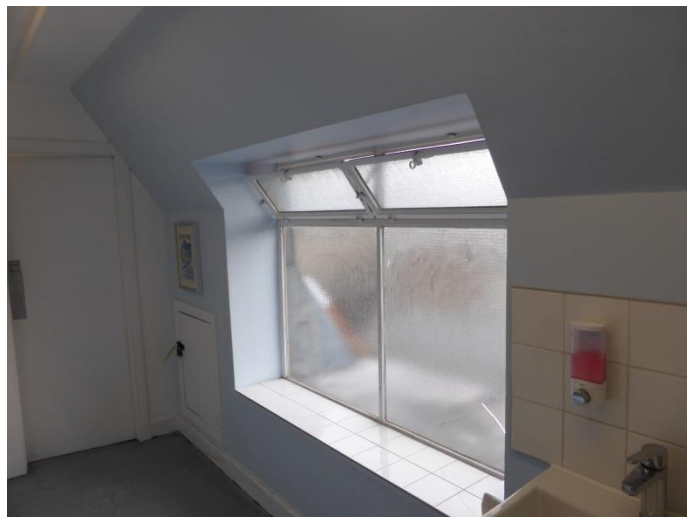
Refurbished windows Type 3

Location: 5th floor WC (to become office)

Material: Steel

Opening type: Bottom hung inward opening casement with fixed lights

Secondary Glazing: Yes

Scope: Obtain specialist condition survey and repair or replace items as required as per the list below.

- 1.) To any distorted windows, straighten and reglaze.
- 2.) Replace defective or ill matching ironmongery.
- 3.) Replace obscure glazing with clear
- 4.) Replace all mastic seals to intermediate couplings, between window and wall, etc.
- 5.) Replace individual glazing beads where damaged.
- 6.) Replace putty throughout. Rake off old glazing putties. Clean out all old mastics from the glazing rebate. Re-putty glazing with new glazing sprigs (where required) and non-setting metal casement putty.
- 7.) Replace damaged glazing beads.
- 8.) Rust: Investigate and treat as follows:
Sections of window requiring replacement due to rust. Cut out defective corroded bars and replace them with new bars.
Local deep set corroded areas: rake out and fill with bulk metal filler, treat with rust neutralising solution and prime with suitable rust inhibiting primer.

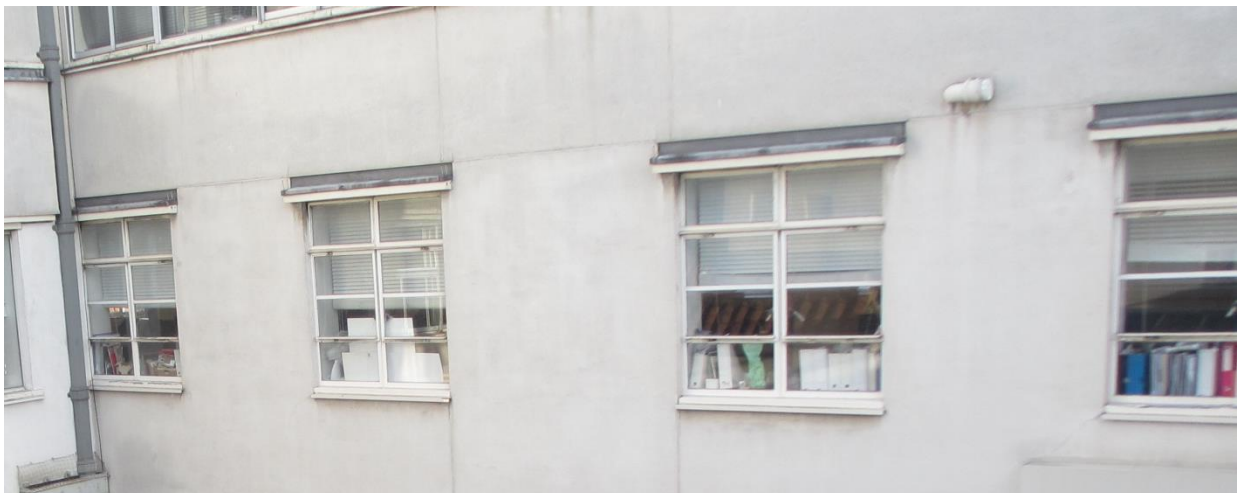
Refurbished windows Type 5

Location: 5th floor offices

Material: Steel

Opening type: Vertical pivot casement with fixed lights

Secondary Glazing: Yes

Scope: Obtain specialist condition survey of all windows and repair or replace items as required as per the list below.

- 1.) To any distorted windows, straighten and reglaze.
- 2.) Replace defective or ill matching ironmongery.
- 3.) Replace broken or cracked glazing. Replace using putty or beads to match.
- 4.) Replace all mastic seals to intermediate couplings, between window and wall, etc.
- 5.) Replace individual glazing beads where damaged.
- 6.) Replace putty throughout. Rake off old glazing putties. Clean out all old mastics from the glazing rebate. Re-putty glazing with new glazing sprigs (where required) and non-setting metal casement putty.
- 7.) Replace damaged glazing beads.
- 8.) Rust: Investigate and treat as follows:
Sections of window requiring replacement due to rust. Cut out defective corroded bars and replace them with new bars.
Local deep set corroded areas: rake out and fill with bulk metal filler, treat with rust neutralising solution and prime with suitable rust inhibiting primer.

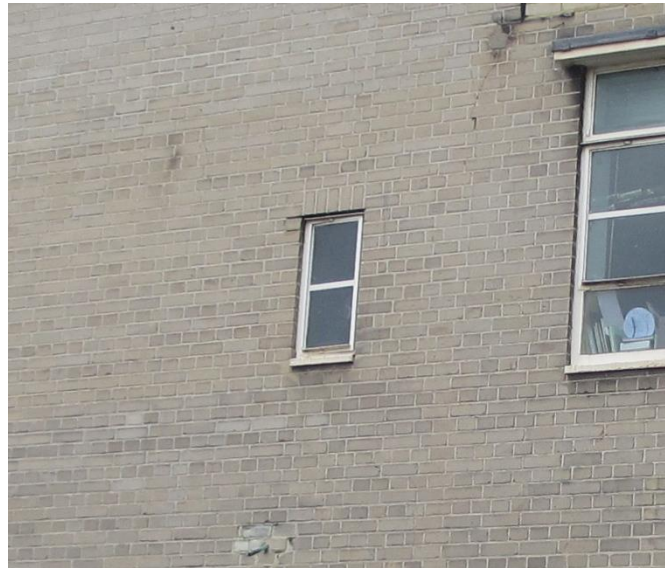
Refurbished windows Types 4 & 6

Location: 5th floor store & WC's

Material: Steel

Opening type: Pivot casement

Scope: Obtain specialist condition survey and repair or replace items as required as per the list below.

- 1.) To any distorted windows, straighten and reglaze.
- 2.) Replace defective or ill matching ironmongery.
- 3.) Replace glazing with obscure or opaque glazing to suit.
- 4.) Replace all mastic seals to intermediate couplings, between window and wall, etc.
- 5.) Replace individual glazing beads where damaged.
- 6.) Replace putty throughout. Rake off old glazing putties. Clean out all old mastics from the glazing rebate. Re-putty glazing with new glazing sprigs (where required) and non-setting metal casement putty.
- 7.) Replace damaged glazing beads.
- 8.) Rust: Investigate and treat as follows:
Sections of window requiring replacement due to rust. Cut out defective corroded bars and replace them with new bars.
Local deep set corroded areas: rake out and fill with bulk metal filler, treat with rust neutralising solution and prime with suitable rust inhibiting primer.

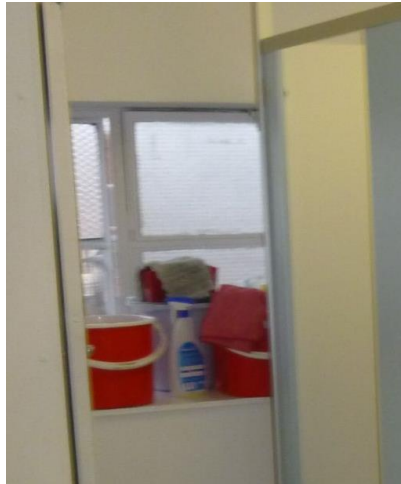
Refurbished windows Type 7

Location: 5th floor WC (to become office)

Material: Steel

Opening type: Vertical pivot casement with fixed lights

Secondary Glazing: Yes

Scope: Obtain specialist condition survey and repair or replace items as required as per the list below.

- 1.) To any distorted windows, straighten and reglaze.
- 2.) Replace defective or ill matching ironmongery.
- 3.) Replace glazing in clear glass. Replace using putty or beads to match.
- 4.) Replace all mastic seals to intermediate couplings, between window and wall, etc.
- 5.) Replace individual glazing beads where damaged.
- 6.) Replace putty throughout. Rake off old glazing putties. Clean out all old mastics from the glazing rebate. Re-putty glazing with new glazing sprigs (where required) and non-setting metal casement putty.
- 7.) Replace damaged glazing beads.
- 8.) Rust: Investigate and treat as follows:
Sections of window requiring replacement due to rust. Cut out defective corroded bars and replace them with new bars.
Local deep set corroded areas: rake out and fill with bulk metal filler, treat with rust

neutralising solution and prime with suitable rust inhibiting primer.

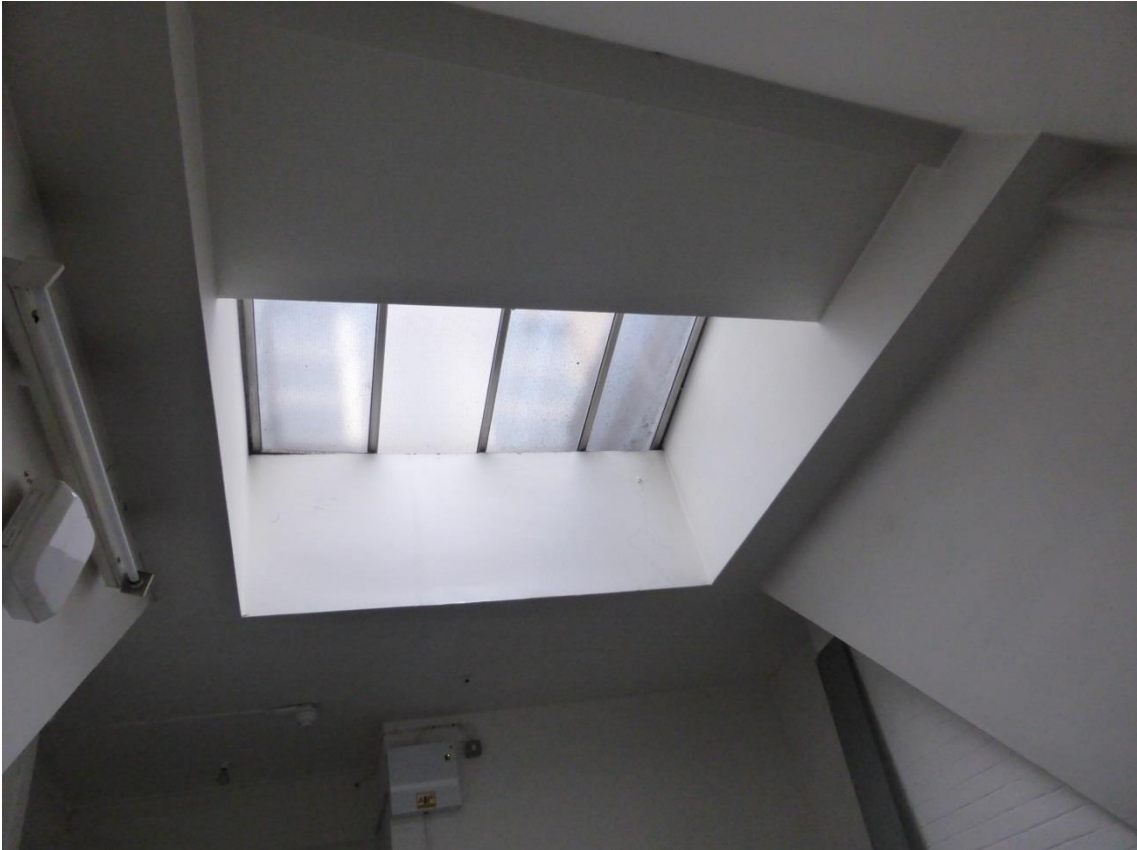
Type – Rooflight to Stair 21

Material: Aluminium

Opening type: Fixed

Scope of works: Replace with new metal rooflight incorporating opening light operated by fire brigade to provide smoke ventilation in accordance with Means of Escape requirements.
