Case Details

Insured	Mr R & Mrs S Brooks	Address	Croftway House, 298 Finchley Road, London, NW3 7AG			
Client	Infront Innovation	Contact	Karen Hanlon Claim No.		IFS-RSA-SUB-09-0014492	
MT Ref	NL/2403091554/TP	Contact	Thomas Peppiatt	Contact No.	08702 416 180

Scope of Report: To survey the property and determine significant vegetation contributing to subsidence damage, make recommendation for remedial action and assess initial mitigation and recovery prospects. The survey does not make an assessment for decay or hazard evaluation.

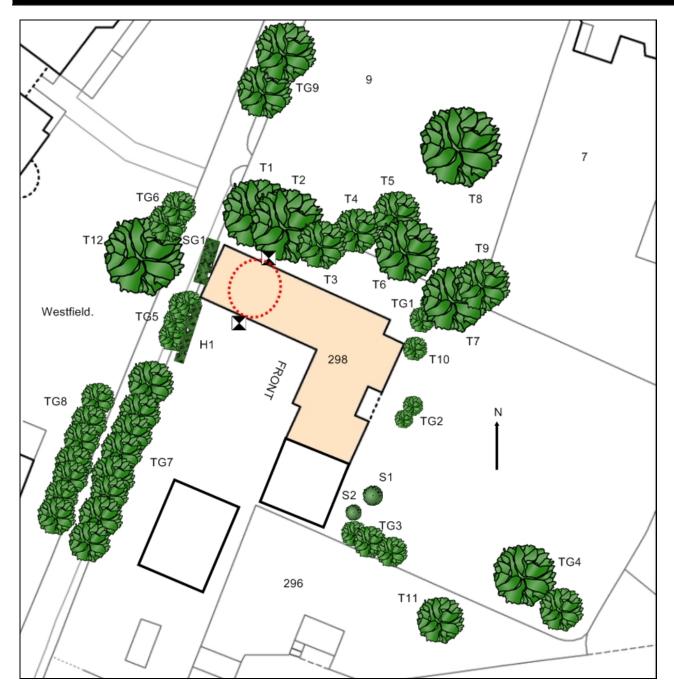
7. Site Plan

Please note that this plan is not to scale. OS Licence No. 100043218

Based on our observations on site and with reference to supporting technical information, it is our opinion that T1 (Ash), T2 (Acer), and T12 (Oak) will be exerting the principal vegetative influence in respect of the current damage.
