Planning Design Statement

6 Perrins Court
London NW3 1QS

May 2013

Richard Mitzman architects llp

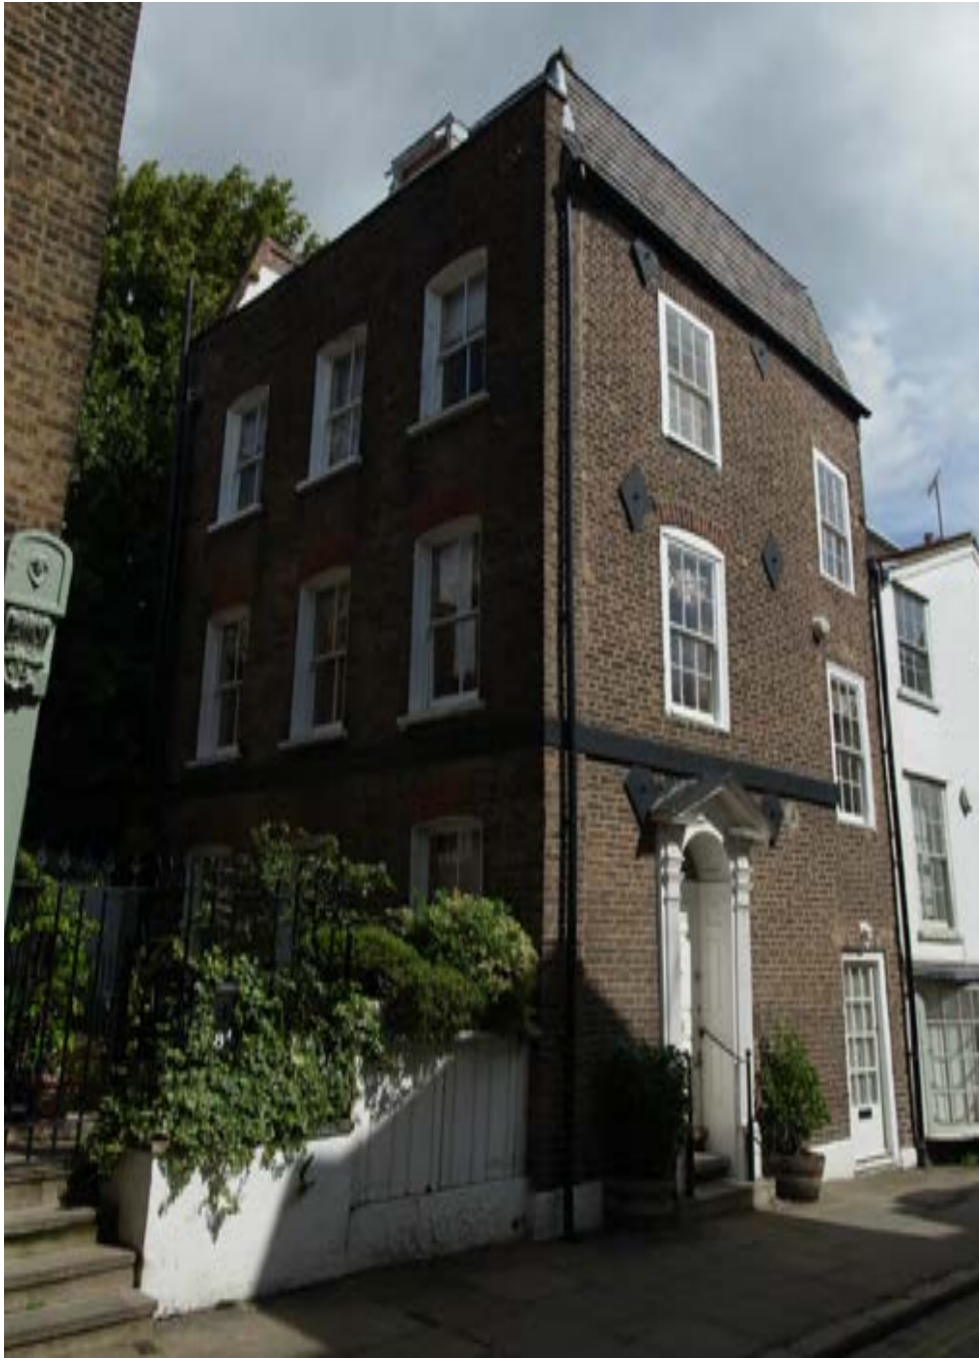
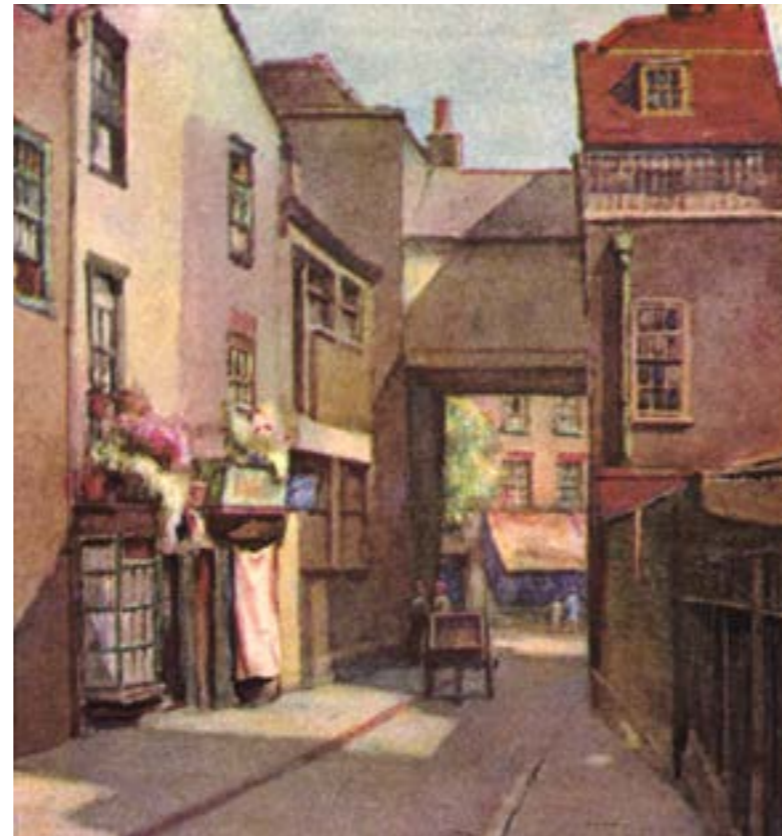
The drawing is of Perrins Court in the 1930s

The part-glazed door opening directly onto the passage pavement noted to the right is wrongly identified as the original entrance. No opening is shown on the 1930s watercolour in this position. The bricks forming the soldier course head appear to be re-used stocks of varying colour and size, and 20th century work.

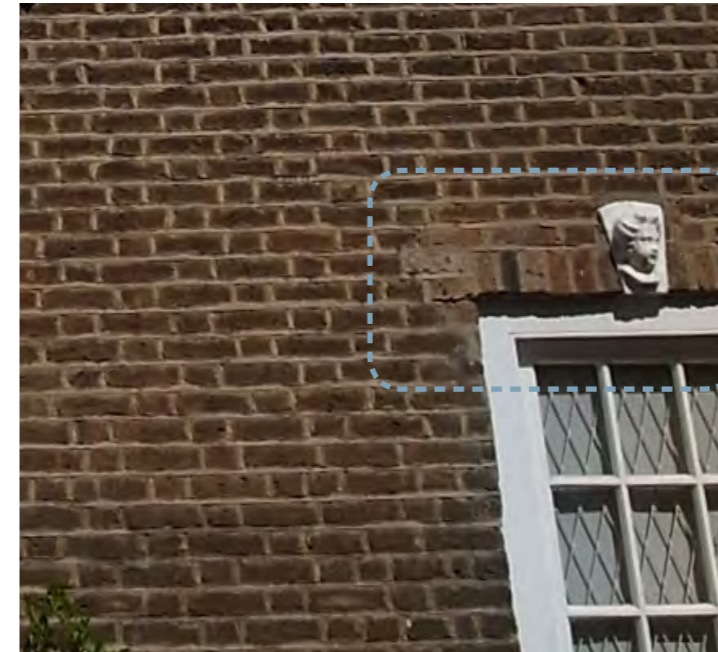
1. Mismatching colours of the upper two brick courses and the pointing indicate the extent to which we believe the original Georgian window opening was infilled

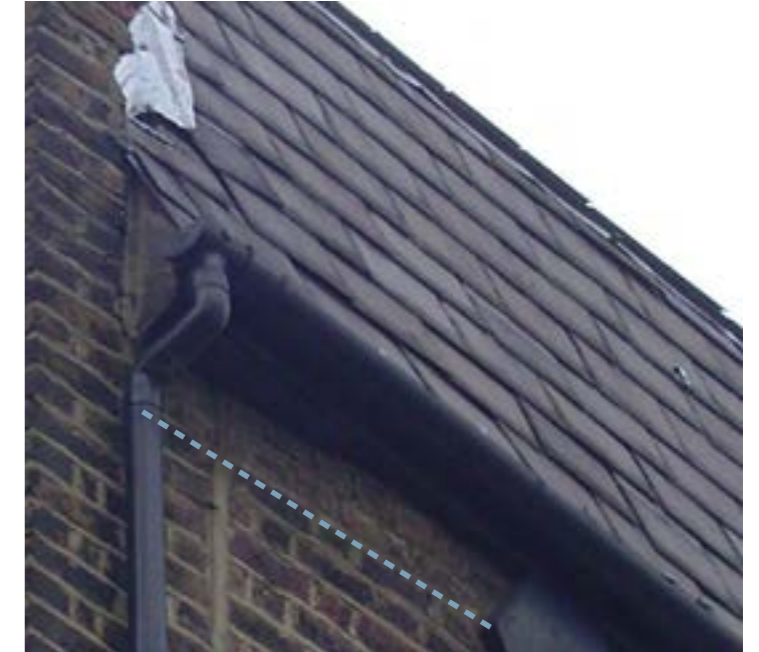
2. Mismatching colours of the upper two brick courses indicate the extent to which we suspect the old parapet was removed when the loft extension was introduced.

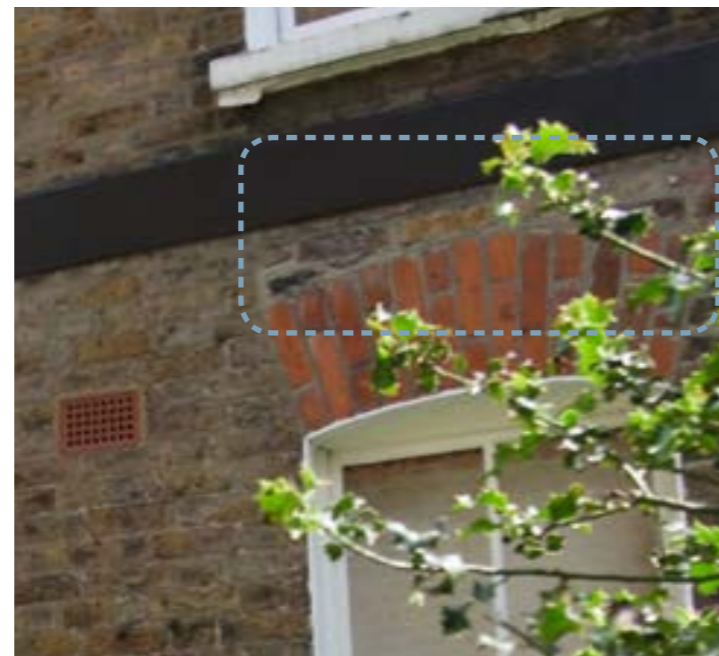
3. Infill brickwork to previous main entrance along the South West elevation clearly visible above the window arch as seen with the differing colour bricks and paler pointing.

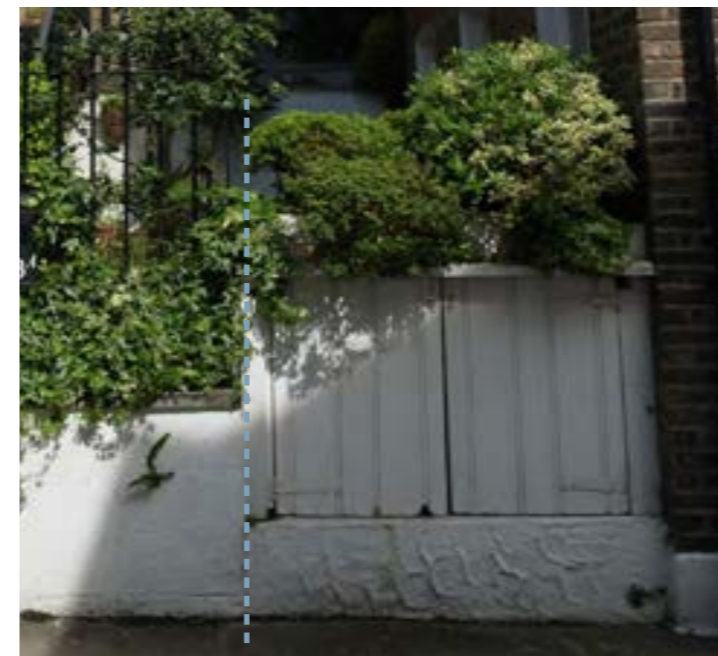
4. Original location of off street entrance visible as indicated by the blue line, the change in masonry styles, and the lack of original features such as coping stone and railings.

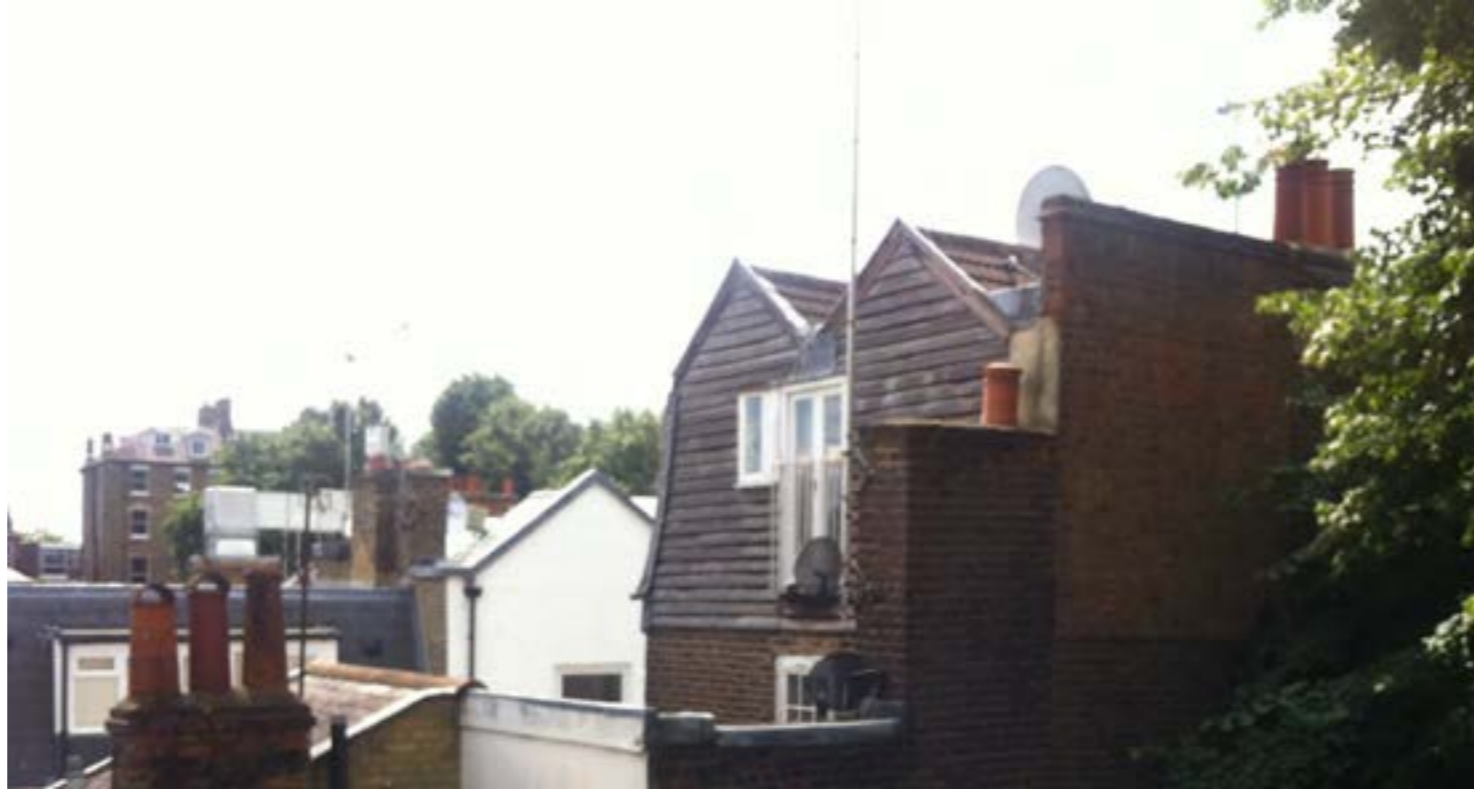
1. View of 6 Perrins Court loft extension with weatherboard gables

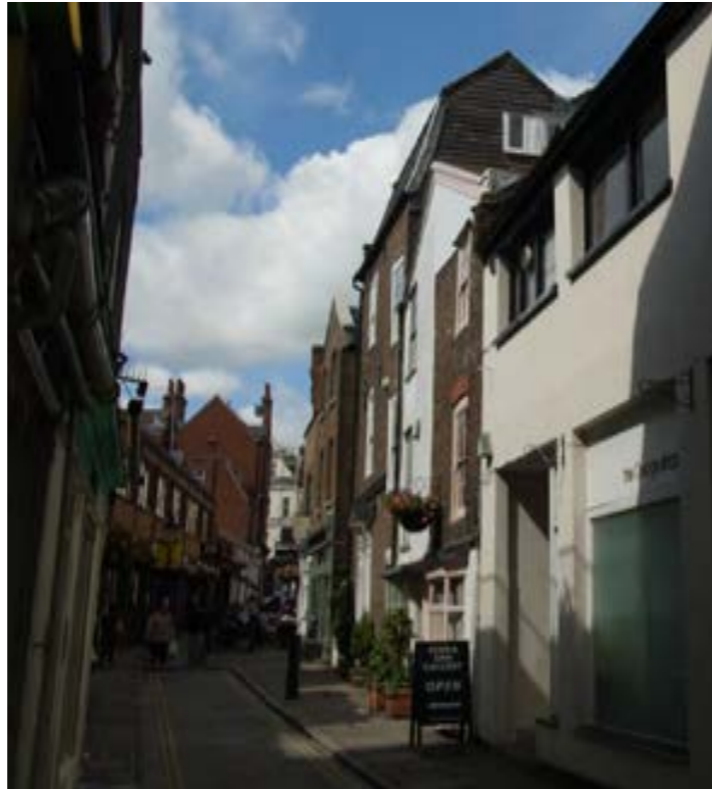
3. View of 6 Perrins Court from Hampstead High Street illustrating the existing weatherboard gable ends.

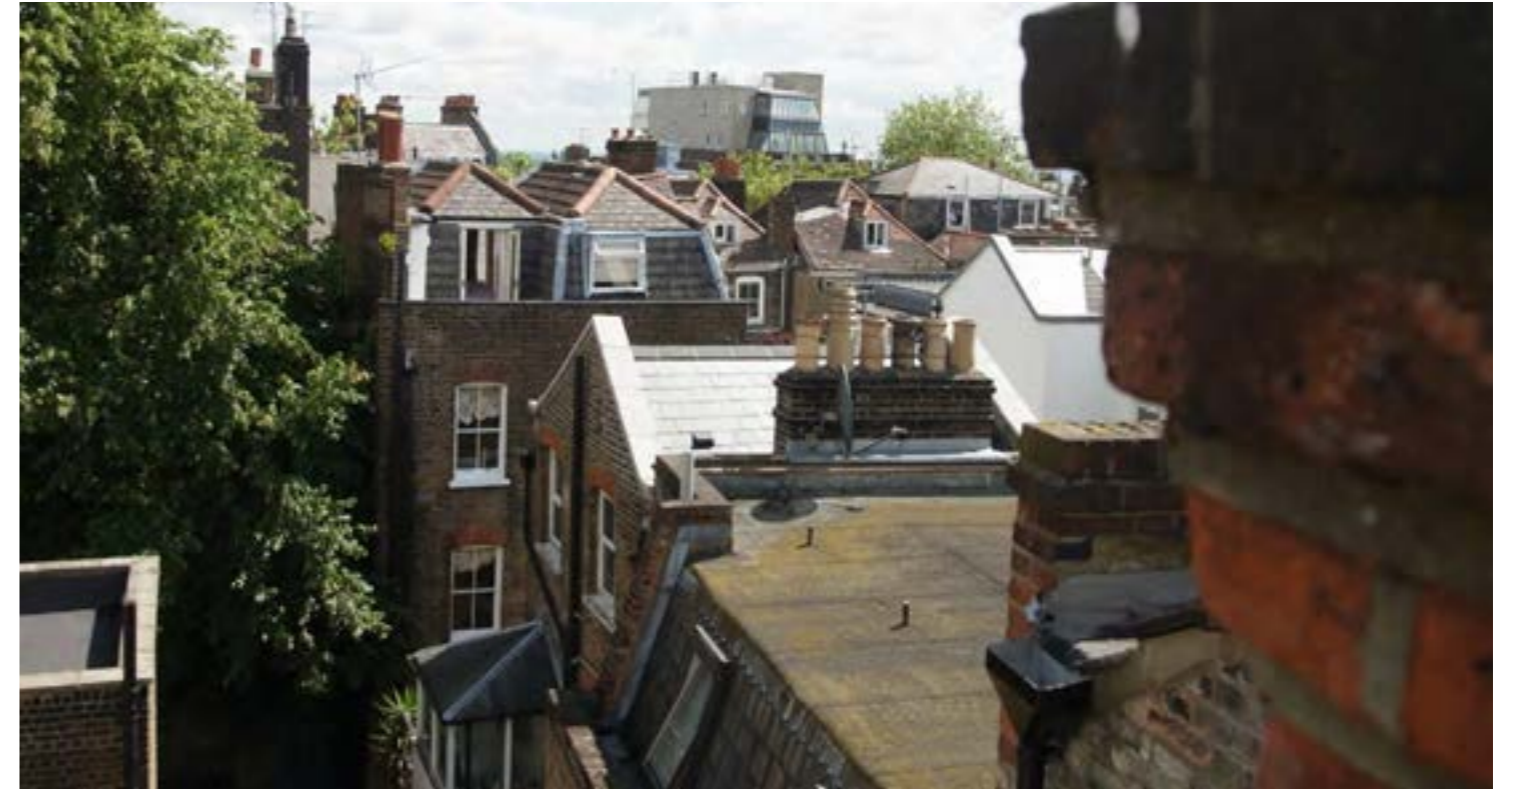
4. View of 6 Perrins Court roof alterations and terrace

Unchanged with no loss of amenity. The existing terrace on fourth floor will be replaced with the proposed terrace at roof level. The proposed roof terrace will only overlook Perrins Court and Oriol Court.

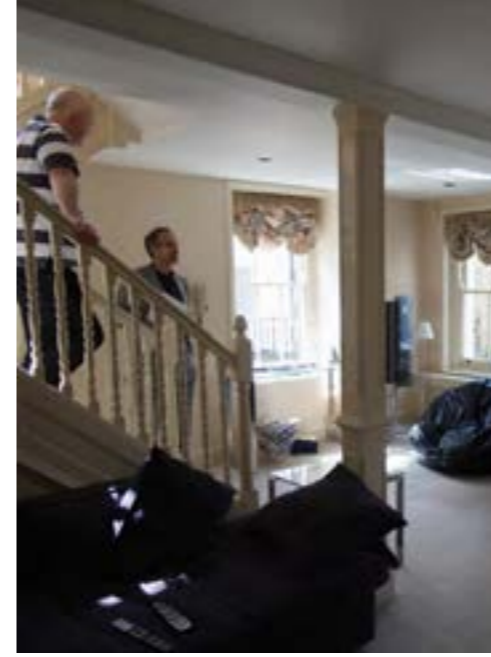
2. Column dating from 1966 works.

The post inserted in 1966 to support the spine beam intrudes into the space. A means should be found to remove it, along the lines suggested by the structural engineer.

The 1966 drawings show that circular hollow section steel posts were inserted beneath each of the floor beams at around mid-span: until then, the beams had spanned clear between the external walls. These posts have simple rectangular end plates which are screwed to the top or underside of each beam and so could be removed with negligible damage. These drawings also show narrow stair wells being formed through the ground and 2nd floors alongside the west wall so that the maisonettes had their own internal stair, and these same wells as being closed up again in 1997. Hence here modern replacement softwood joists should be anticipated. Although not shown on these drawings, the joists between the ground floor fireplace and the beam, which are exposed below, are also not original but modern replacements and are supported on a trimmer that is

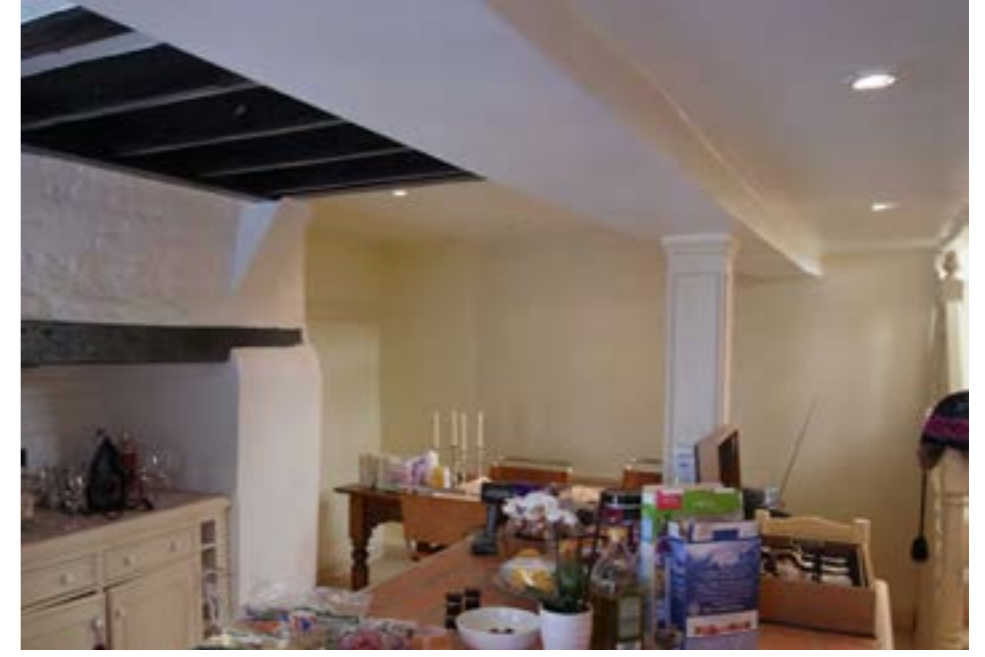
3. Low and inconsistent ceiling levels at Lower Ground Floor likely resulting from changes to the floor level above over the years.

- It is proposed to lower the floor of the basement level as the ceiling level is below 2m in places.
- There is an existing glass and steel canopy that covers a large proportion of the basement court yard. It is proposed to remove the canopy and replace it with a single frameless glass panel, supported on minimal perimeter fixings that will enable the yard to be enclosed.
- As part of the reinstatement of the original roof profile it is proposed to replace the two dormer window with conservation rooflights.
- A minimal glazed rooflight enables access to the roof terrace.
- New opening sash windows are to be installed along the South East Facade.

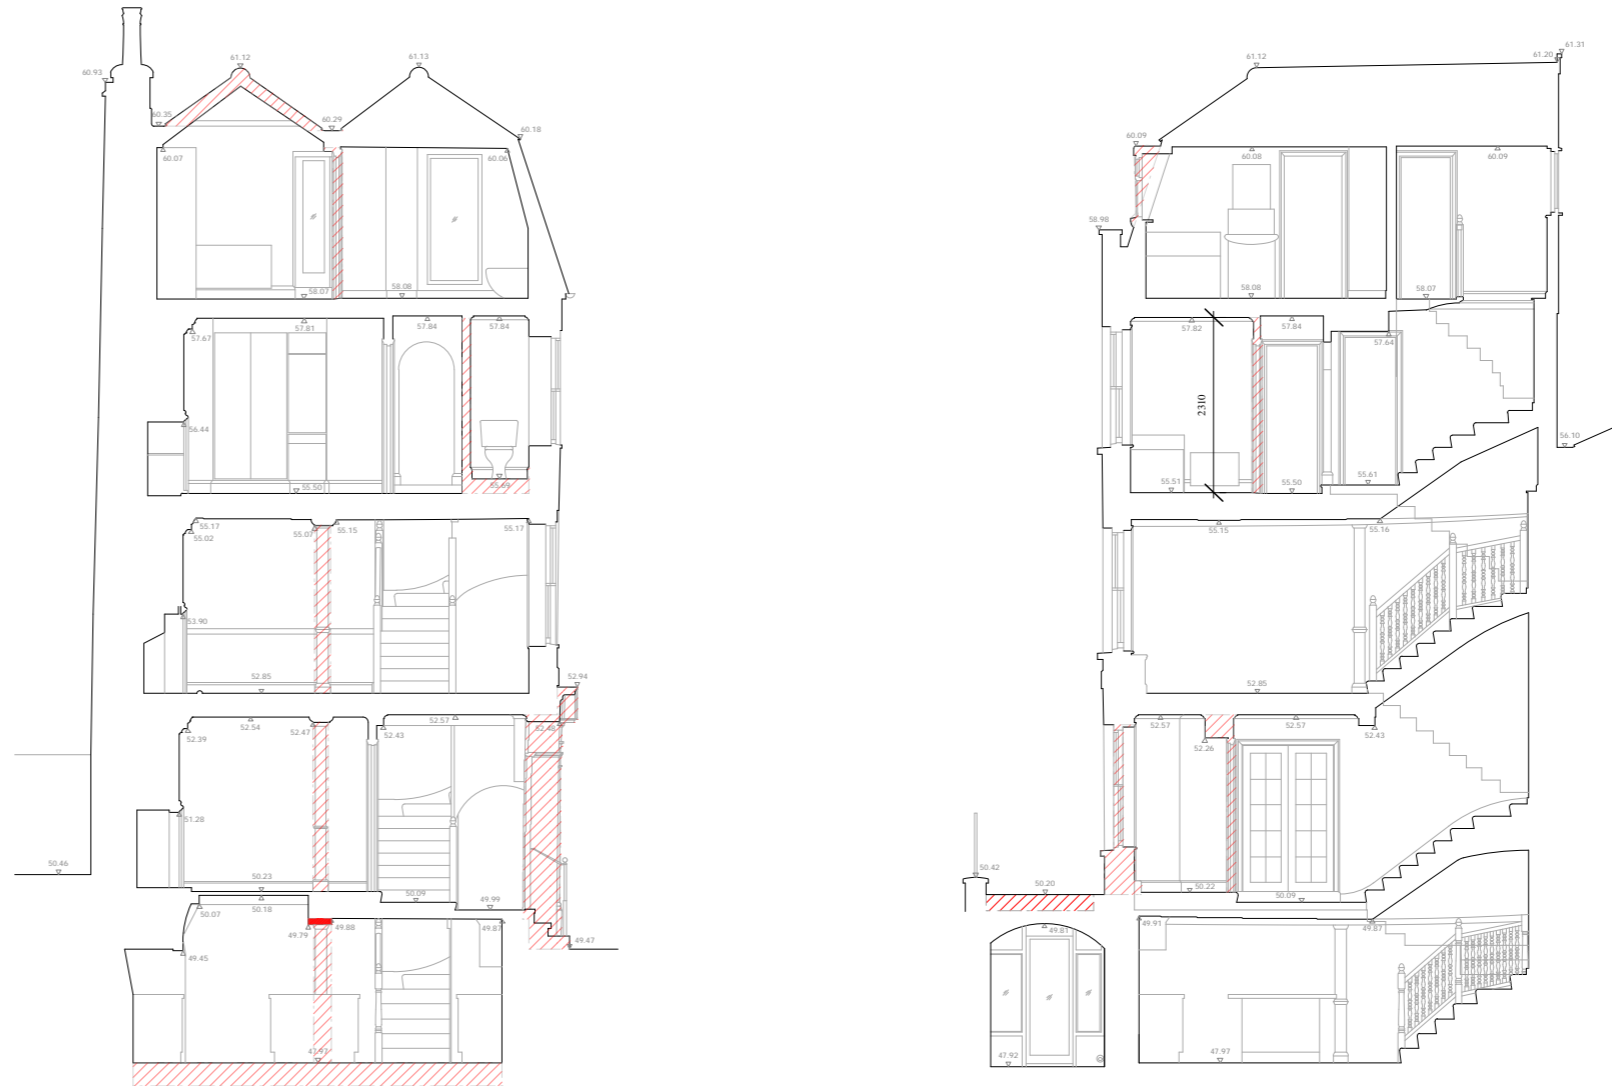
4.02 Existing Sections Indicating Proposed Demolition Works

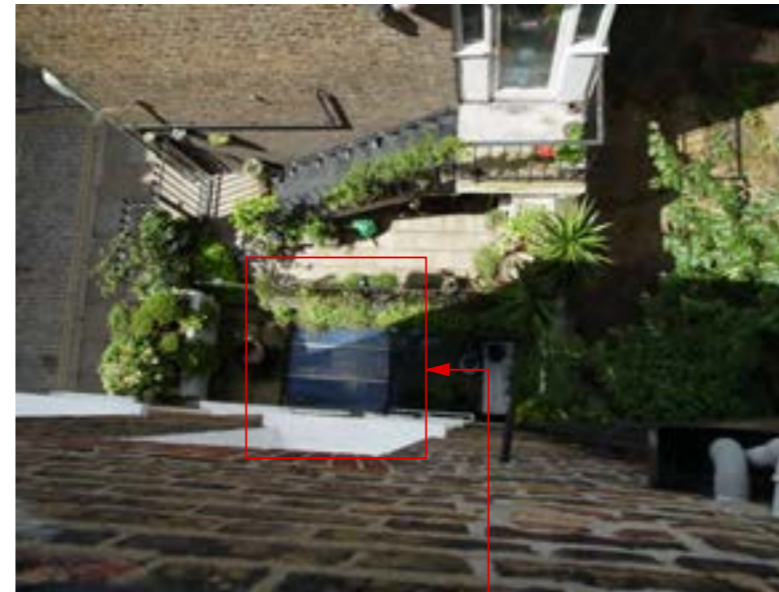
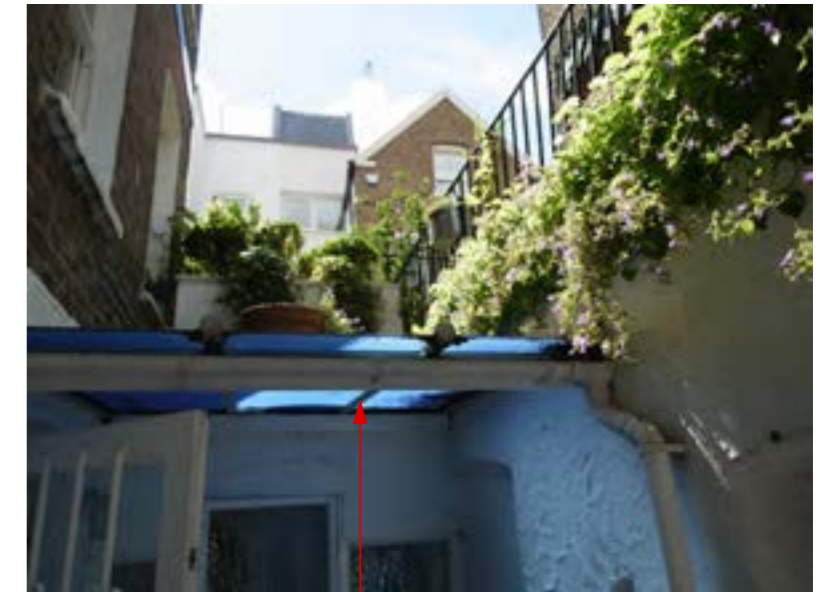
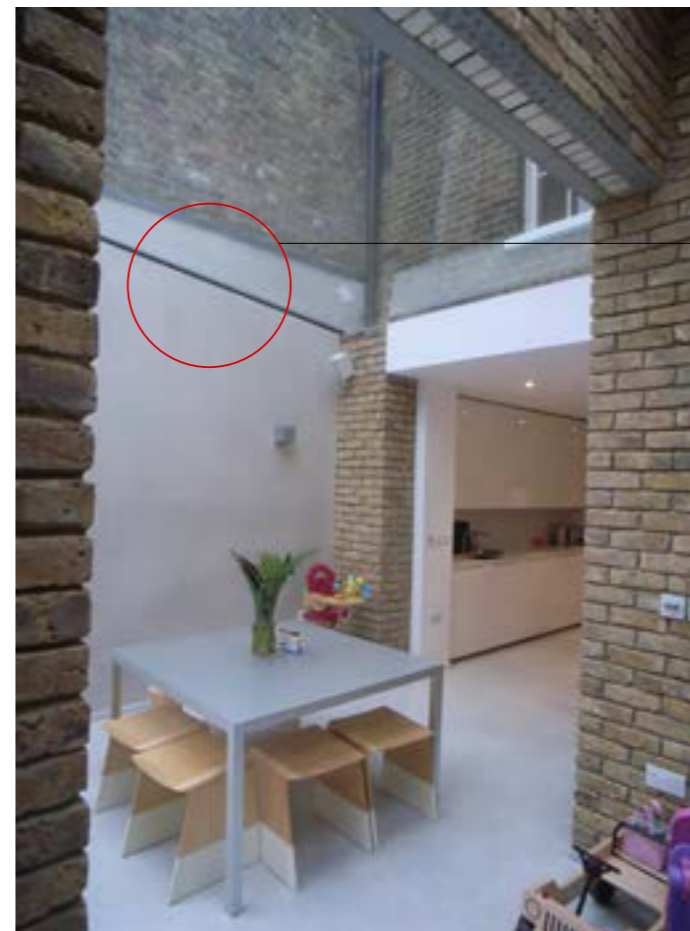
5.05 GLAZED ROOF STUDY

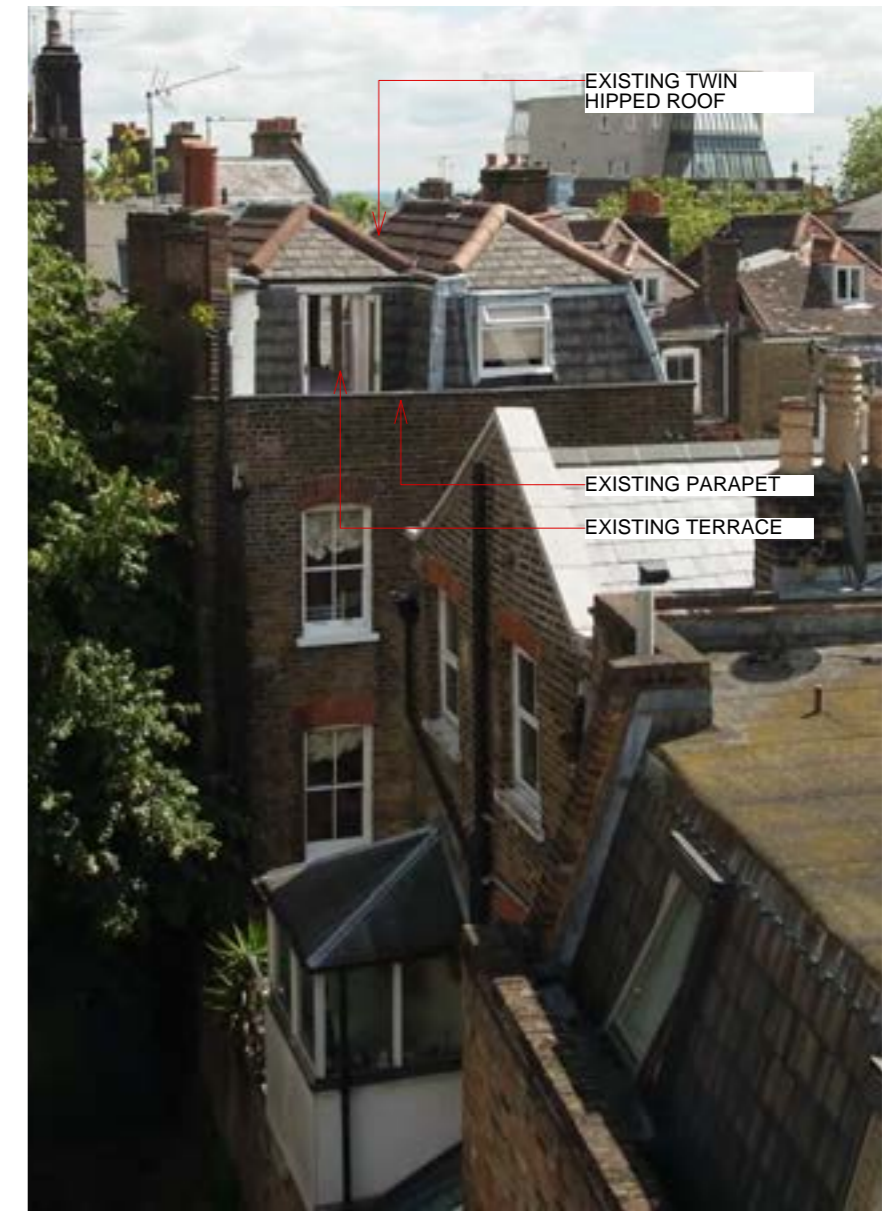
03 Photo of Existing Roof

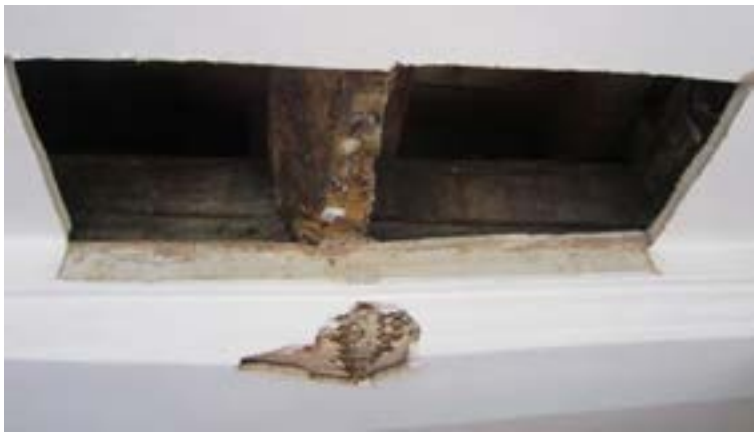
All of the beams are now clad in plaster, a plain boxing in the basement and moulded on the upper floors. However inside the basement boxing, the beam was found to be moulded, apparently by fixing moulded lengths of timber to an underlying rectangular beam, and then painted.

On the upper floors, the moulded profile of one of the beams proved to be run in plaster on expanded metal over a rectangular section with a plain chamfer on its bottom arrises: this is confirmed by the 1st floor beam as part of its plaster casing is missing. The moulded plaster casings are therefore probably both a modern addition to increase the beams' fire resistance when the house was in multiple occupation, and also reproduce an

Plaster casing tail-off
& underlying timber
sections exposed.

Beam over covered in plaster moulding
run over expanded metal web fixed
to rectangular timber beam with
plain chumpins along bottom chord.

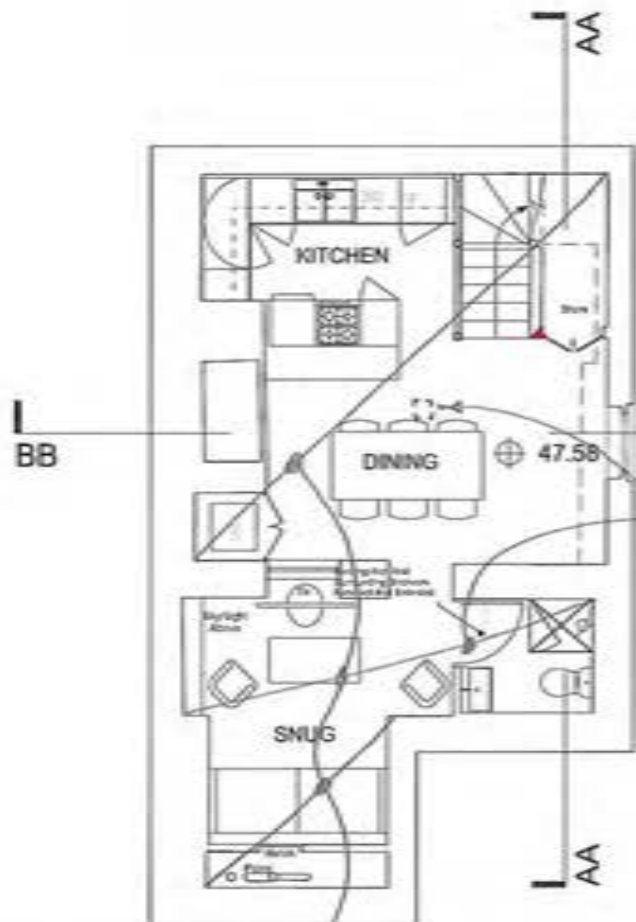
PROPOSED BASEMENT

Lowering of the basement floors would require the existing walls to be underpinned: this can be achieved with minimal adverse effect on the structure

Drainage below the ground would need some attention.

Steel posts can be removed on all floors and the floors levelled with minimal loss of historic material.

The proposed lowering of the basement floor, the yard and the adjacent vault is entirely possible by conventional underpinning in bays around 1m long, and this would have little effect on the structure above as long as it is done carefully and competently. Although some slight longer term movement may occur as the foundations settle down, the flexibility of the superstructure should accommodate these without distress. The drainage is reasonably deep below the yard, but the shallower drain runs will need to be re-laid. This lowering of the floor would remove any traces of previous construction on the site, such as the cobble paving seen beneath the north-east corner, but neither of the trial pits within the house revealed any earlier floors: these were probably removed when the present concrete ground slab was laid.
