PROJECT QUAD LIMITED
PROJECT QUAD
GROUND MOVEMENTS REPORT
REVISION 2
March 2015

GROUND MOVEMENTS REPORT

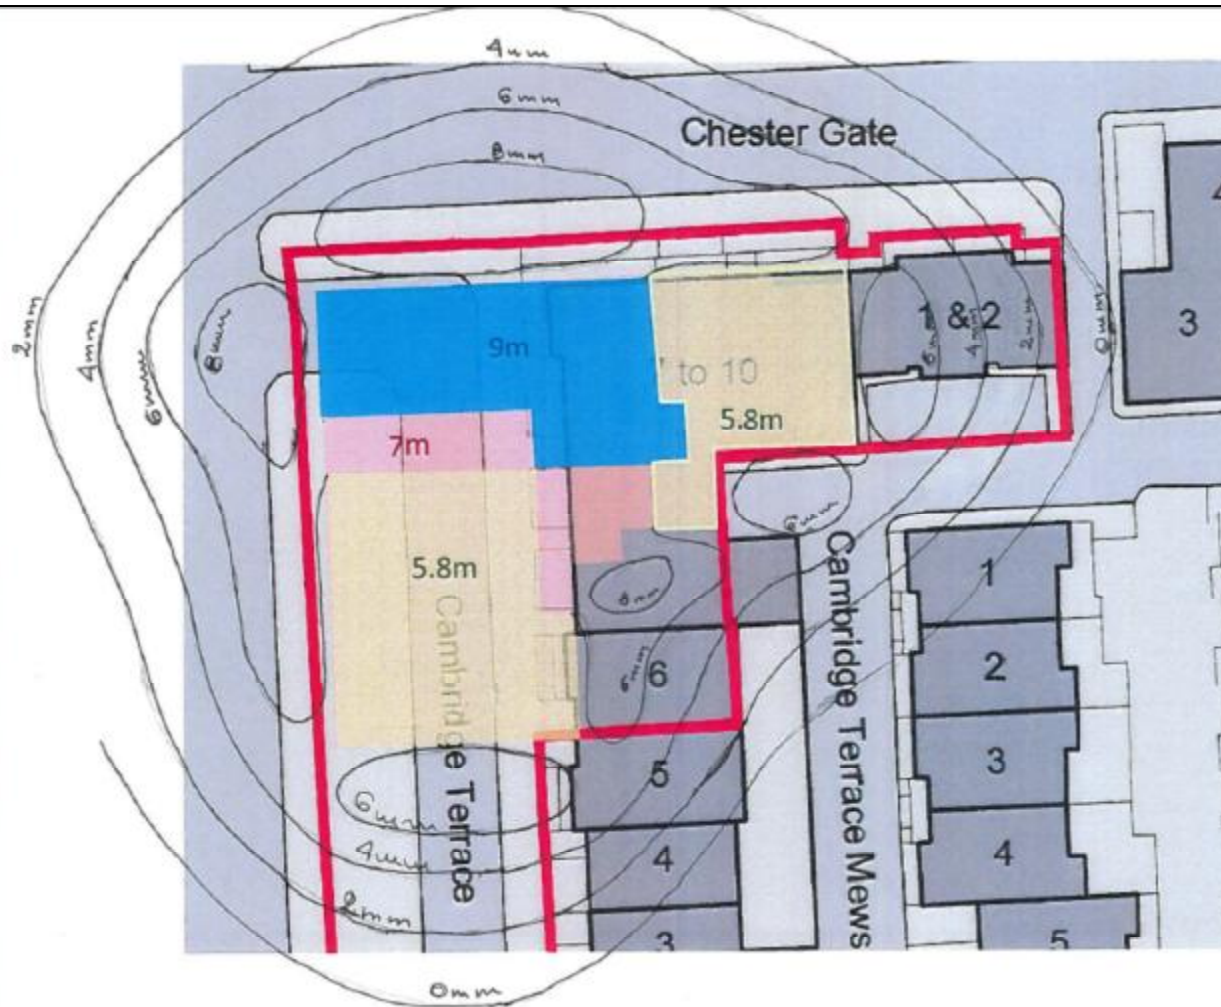
Project Quad Limited Project Quad	Figure 8
	Ground movements induced around the site Vertical movements due to basement excavation and installation of bored piles

Contour plots of the predicted ground movements due to the combined effect of excavation and bored pile installation around the basement area have been constructed and are shown in Figures 8 and 9.

The basement construction would induce ground movements on the surrounding area that would induce the structures around the basement to settle and move towards it as shown in Figures 8 and 9. The structure No. 7 Cambridge Terrace is supported on piles and therefore it is unlikely to be significantly affected by the induced ground movements. Similarly, there would not be significant effect on the party walls of No. 6 Cambridge Terrace, which are supported on piles. However, it is understood that this structure has other load bearing masonry walls, which are likely to be affected by the movements. Distortions could therefore occur on this structure. This is part of the site and damage would be repaired after the basement works are completed.

Behind the wall, ground would distort during excavation as shown in Figures 8 and 9. The potential damage of these ground movements on the house can be estimated as suggested in CIRIA C580 by looking at the combined effects of the horizontal strains and the deflection ratio, which is the ratio between the maximum distortion of a structure and its length.

As shown in Figures 8 and 9 the ground movements induced by the basement construction would tend to make this house tilt towards the new basement.

Figures 8 and 9 show that the predicted ground movements are not expected to extend under these houses except on No.1, which could experience minor distortions. These are unlikely to cause damage higher than Category 0 ('negligible').

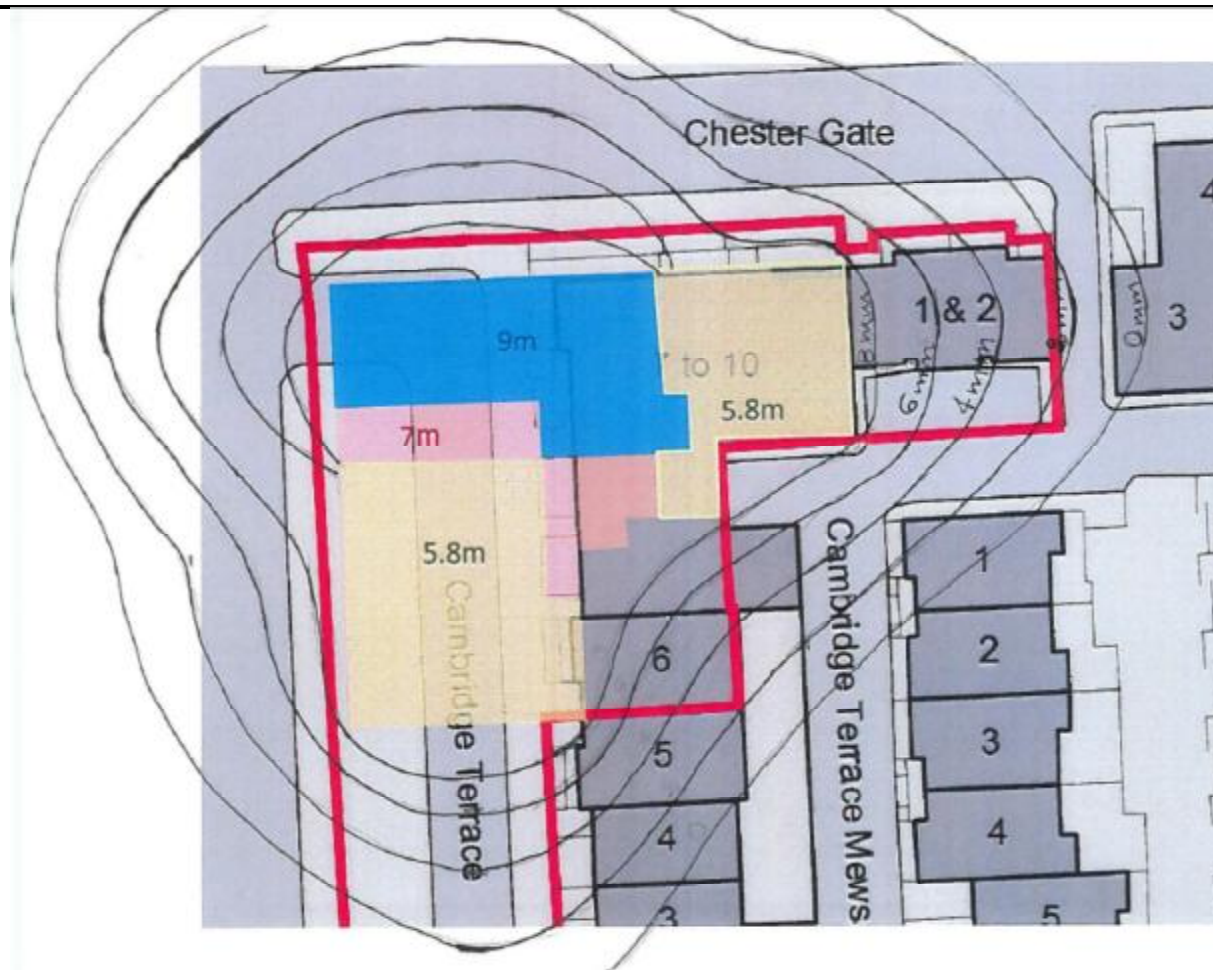
Project Quad Limited Project Quad	Figure 9
	Ground movements induced around the site Horizontal movements
